West of Devers Upgrade Project

Figure D.18-1
Viewshed Analysis
Segment 1

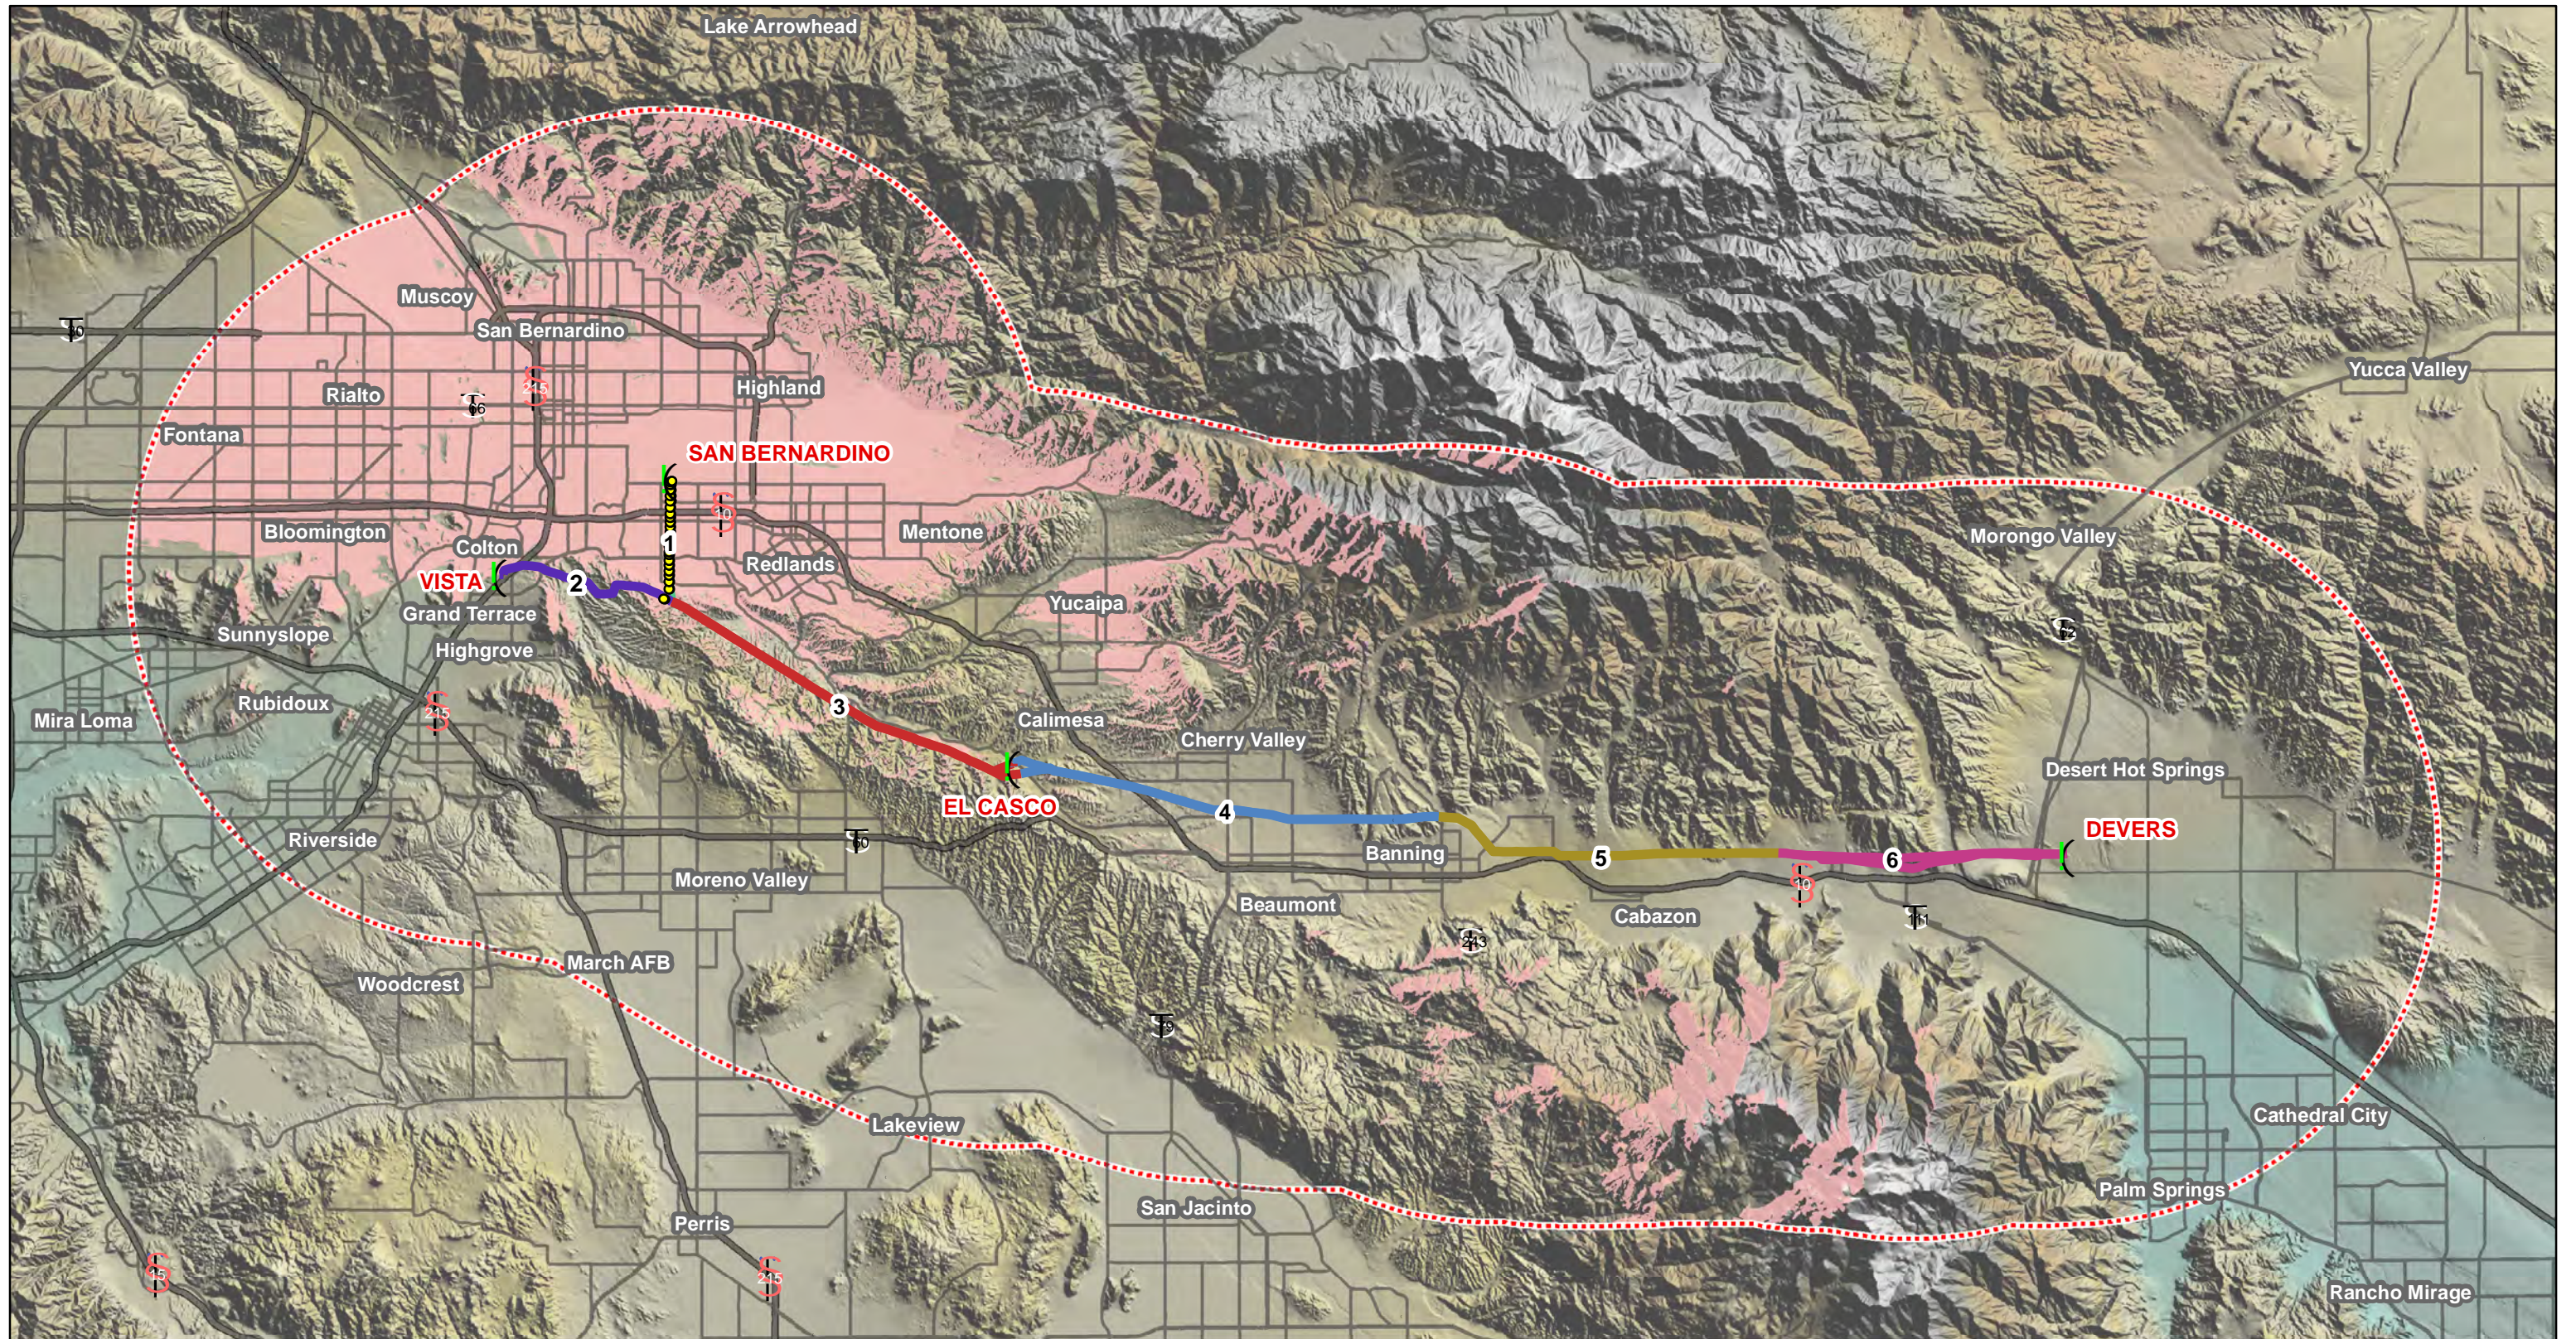
Segment 1 Structures (Proposed or Modify)
-

Visibility of Segment 1 Towers

Not Visible
-

Visible
