West of Devers Upgrade Project

Figure D.18-2
Viewshed Analysis
Segment 2

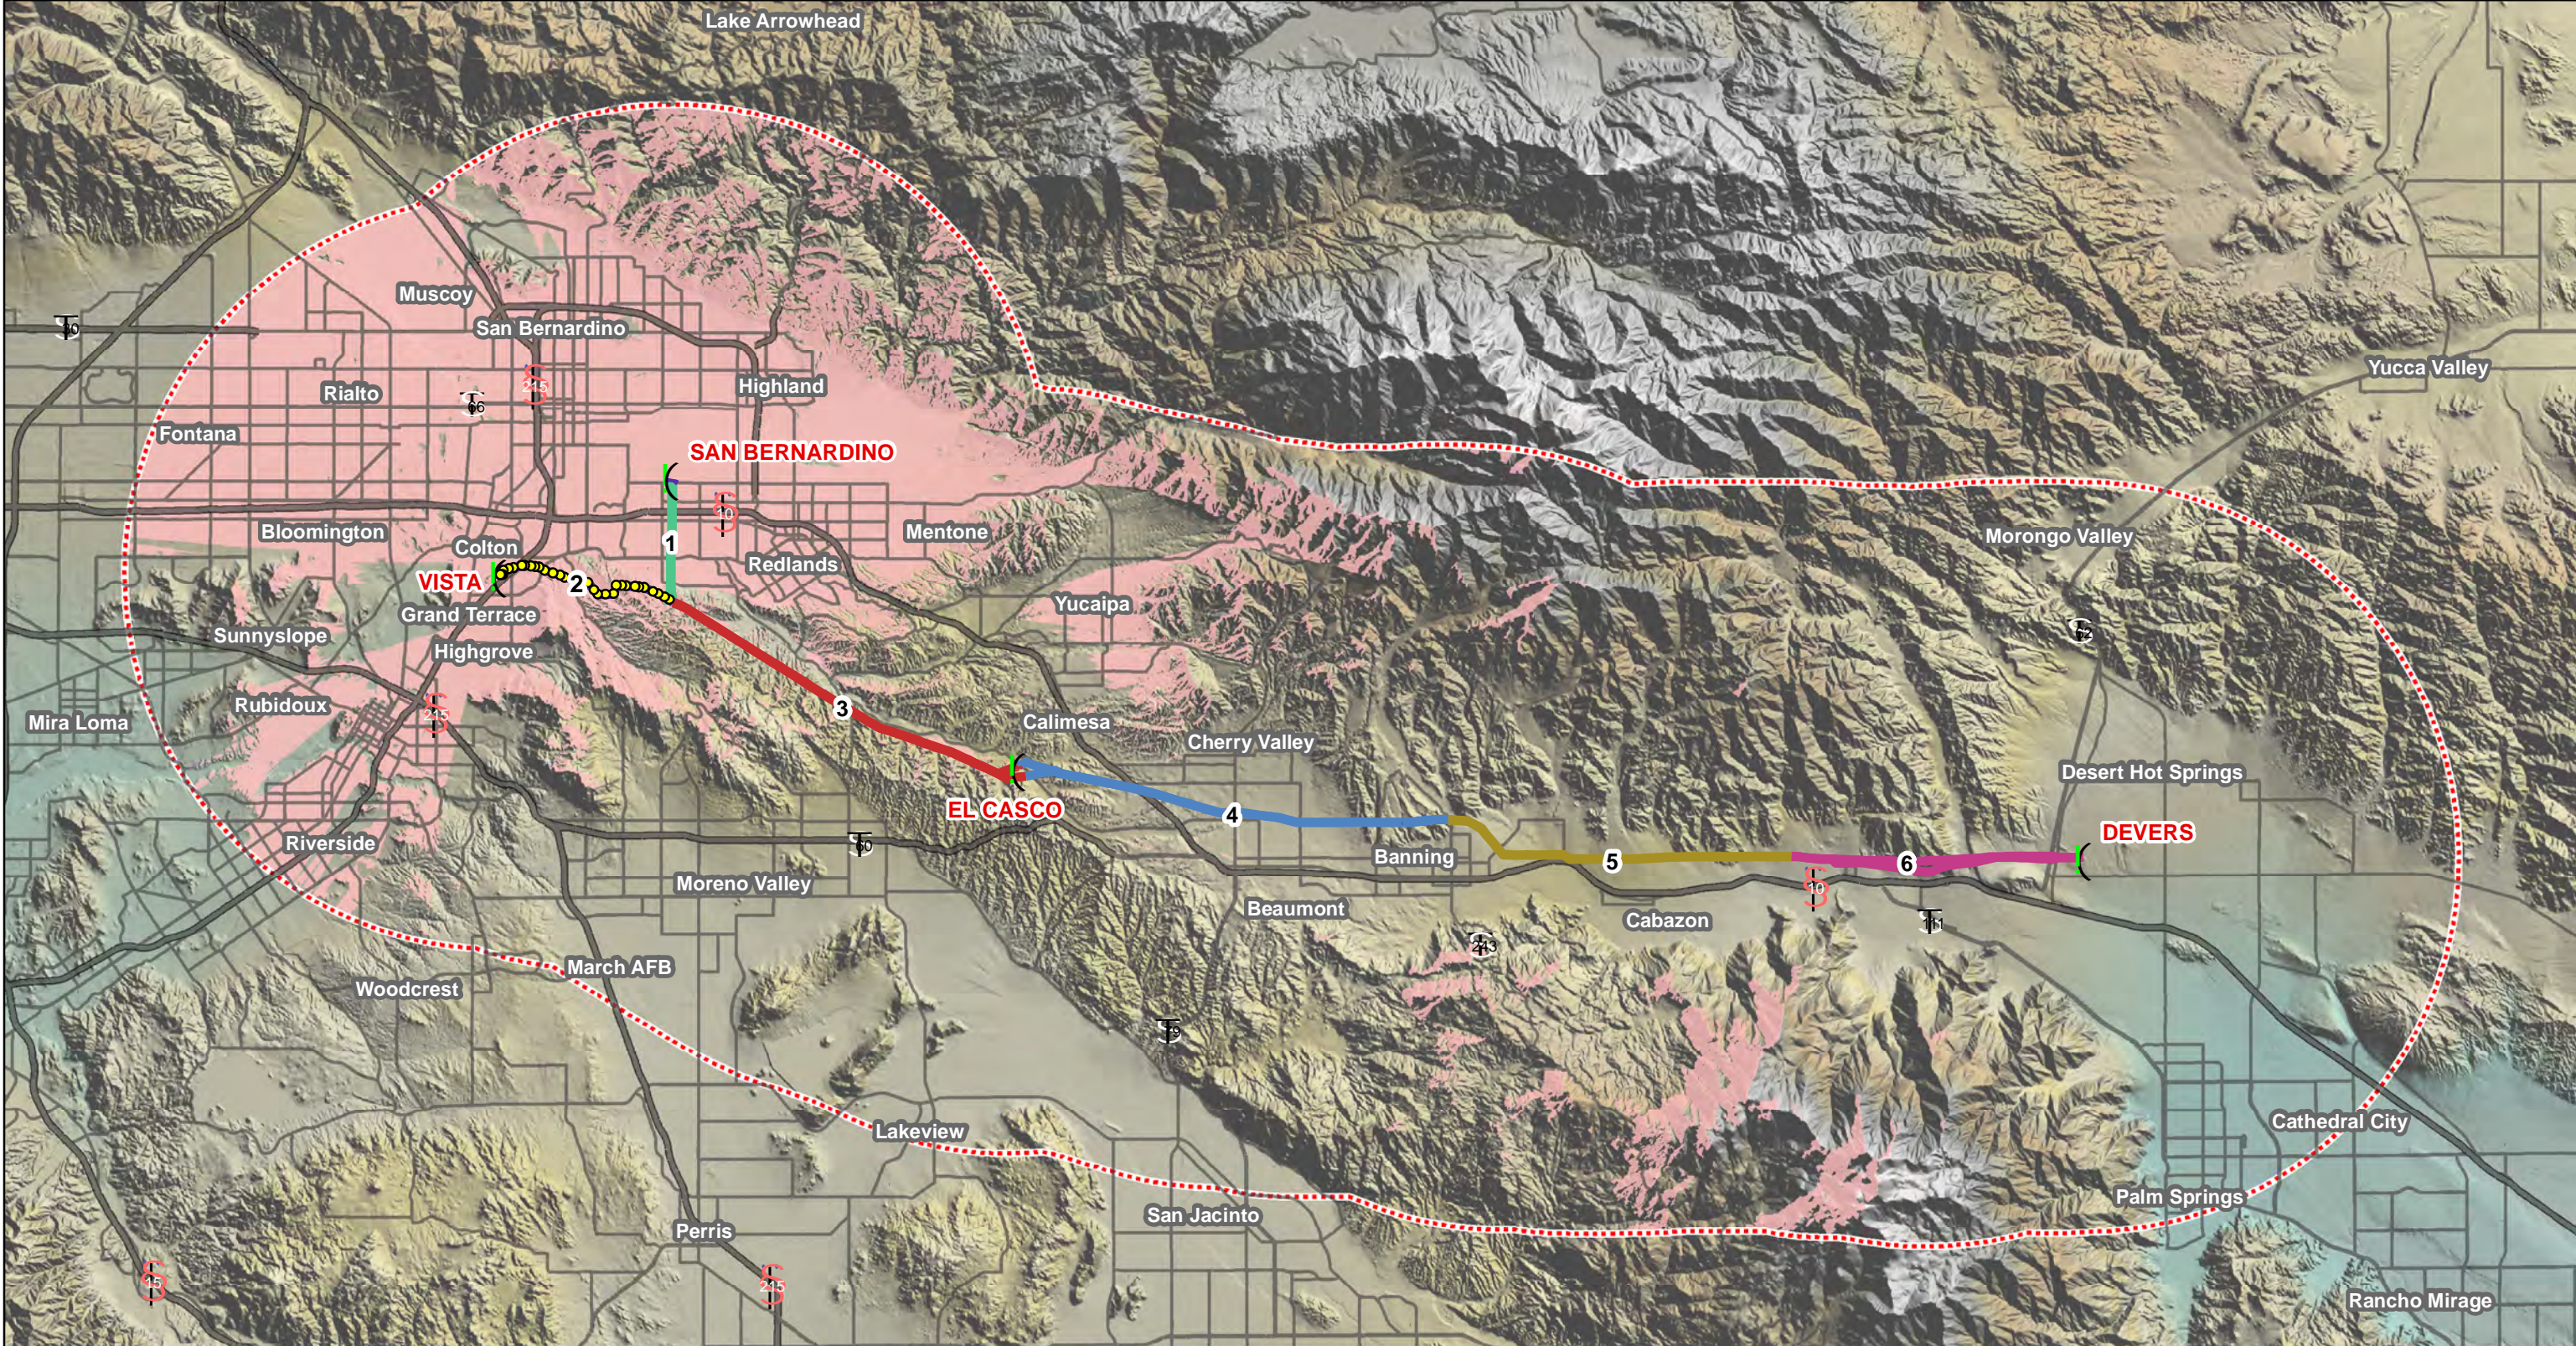
- Segment 2 Structures (Proposed or Modify)
- ⌈ Substation
- 10-mile Buffer around Project

Transmission Line Segment

Visibility of Segment 2 Towers

- Not Visible
- Visible
