West of Devers Upgrade Project

Figure D.18-1
Viewshed Analysis
Segment 1

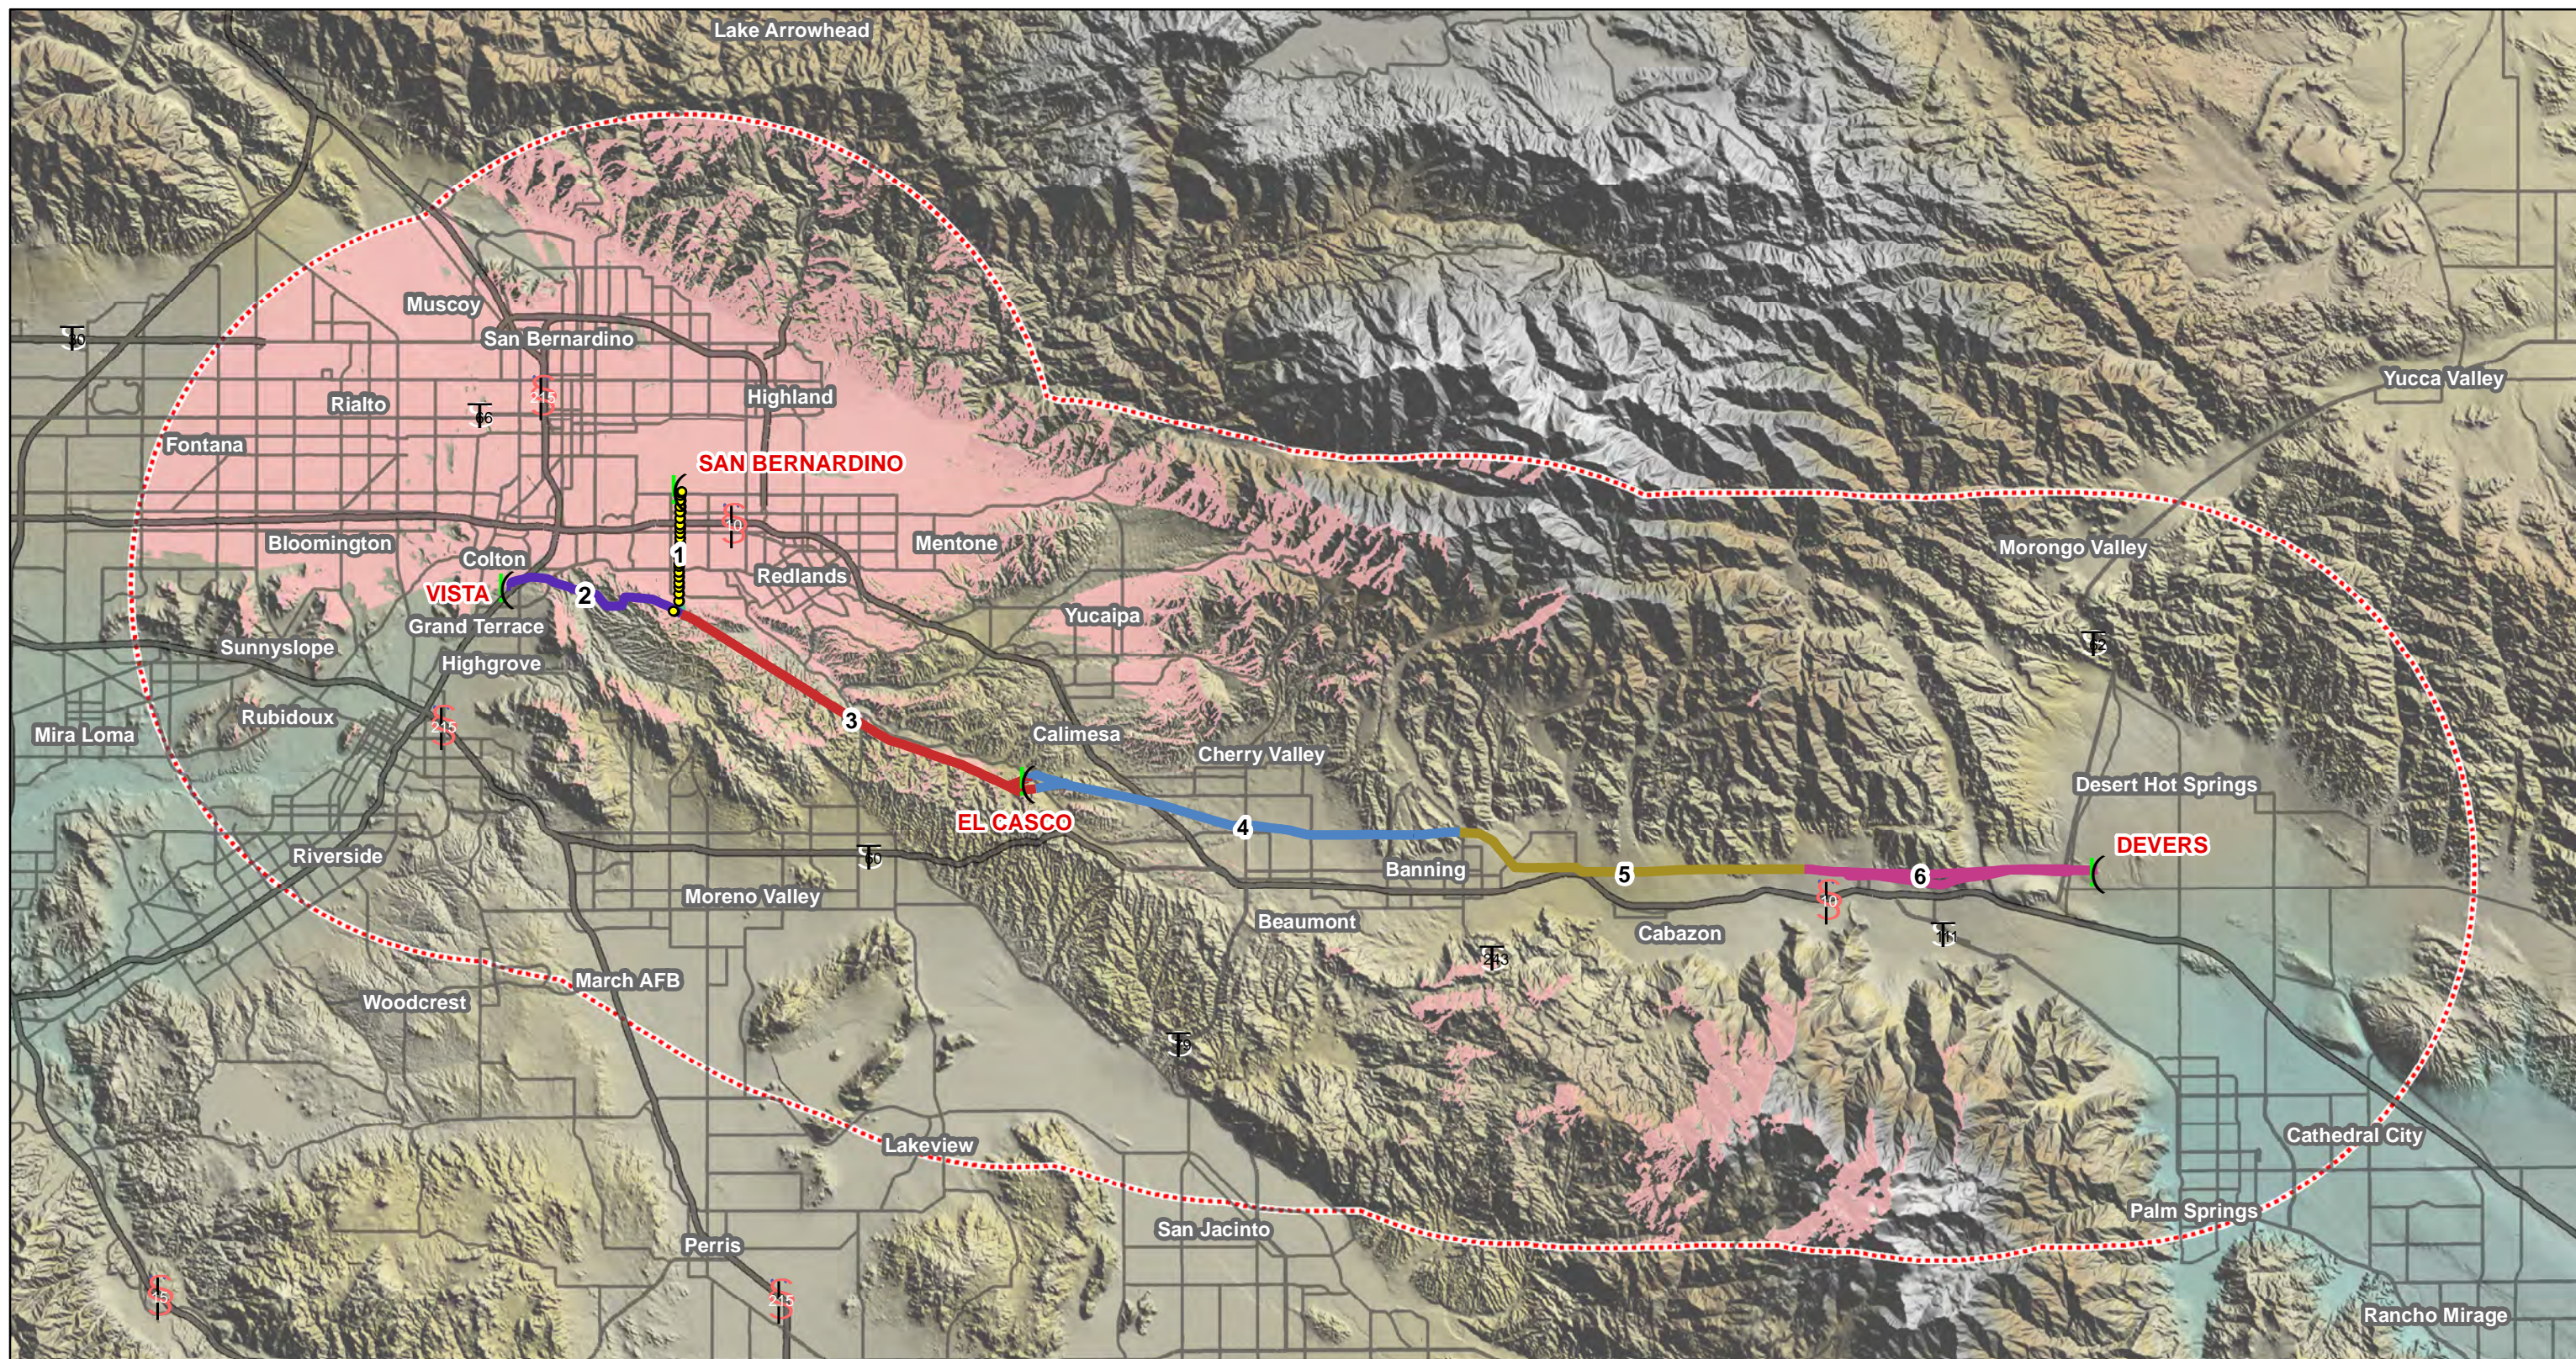
- Segment 1 Structures (Proposed or Modify)
- Substation
- 10-mile Buffer around Project

Visibility of Segment 1 Towers
