<p>California Public Utilities Commission <i>Mitigation Monitoring, Compliance, and Reporting Program</i></p>
	<p>Cleveland National Forest Power Line Replacement Projects</p> <p>Compliance Status Report: 042</p> <p>April 29, 2018</p>

SUMMARY

This compliance status report covers construction activities from April 16, 2018 through April 29, 2018.

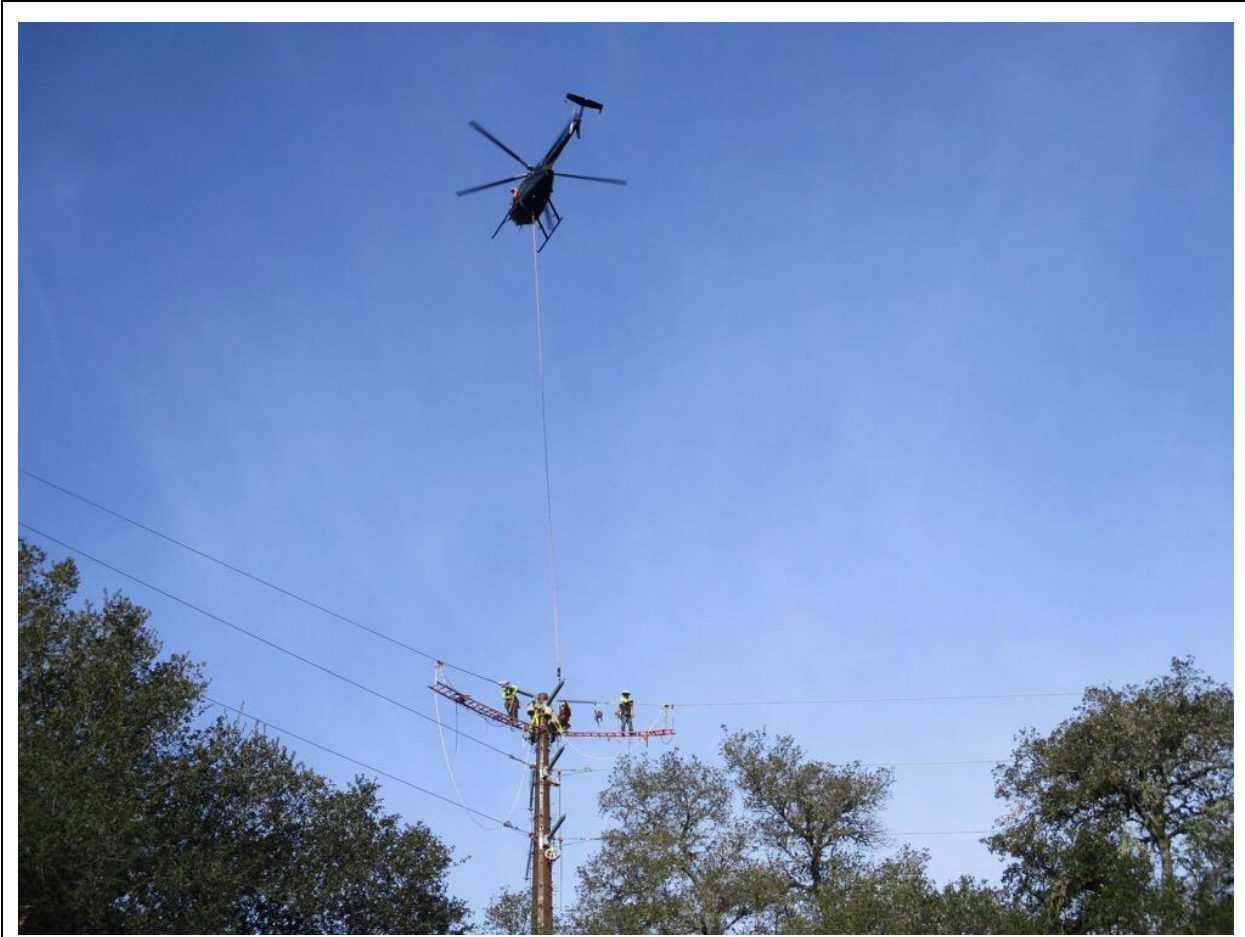
Photo 1: A crew is observed dead-ending transmission lines at Z118145 (TL 682). A helicopter was used to transport linemen to the tower using human external cargo operations in accordance with the Aviation Safety Plan and MM PHS-5.

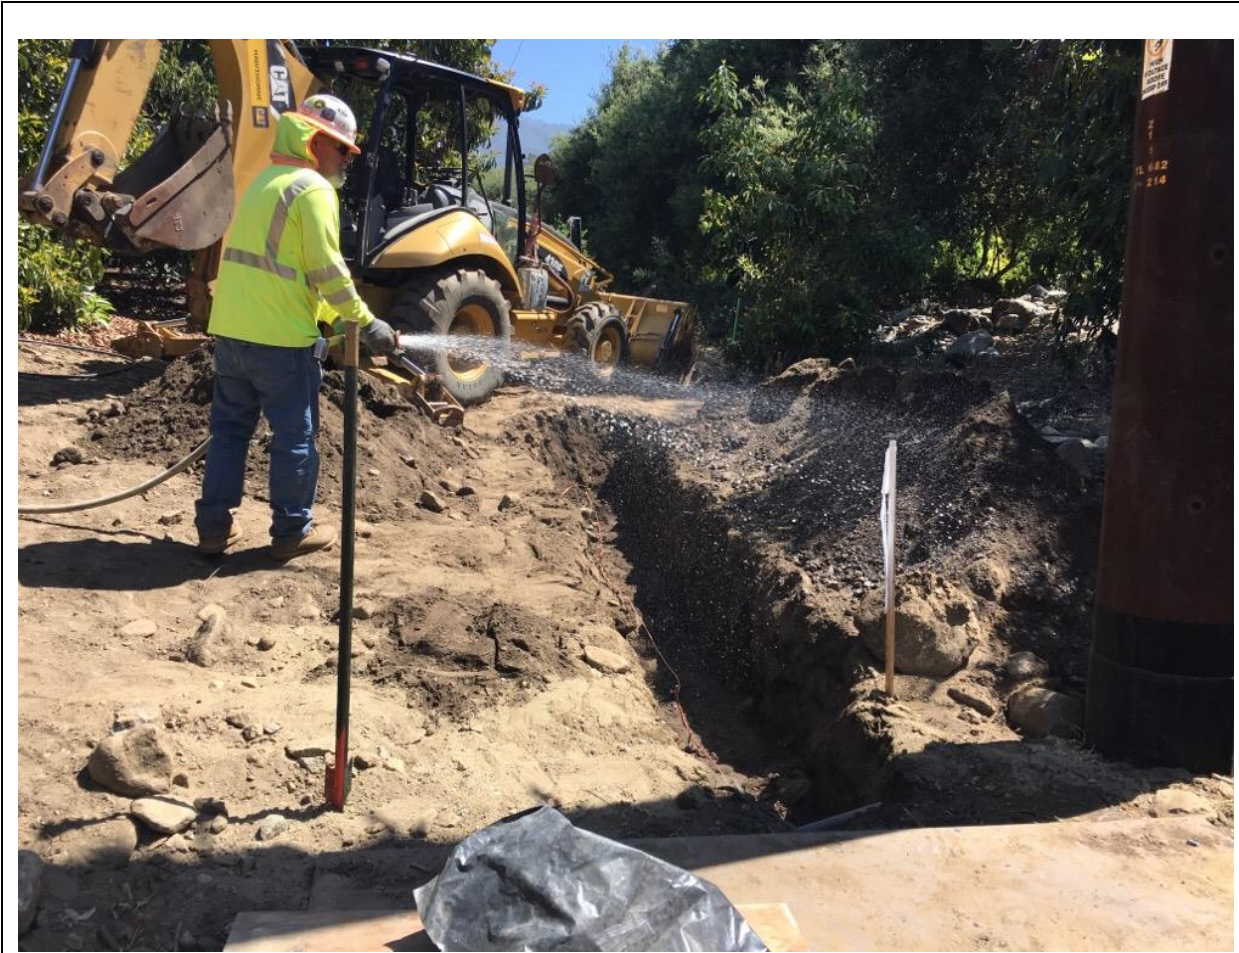
Photo 2: During grounding rod installation at TL 682, a crew member waters down spoils before backfilling in order to reduce fugitive dust emissions in accordance with APM AIR-02.

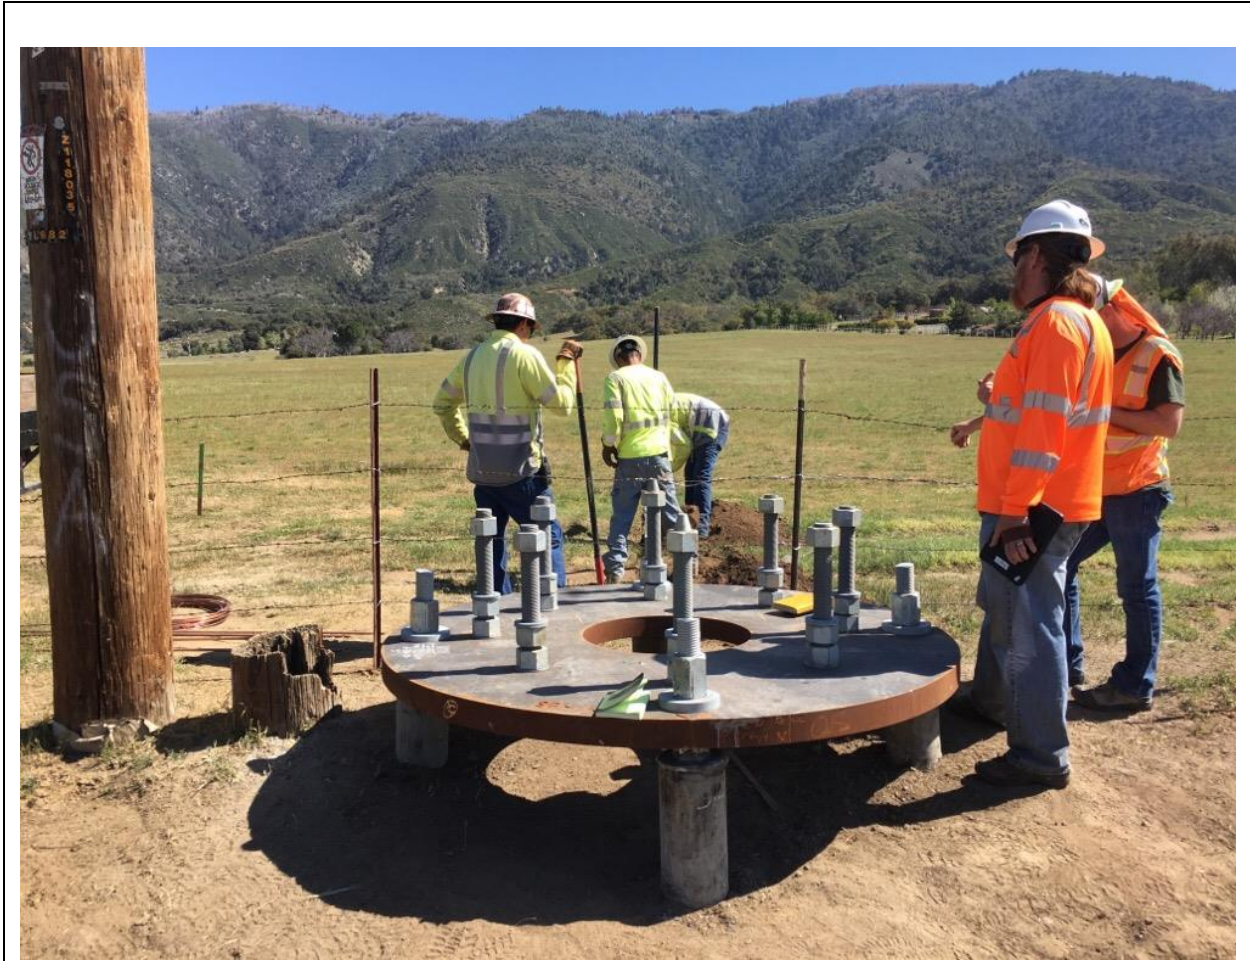
Photo 3: A crew digs a trench with hand tools to install grounding rods at pole Z118035 (TL 682) with biological and archaeological monitors present, in accordance with MM BIO-3, MM CUL-1, and APM CUL-04.

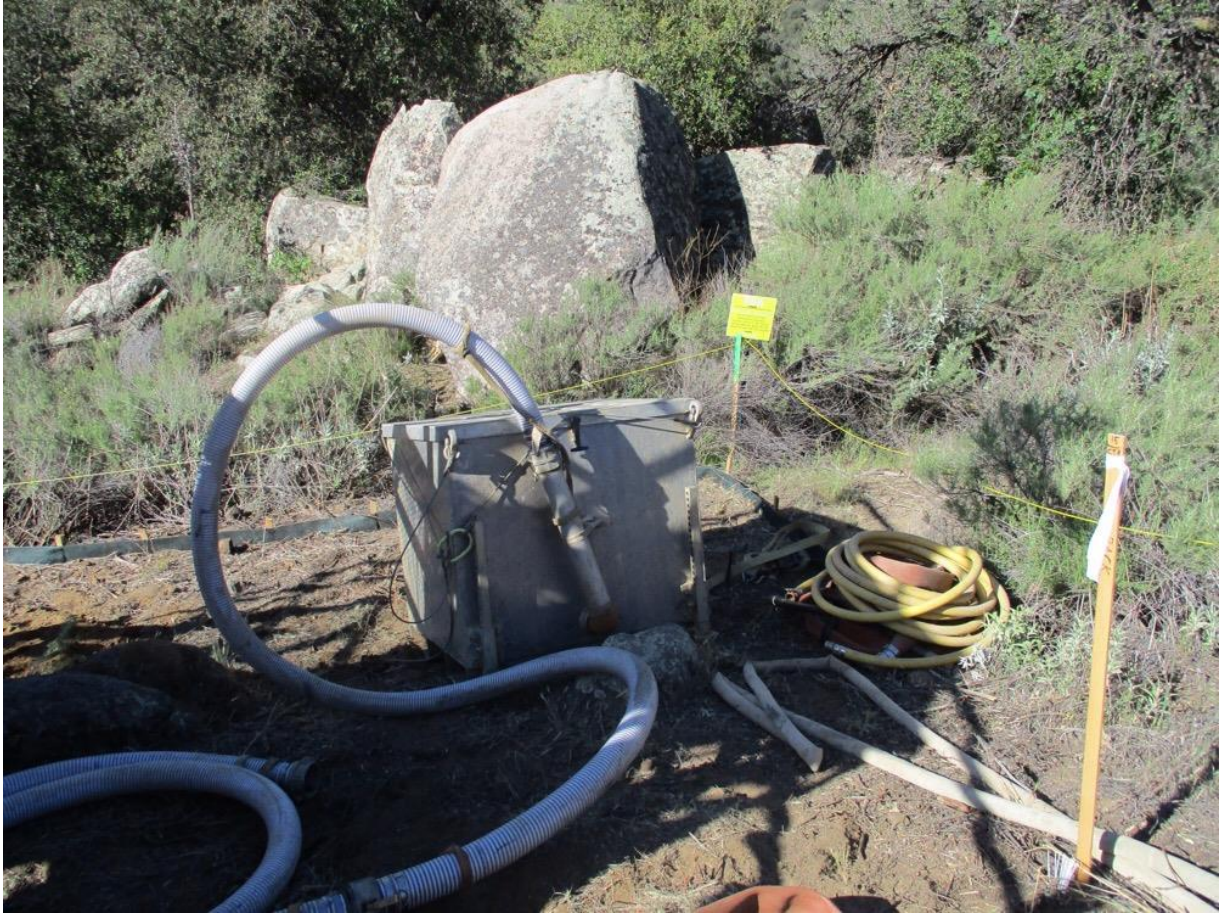
Photo 4: During drill site setup at a pole site along TL 682, a cultural ESA fence was observed installed around the perimeter of the workspace by the archeological monitor, in accordance with the HPMP and MM CUL-1. A containment box was staged on site to catch drill cuttings and reduce dust emissions in accordance with APM AIR-02.

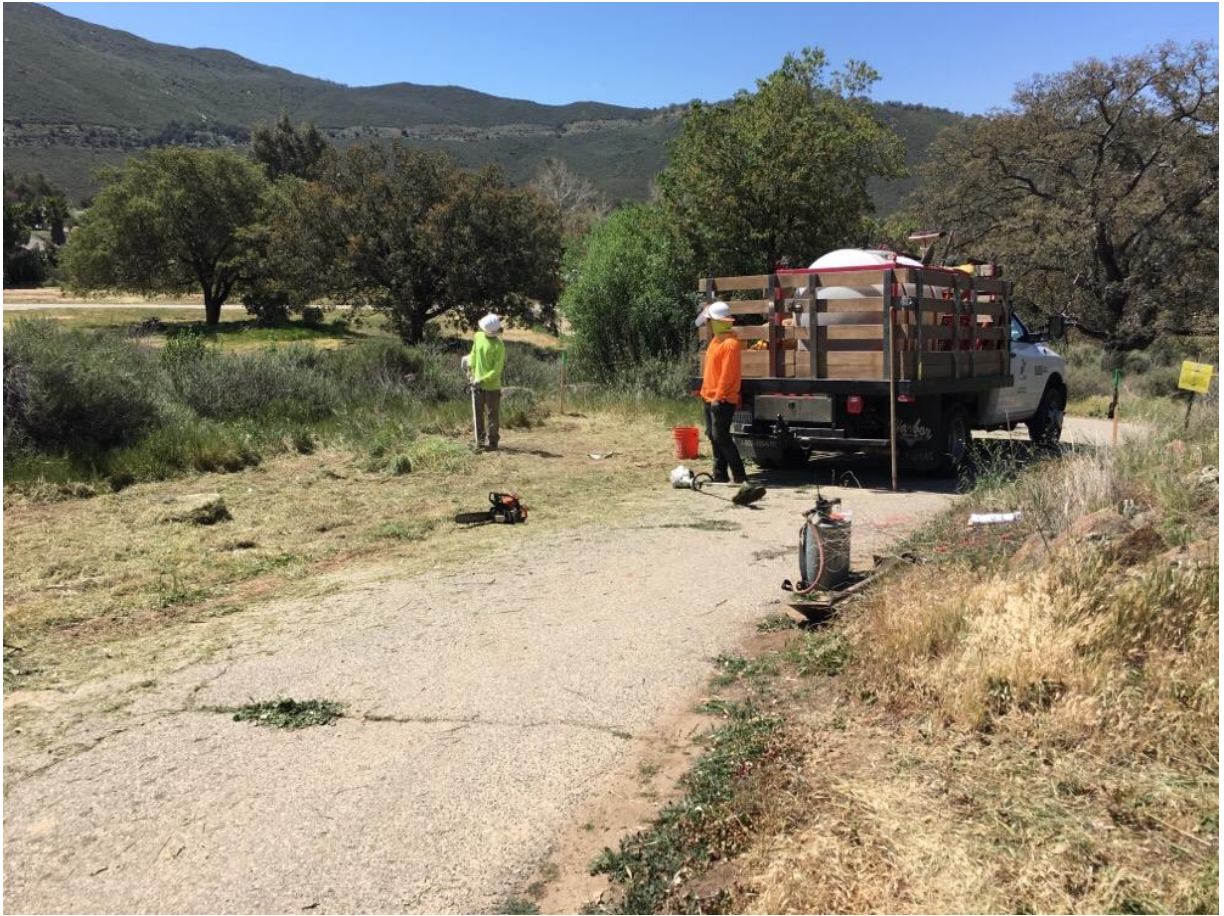
Photo 5: A crew is observed removing vegetation at Pole Z118074 (TL 682). Fire tools were observed within 50 feet of activity in accordance with the Construction Fire Protection and Prevention Plan (MM FF-1). Native American and biological monitors were present to observe vegetation clearing and removal in accordance with MM BIO-3, APM CUL-04, and the HPMP.

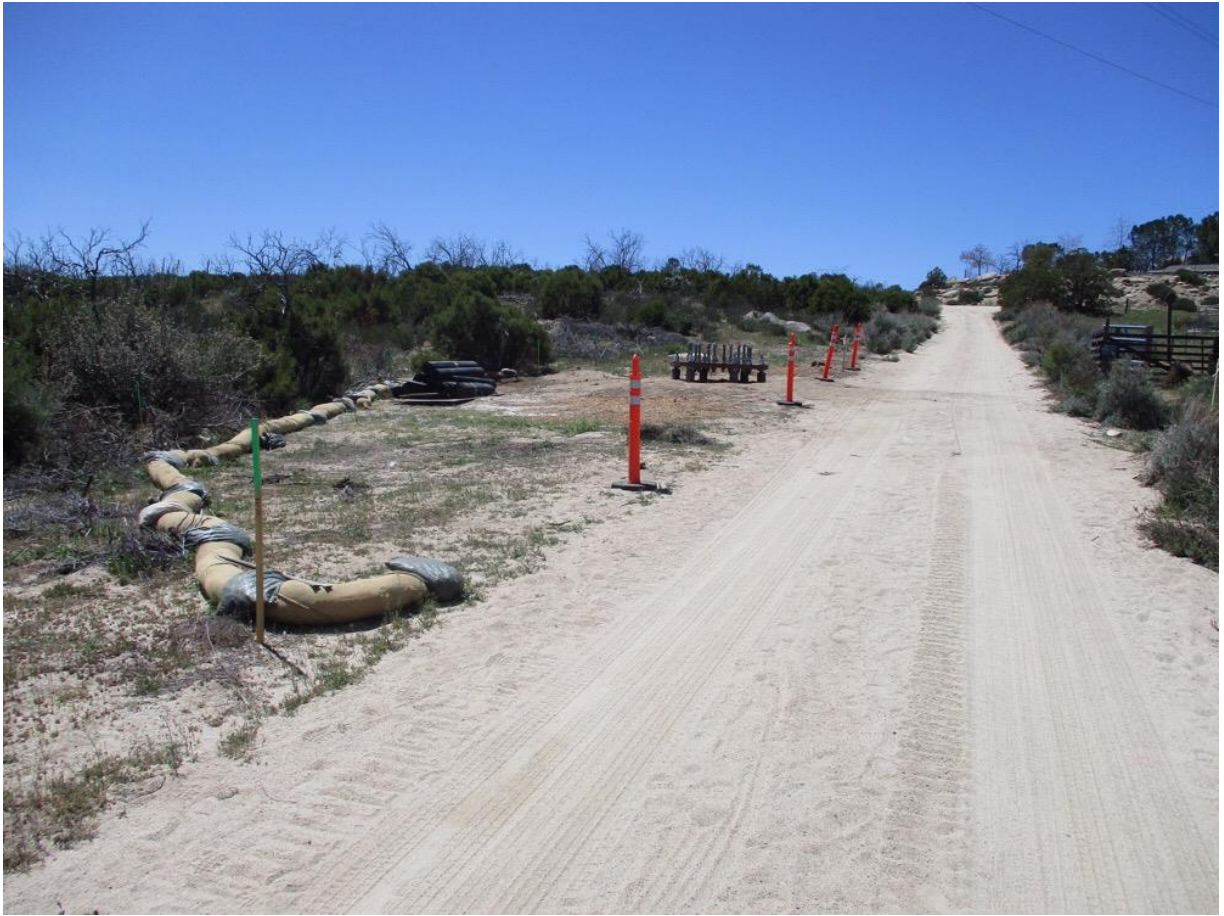
Photo 6: At Z44226 (TL 629E), perimeter fiber rolls were observed installed in accordance with the Erosion Control Plan and SWPPP.
