California Public Utilities Commission <i>Mitigation Monitoring, Compliance, and Reporting Program</i>
	Central Valley Gas Storage Project Compliance Status Report 10 September 15, 2011

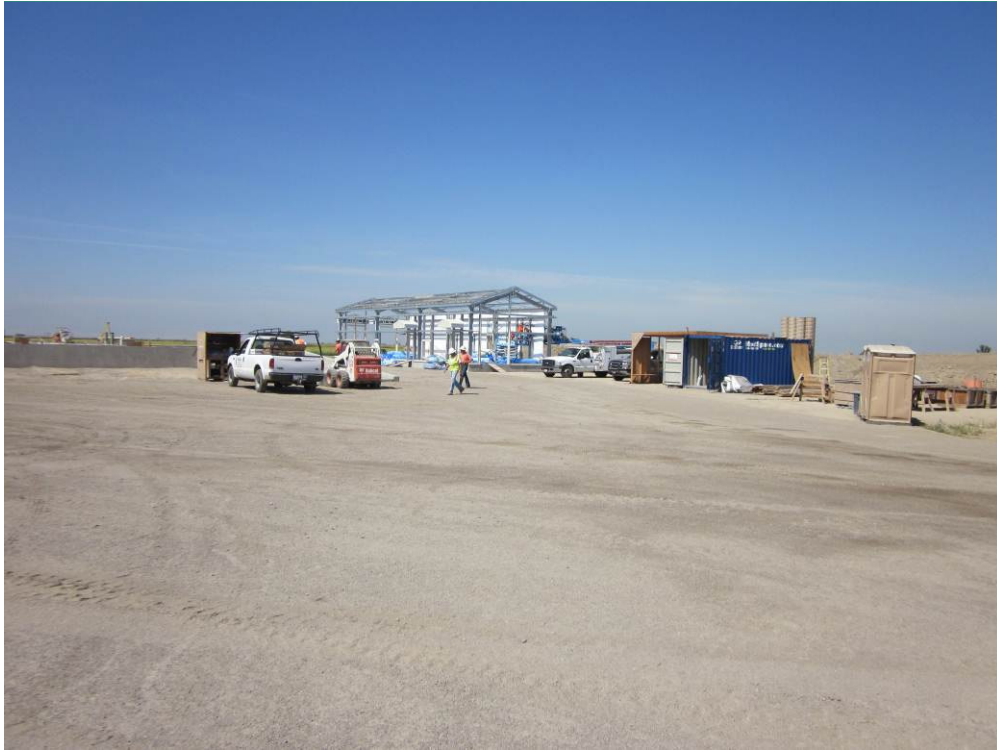
Photo 1: Compressor Station utility building under construction, siding being installed.

Ongoing work at the compressor station site included construction of building foundations, framing and siding for the utility building (see Photo 1, Attachment A), and continuation of pipe assembly.

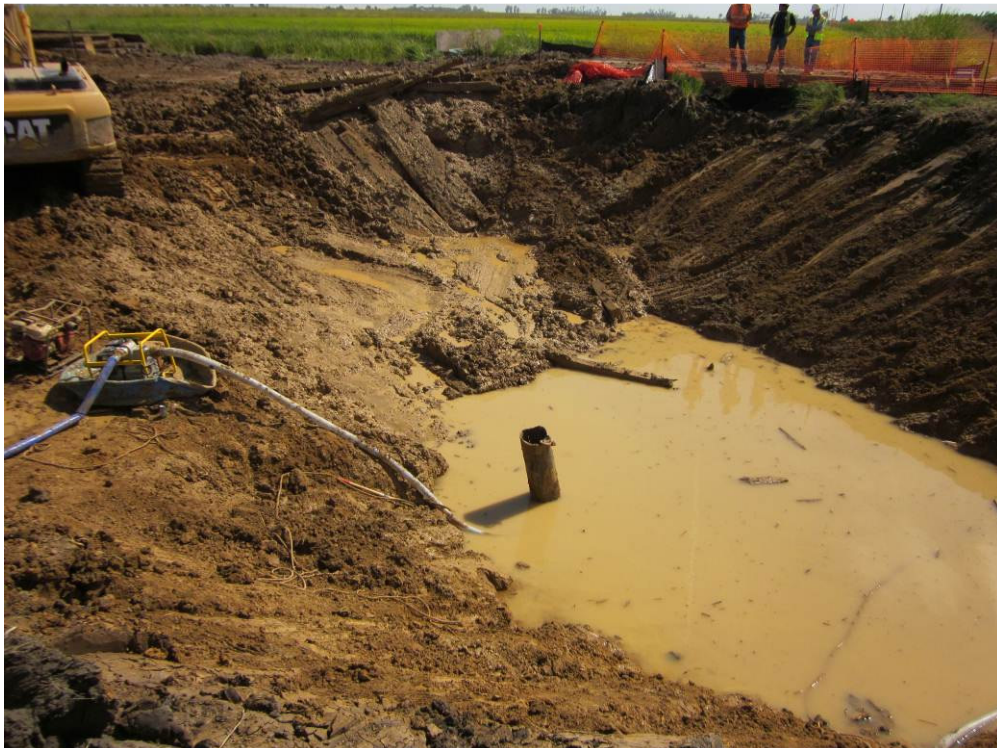
Photo 2: Auger bore hole excavation and dewatering at the Dirks Road crossing.

Construction activities along the natural gas connecting pipeline right-of-way undertaken during the period covered by this report included: staging of equipment; excavation and auger boring (at D-11, D-14, D-23, D-25, Dirks Road, and the private runway in the Gunnersfield property) (see Photo 2, Attachment A); potholing; completion of HDD at the Colusa Drain, disassembly of the HDD rig, relocation of the HDD rig to the Interstate 5 crossing, initiation of HDD at Interstate 5 (see Photo 3, Attachment A); pipe stringing, welding, and bending; trenching; lowering pipe into trenches; backfilling trenches; dewatering (see Photo 4, Attachment A); and regarding/raking of the right-of way between Interstate 5 and Loretz Road (see Photo 5, Attachment A).

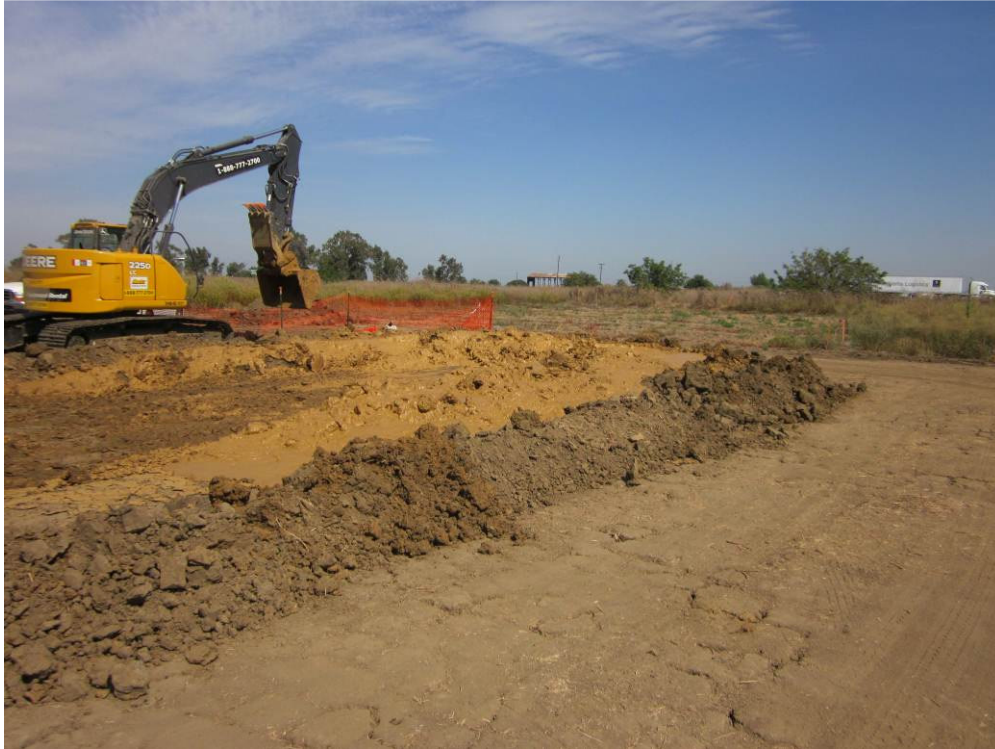
Photo 3: HDD at Interstate 5. Drill mud being contained and loaded into trucks for hauling offsite and treatment.

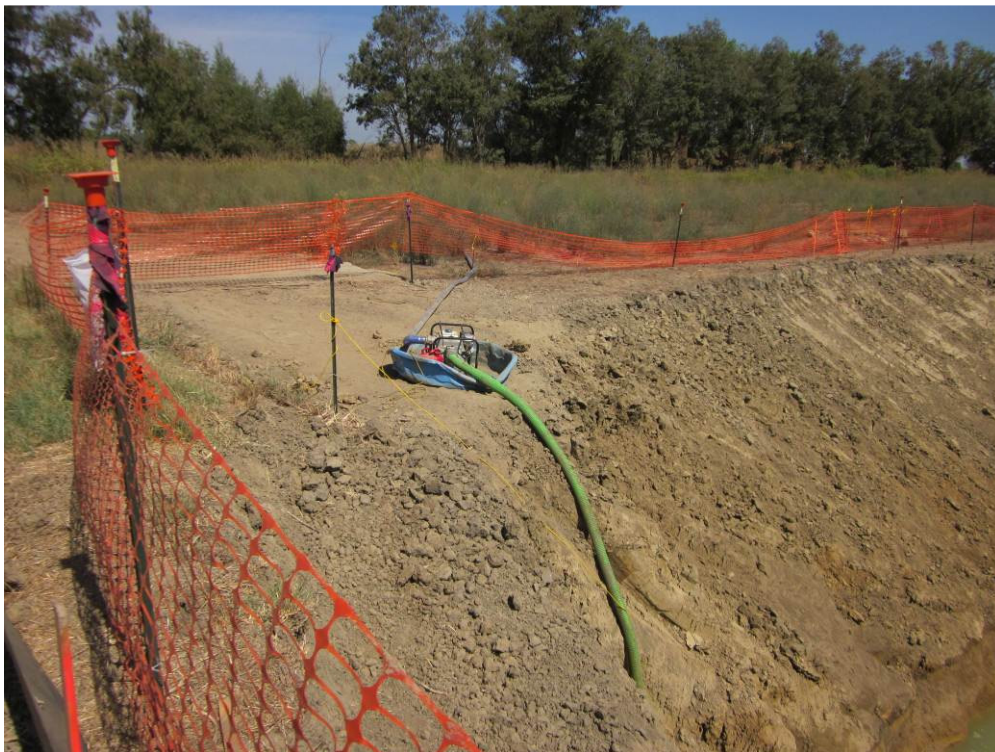
5. Dewatering – CPUC environmental monitors observed dewatering activities inconsistent with the methods described in the Dewatering and Discharge Plan for the Central Valley Natural Gas Storage Project (June 2011). Specifically, discharge operations were observed onto parcels not identified in the Dewatering and Discharge Plan and discharge directly into drainages was observed adjacent auger bore sites along the 24-inch gas pipeline alignment. CVGS will be revising the project Dewatering and Discharge Plan and, in the interim, will not discharge water in a manner inconsistent with the current Dewatering and Discharge Plan.

Photo 4: Dewatering operations at the D-24 auger bore onto non-approved parcel. Dewatering at this location has ceased pending submittal of the revised Dewatering and Discharge Plan.

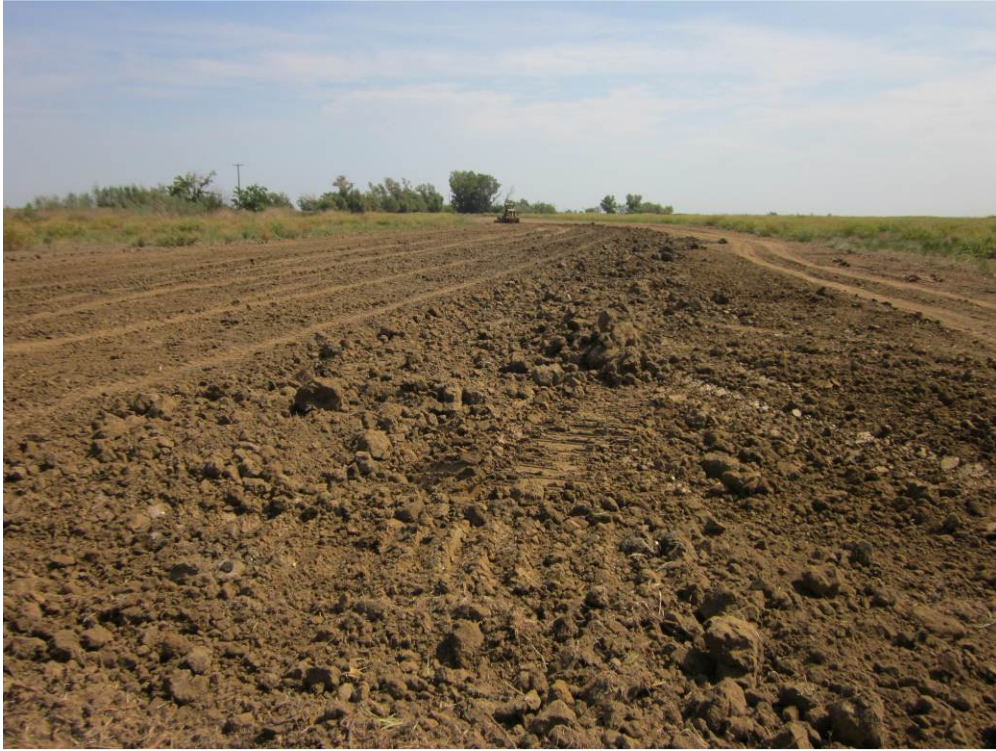
Photo 5: Pipeline right-of-way backfilled, graded and raked east of D-44.

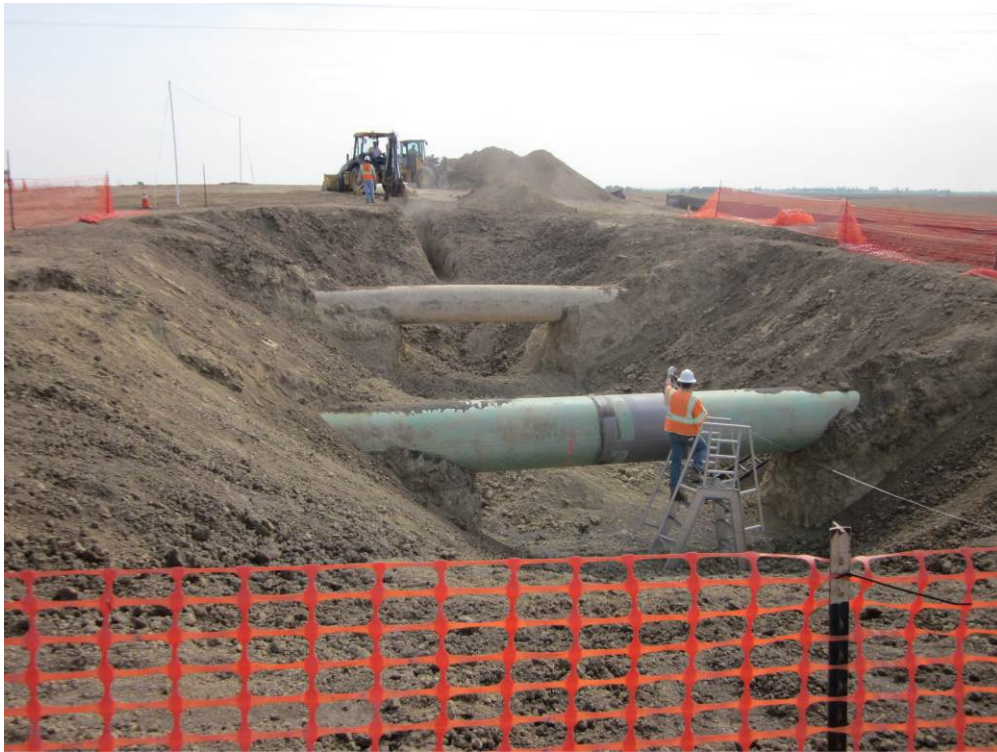
Photo 6: PG&E crew working at the 400/401 Line Interconnect. The 400 and 401 lines have been excavated and trenching is underway for the connection to the Metering Station.

PG&E crews have excavated the area above the 400/401 line interconnect, initiated trenching between the 400/401 Line Interconnect and the Metering Station (see Photo 6, Attachment A), and welded the pipeline between the Metering Station location and the 400/401 Interconnect location. The approved temporary work area was being used for excavated soil storage. Silt fence had been installed along the west, south, and east edge of the temporary impact area. Silt fence was observed to be in proper working order.
