Subject: Addendum to the Groundwater Characterization and Water Supply Well Destruction Work Plan, Water Supply Well Status Summary and Destruction Procedures, Kern Power Plant, Bakersfield, California

**Subject: Addendum to the Groundwater Characterization and Water Supply Well Destruction Work Plan, Water Supply Well Status Summary and Destruction Procedures
Kern Power Plant, Bakersfield, California**

PACIFIC GAS & ELECTRIC COMPANY
 KERN POWER PLANT
 BAKERSFIELD, CALIFORNIA

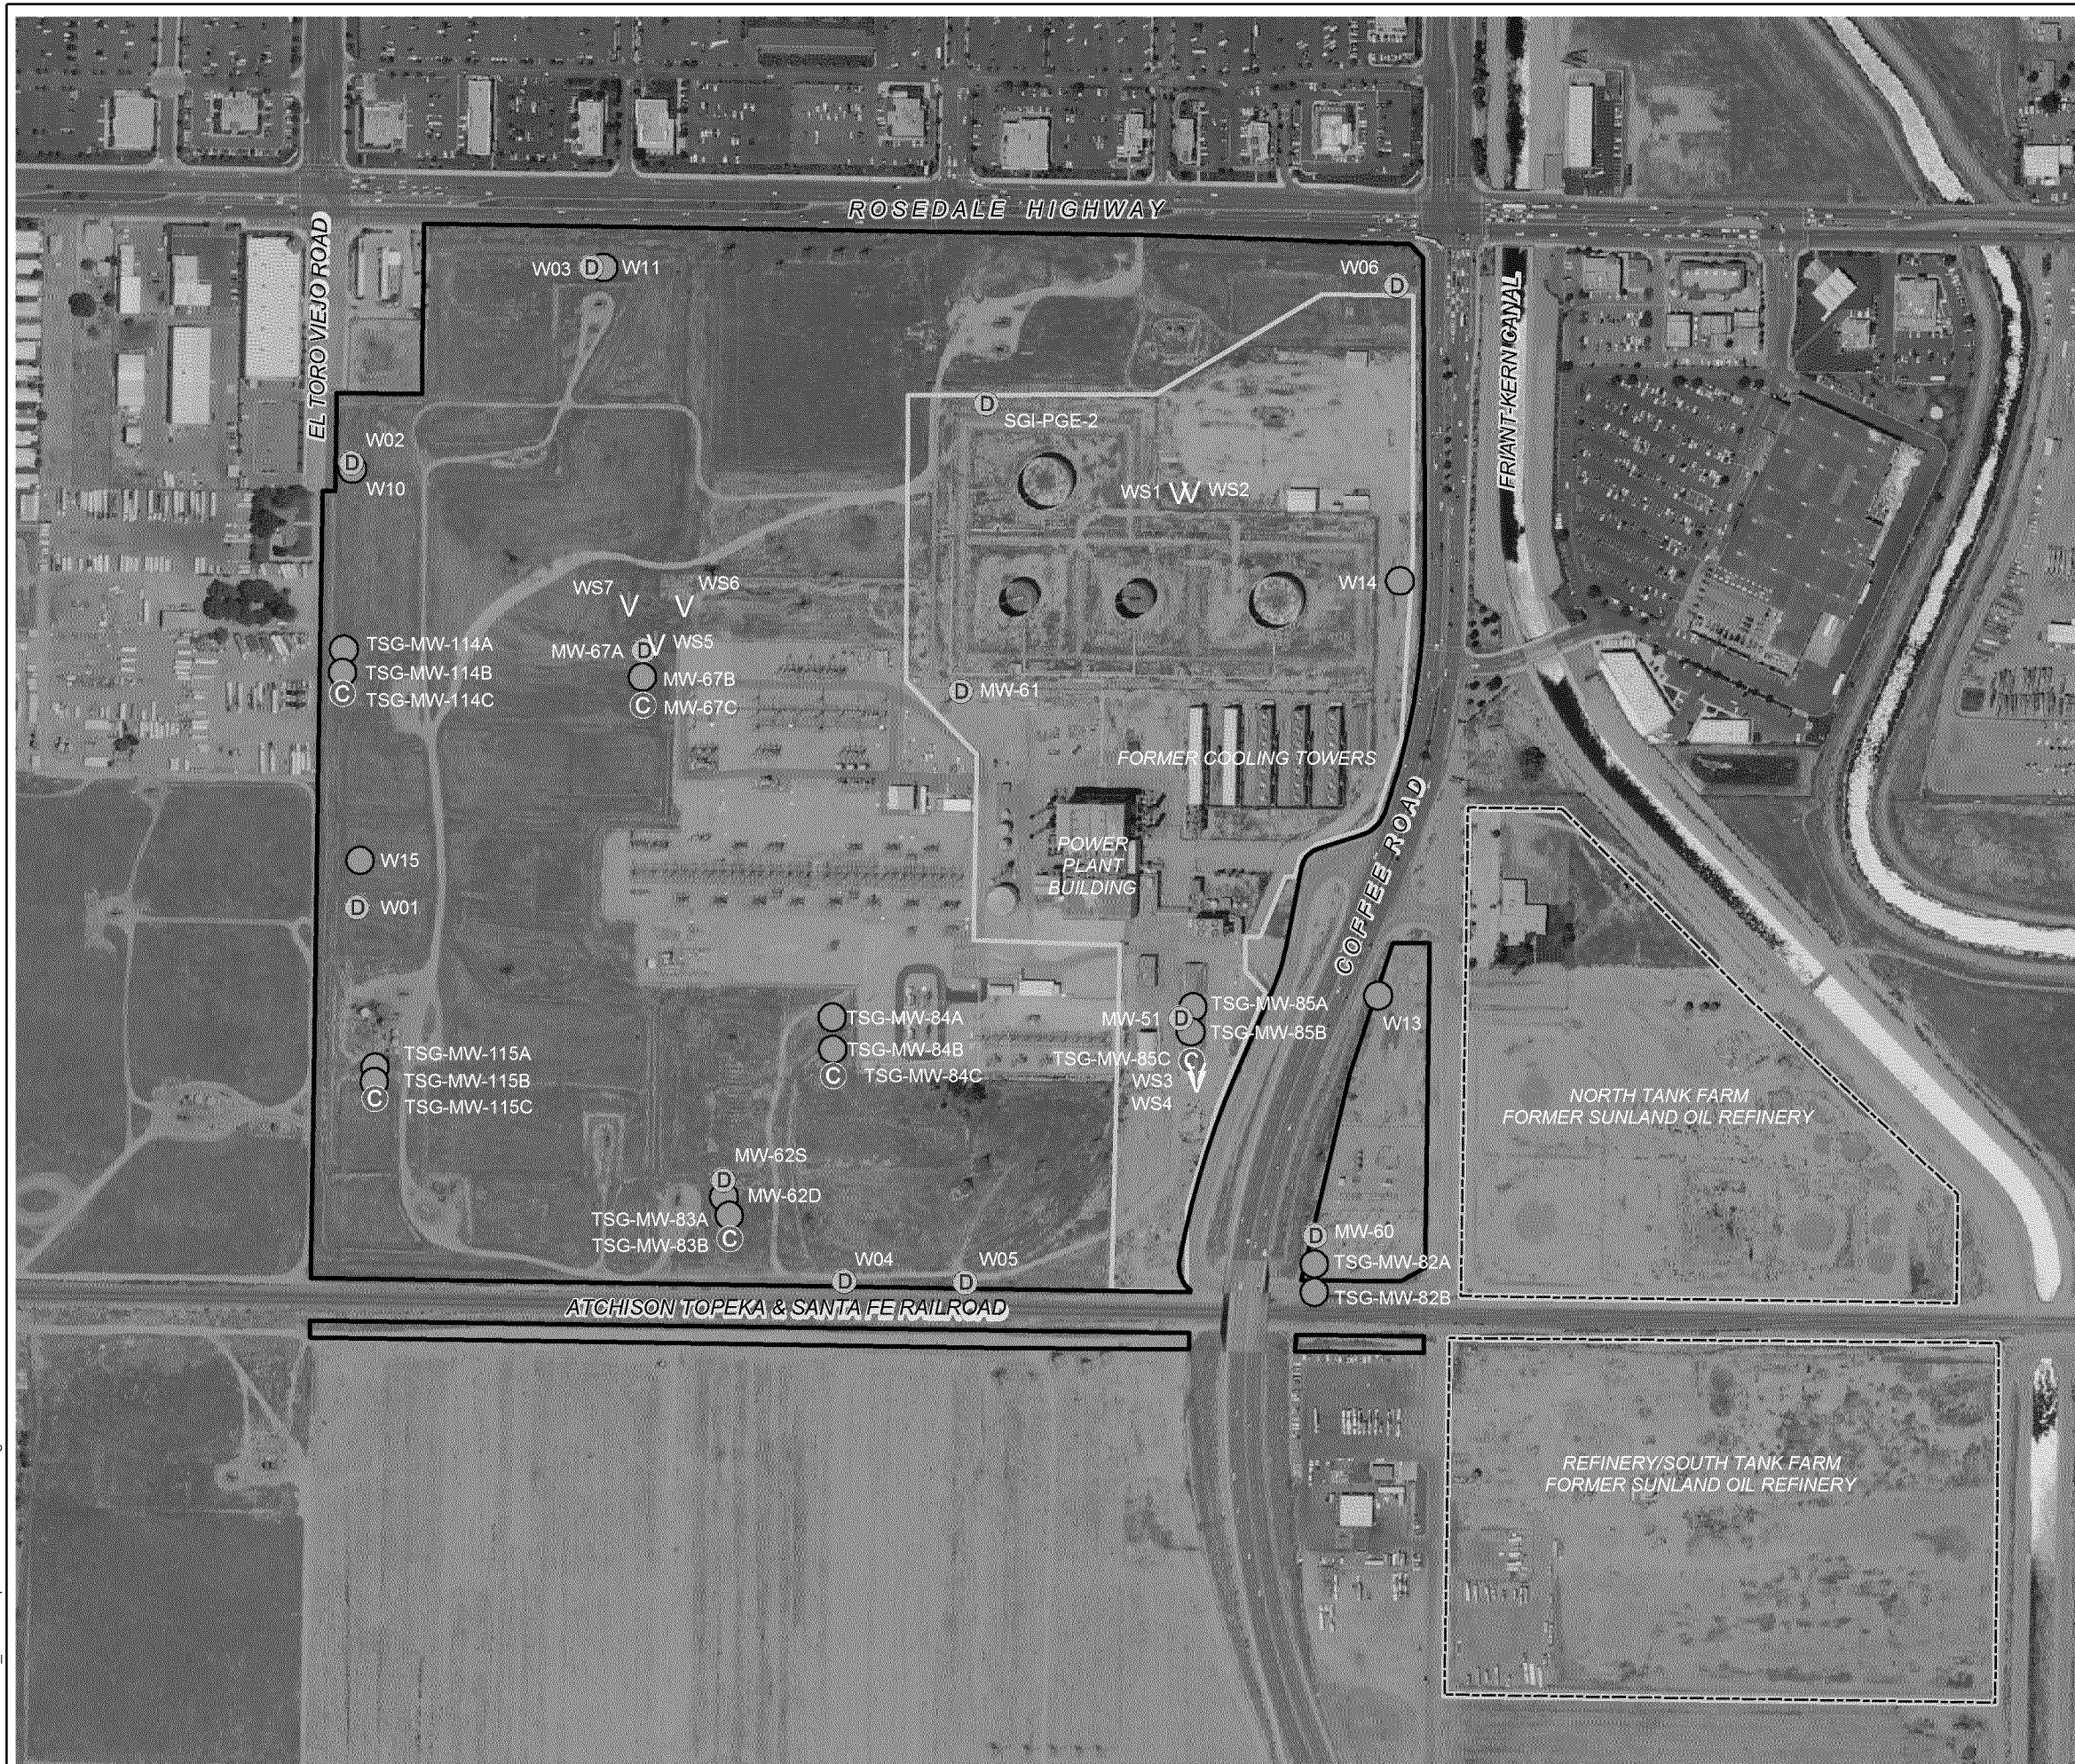
DRAWN BY	APPROVED BY	DATE	FIGURE
PEM	JB	06/21/13	2

Five water supply wells (WS1, WS2, WS3, WS4, and WS6) remain at the Site and are no longer in use (see Figure 2). Therefore, in consideration of California well standards and Kern County ordinance (see Attachment 1), these five water supply wells are proposed for destruction.

During facility demolition activities in early April 2012, the demolition team identified two open vertical pipes beneath temporary covers in the eastern portion of the Site (see Figure 2). JJ&A and its underground utility location subcontractor investigated these features on April 12, 2012, and concluded the two vertical pipes were water supply wells WS3 and WS4 based on their location and construction (16-inch diameter steel casing). The demolition team also identified water supply well WS2 while dismantling the fence and foundation pad around nearby well WS1.

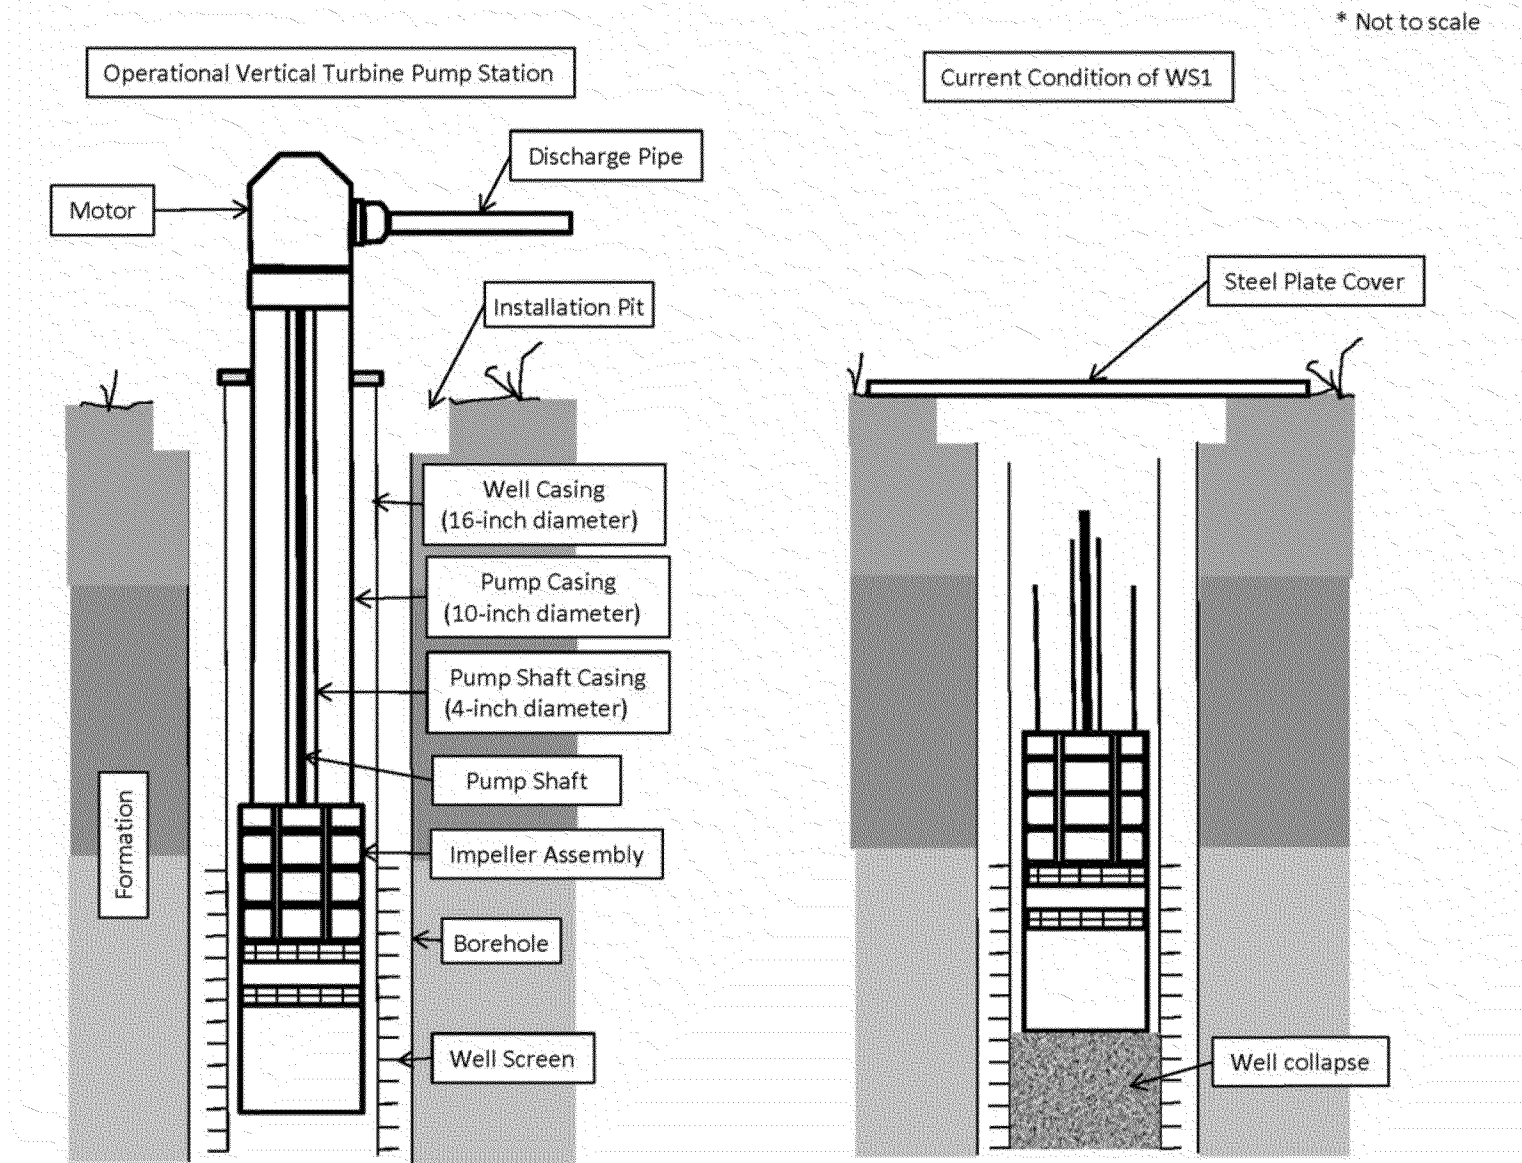
| Figure 4 | Vertical Turbine Pump Schematic Diagram |

The vertical turbine pump is lodged below the ground surface inside well WS1. The top of the 10-inch diameter pump discharge pipe is stuck inside the 16-inch diameter well casing at approximately 21 feet bgs, leaving an estimated 238 feet of discharge pipe, drive shaft, and turbine pump (assembly) inside the 16-inch well casing. The top of the pump driveshaft is approximately 11 feet bgs. The current condition of the pump assembly will not allow sampling or measurements of the well. Though water is present within the pump casing, it is not believed to be directly connected to the surrounding water-bearing zone, and, therefore, is not representative of the formation. Centralizers holding the pump shaft within the 10-inch diameter pump casing prevent use of down-hole monitoring and sampling equipment inside the pump casing. JJ&A discussed the pump removal attempt and result with staff from the Kern County Environmental Health Services Department, who approved in-place destruction of the vertical turbine pump⁴.

The Groundwater Work Plan specifies removal of pumps or other down-hole equipment from the water supply wells before they are destroyed. JJ&A attempted to remove the vertical turbine pump from well WS1 on April 16 through 19, 2013 (see Photographs 9 through 15 in Attachment 2). Using a hydraulic jack table, the 10-inch diameter pump casing and 3-inch diameter drive shaft were slowly lifted from their static position to approximately 6 feet above grade. Once the casing and drive shaft were sufficiently above ground level, the casing was attached to a large excavator to assist the lifting process.

The casing was carefully lifted and secured as 20-foot sections were disconnected at the threaded joints and removed. After the second 20-foot section was removed, the pump became stuck and separated at the third threaded joint. Several attempts were made to free the pump without success. The team made the decision to cut the remaining pump assembly free and let it fall back into the well. Ultimately, approximately 60 feet of pump casing and 50 feet of driveshaft were removed from the well. Figure 4 shows a conceptual configuration of a vertical turbine pump inside well WS1 prior to and following the attempted removal.

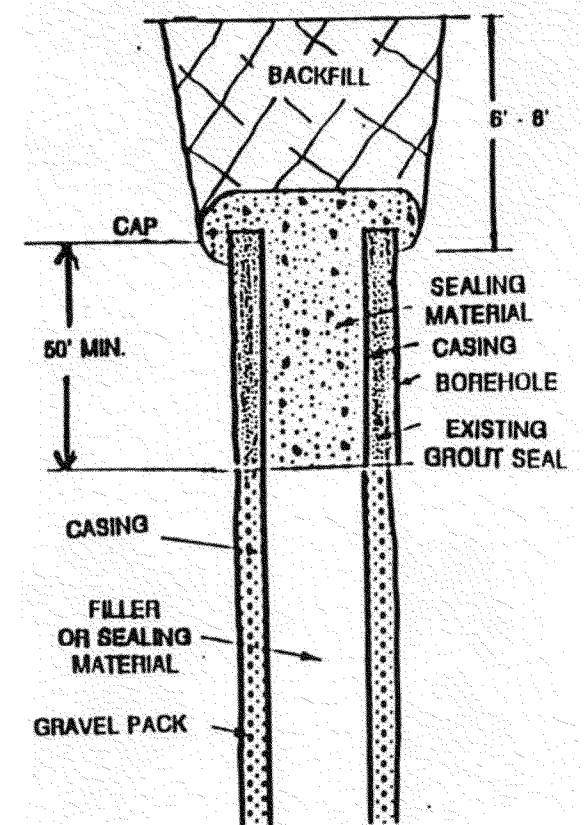
DESTRUCTION OF WELL WITH REGIONAL CONFINING CLAY

For wells that penetrate a regional confining clay, additional requirements are as follows:

1. Depth of the annular seal will be determined at the time the application is submitted or after the application is submitted to the Kern County Water Agency for review.
2. Casing may be required to be perforated across the regional confining clay with a mills knife or wire line casing shot.
3. The casing is to be immediately pumped full of approved sealing material with the aid of a tremie pipe from 10' below the regional confining clay to the top of the well casing.
4. The destruction procedures for the upper seal are the same as for the shallow well destruction.

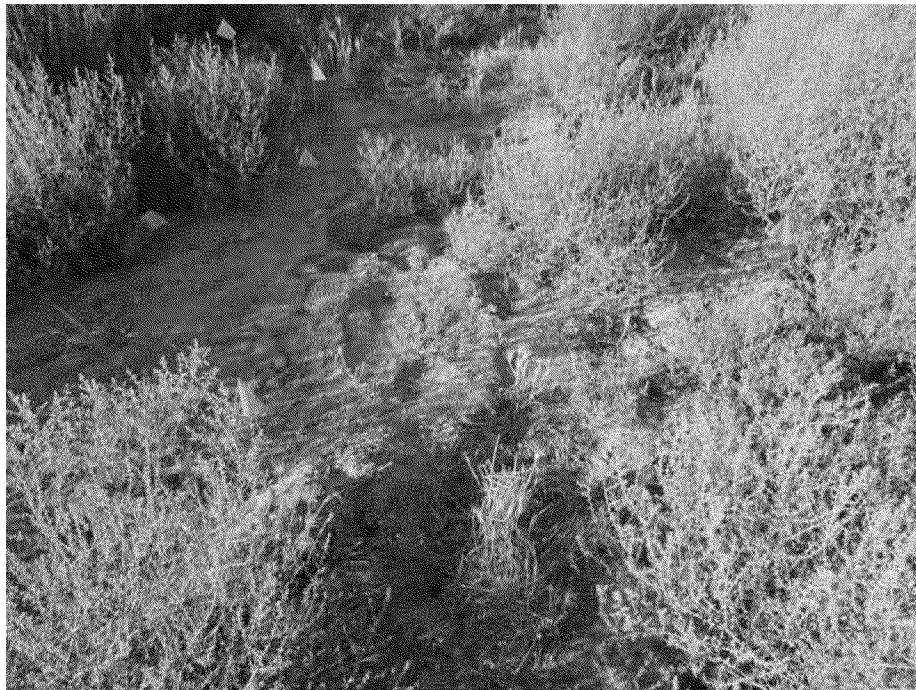
Photo 1. Search area of WS7. Flags and paint mark probable WS7 location. Looking south. July 24, 2012.

On August 16, 2012, the demolition team provided a tracked loader and operator to assist JJ&A with locating well WS7. Soil was carefully removed approximately 1 foot at a time from where WS7 was suspected to be located, based on the historical maps and the magnetic anomaly (see Photographs 1

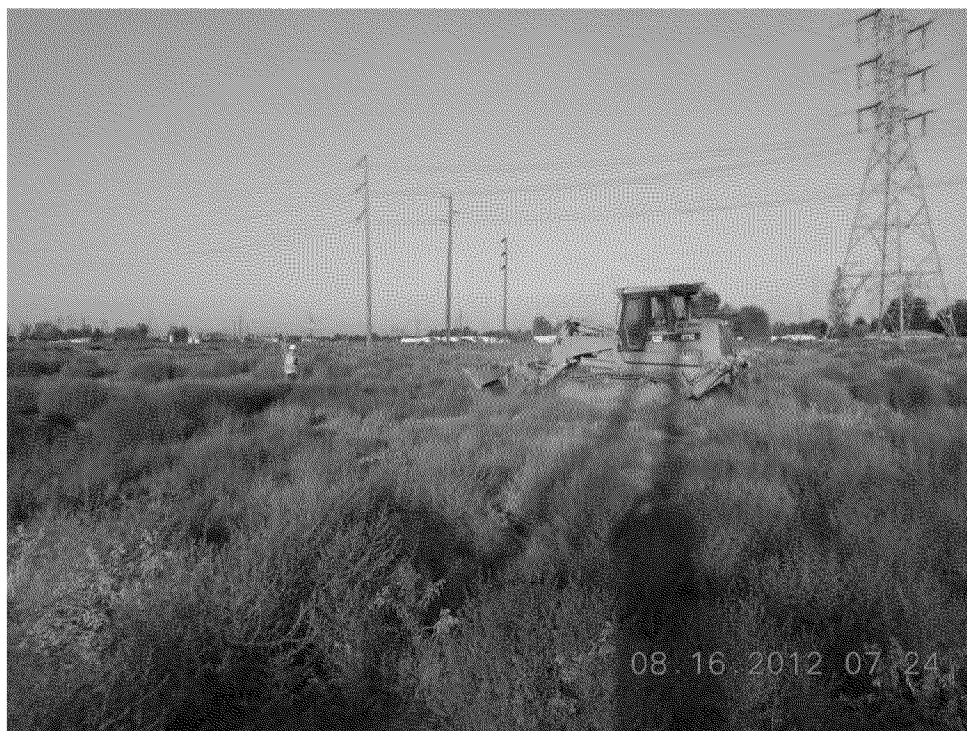
Photo 2. Attempting to locate WS7. Looking southwest. August 16, 2012.

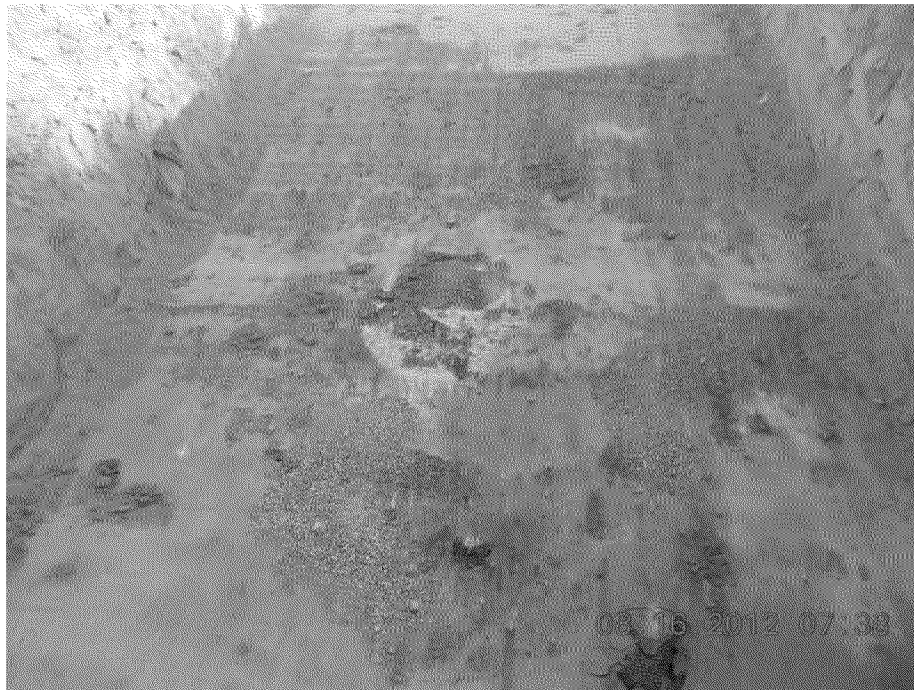
Photo 3. Cement grout found approximately 5 feet below ground surface at WS7 search area. Looking north. August 16, 2012.

through 4 in Attachment 2). A block of cement was found at approximately 5 feet bgs and is believed to be the former well WS7, which appears to have been cut below grade and backfilled with cement grout (consistent with Kern County well destruction requirements). Based on these findings, well WS7 appears to have been properly destroyed.

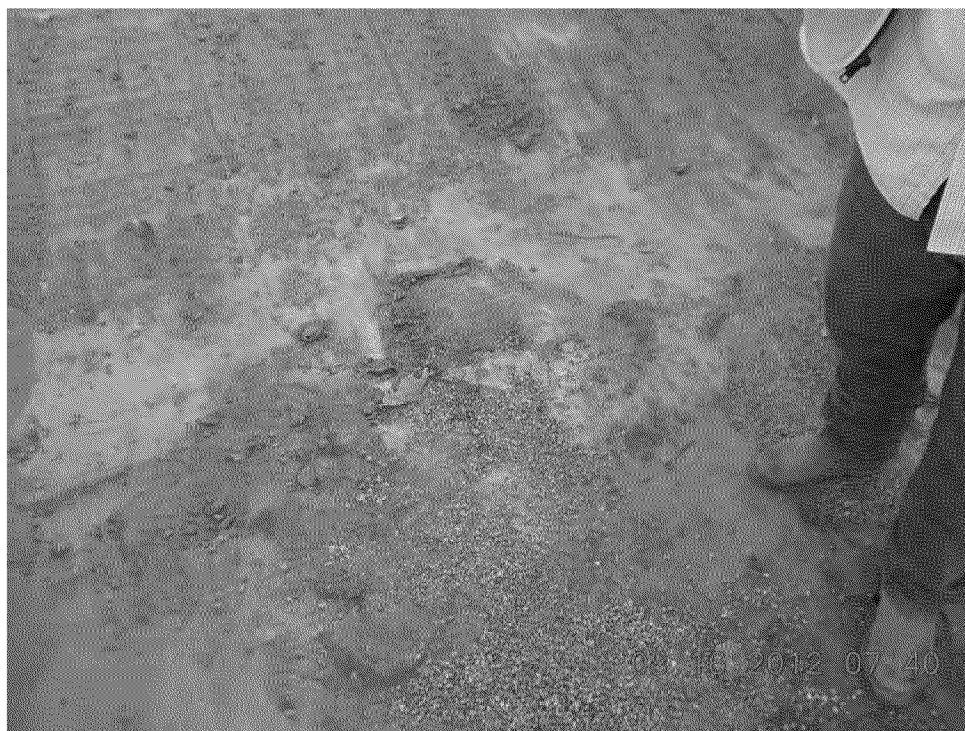
Photo 4. Cement grout seal of WS7. Looking north. August 16, 2012.

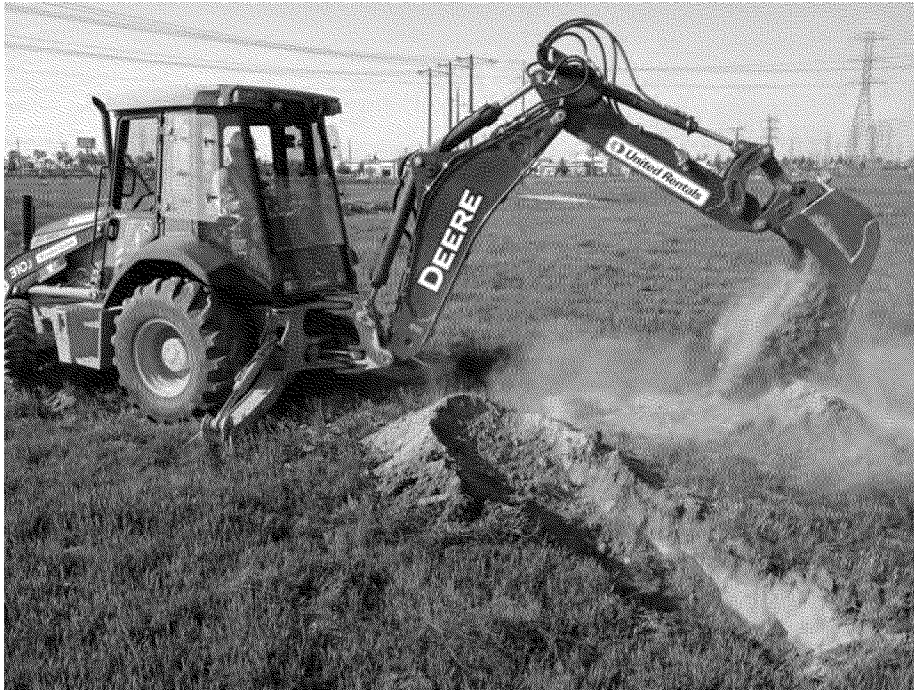
Photo 5. Beginning excavation to find WS5 at location 1. Looking northwest. March 12, 2013.

On March 12, 2013, JJ&A conducted an investigation to locate well WS5. Two possible locations for the well (based on historical maps and graphics files) were measured from a known, surveyed reference point and were marked on the ground with paint. Using a backhoe (see Photographs 5 through 8 in Attachment 2), the possible areas were excavated to approximately 8 feet bgs. No evidence of a well was identified in either location. The area was checked by a utility location subcontractor on April 16, 2013, again with no anomalies indicative of a well identified.

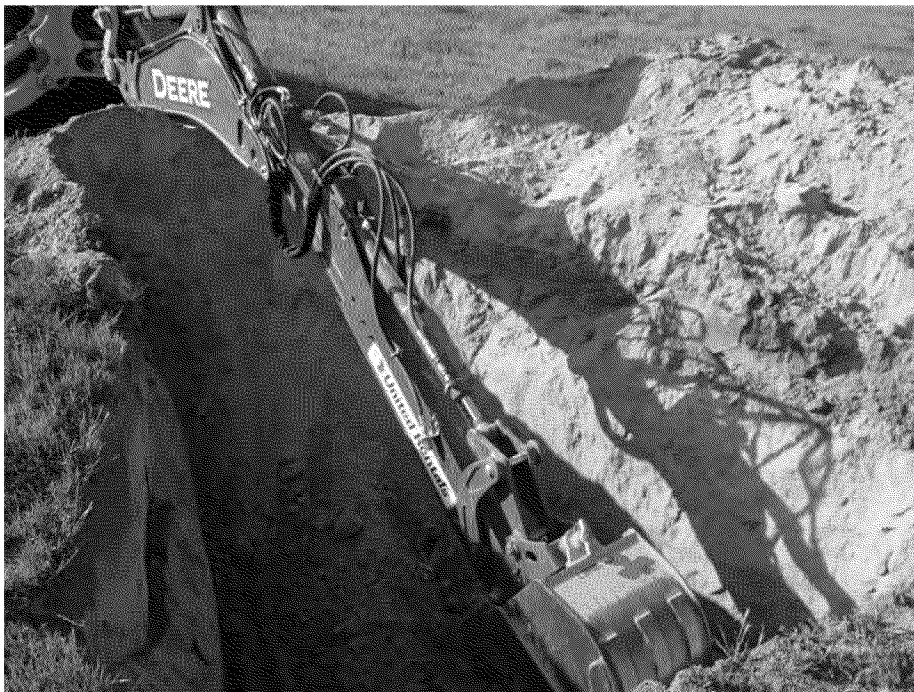
Photo 6. Reaching final depth of approximately 8 feet below ground surface in location 1. Looking northwest. March 12, 2013.

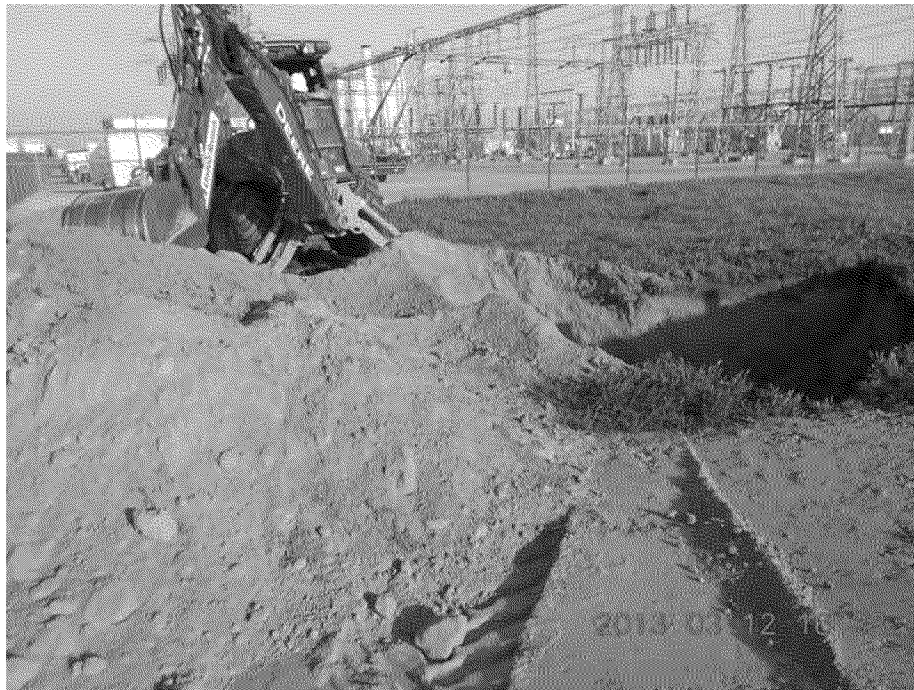
Photo 7. Excavation of location 2 for WS5. Looking southeast. March 12, 2013.

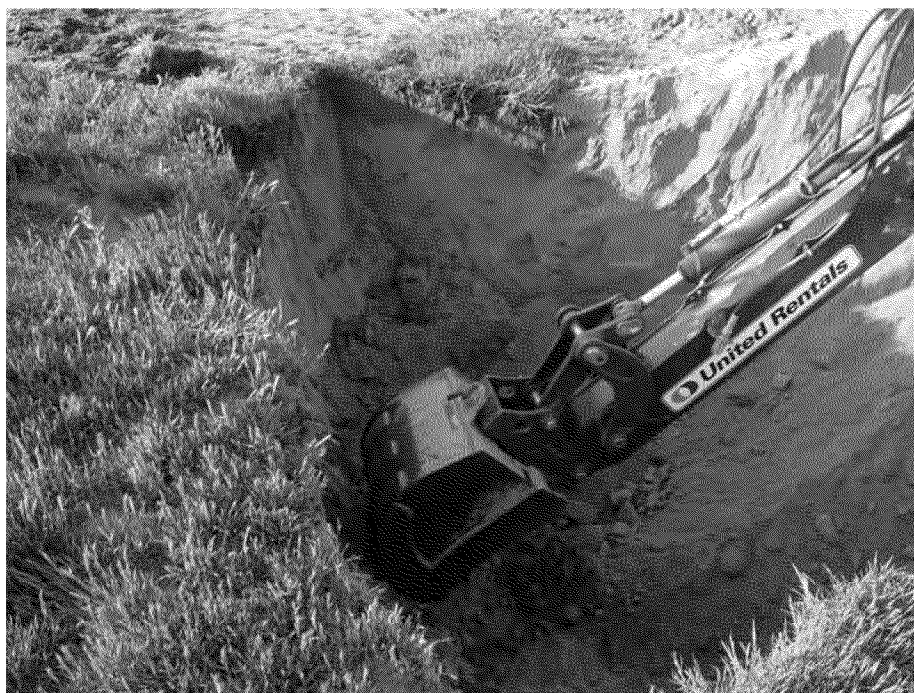
Photo 8. Reaching final depth of approximately 9 feet below ground surface at location 2. Looking northwest. March 12, 2013.

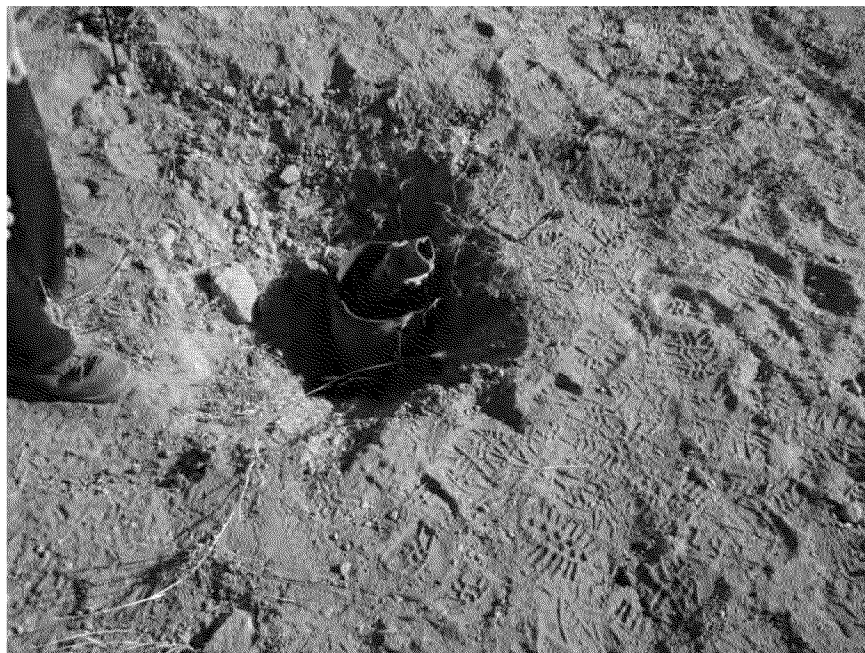
Photo 9. WS1 prior to pump removal attempt. Visible is the 10-inch diameter pump casing and interior oil tube/driveshaft. Looking north. April 16, 2013.

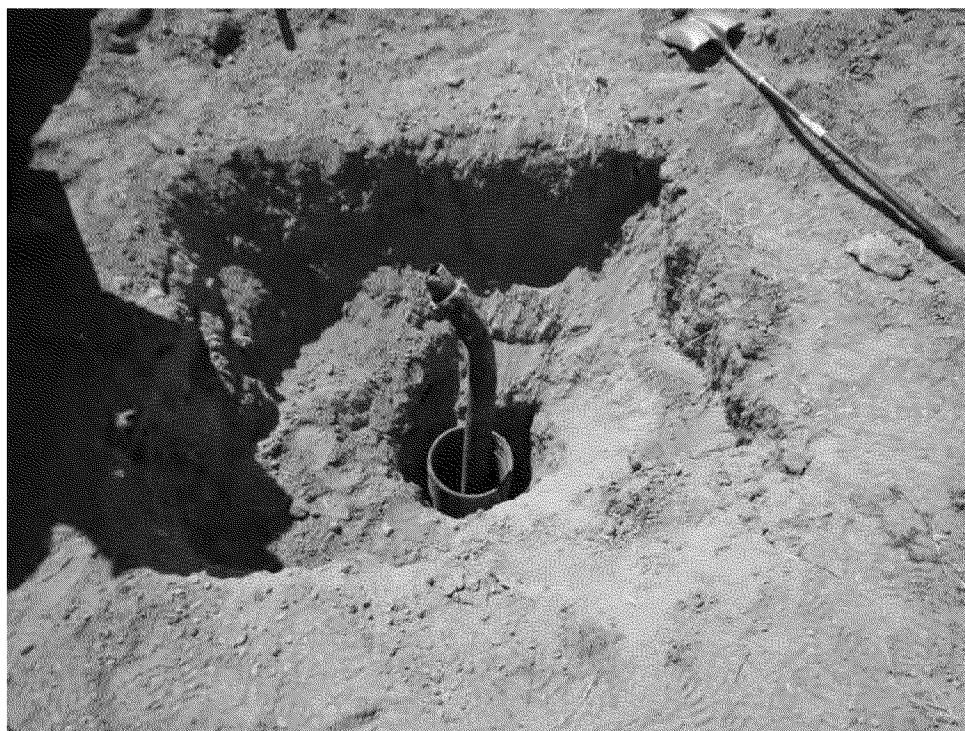
Photo 10. Preparing for pump removal. Looking south. April 16, 2013.

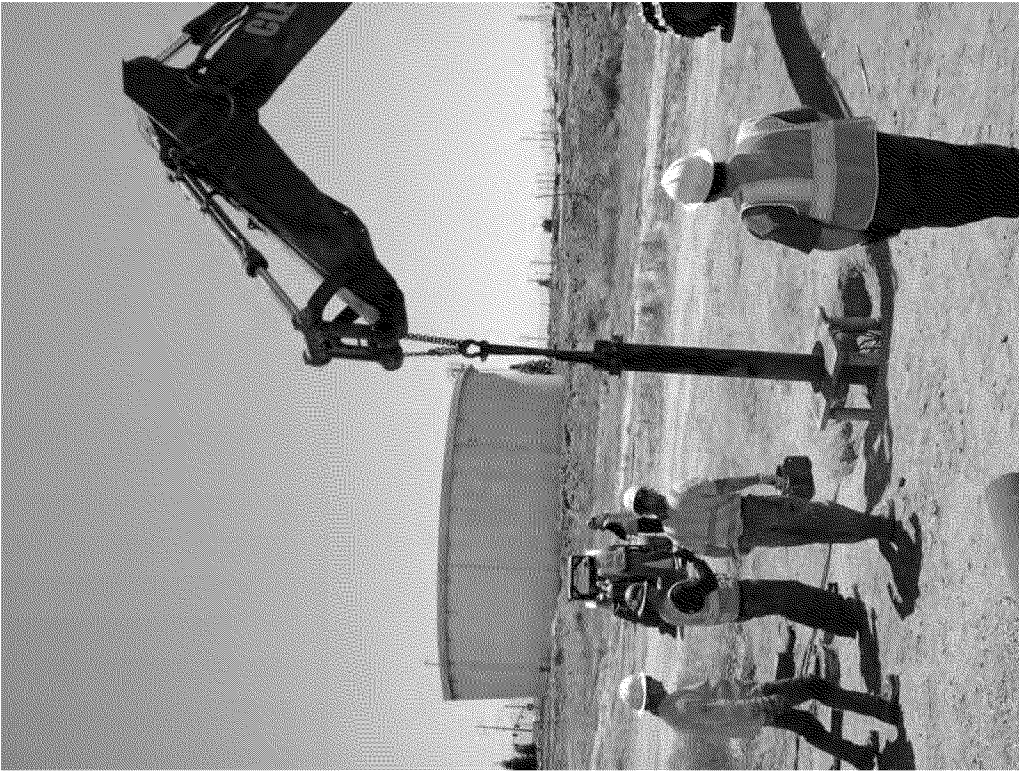
Photo 12. Pump removal by excavator. Looking southeast. April 18, 2013.

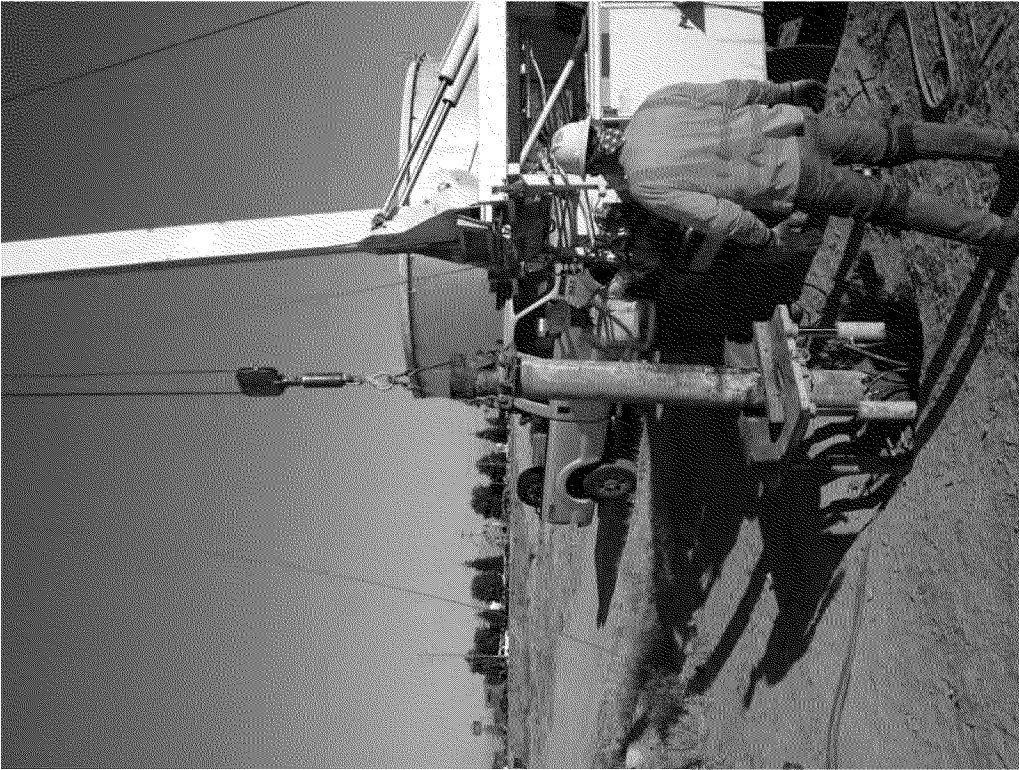
Photo 11. Hydraulic jack table beginning extraction of WS1 pump. Looking east. April 17, 2013.

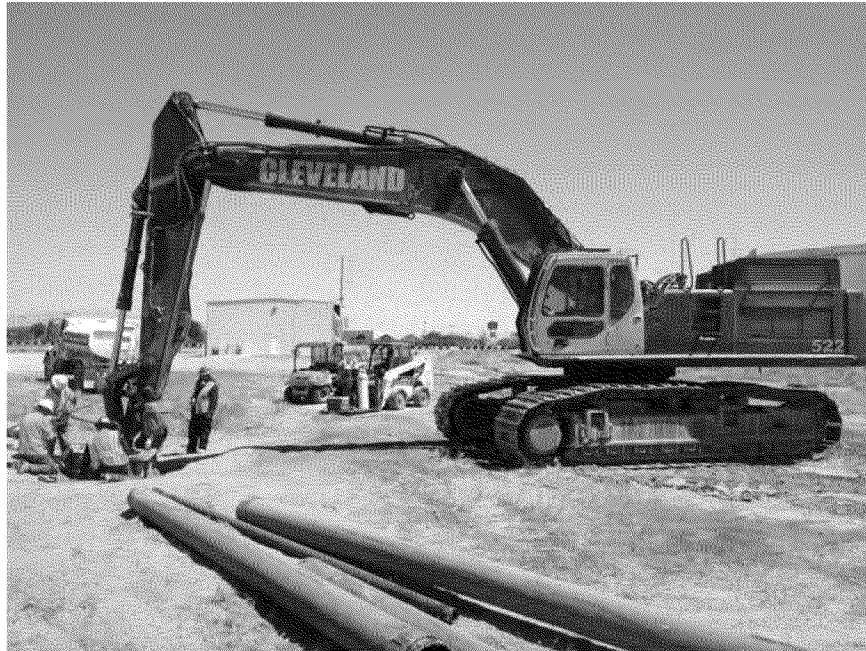
Photo 13. Removed pump casing and driveshaft from WS1. Attempting to free remaining pump from the well. Looking east. April 18, 2013.

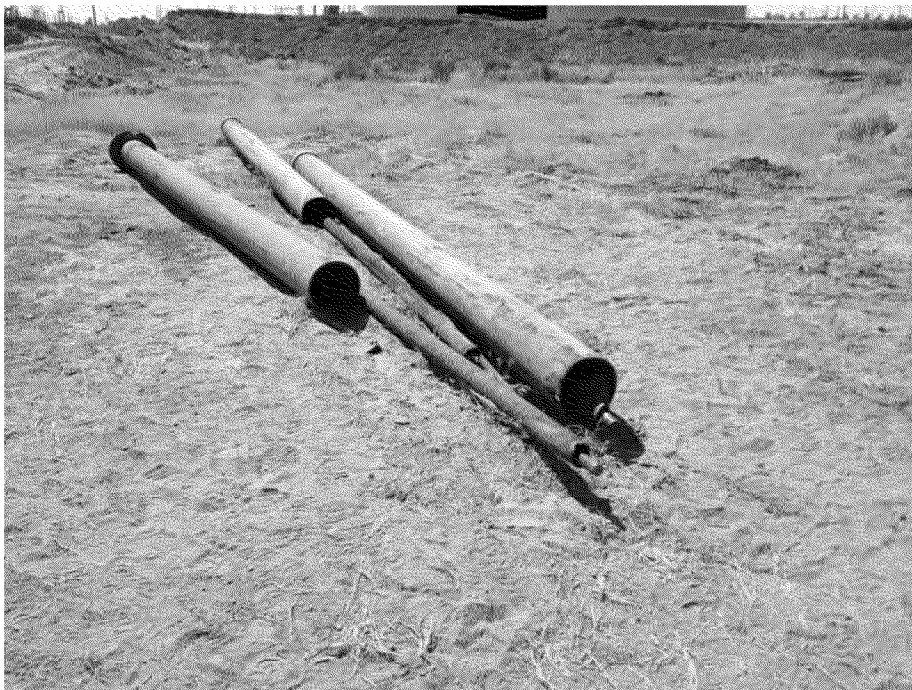
Photo 14. Sixty feet of pump casing removed from WS1. Looking west. April 18, 2013.
