A. Damage to PG&E's Electric Distribution System

B. Electric Distribution System Restoration and Contact Center Activities

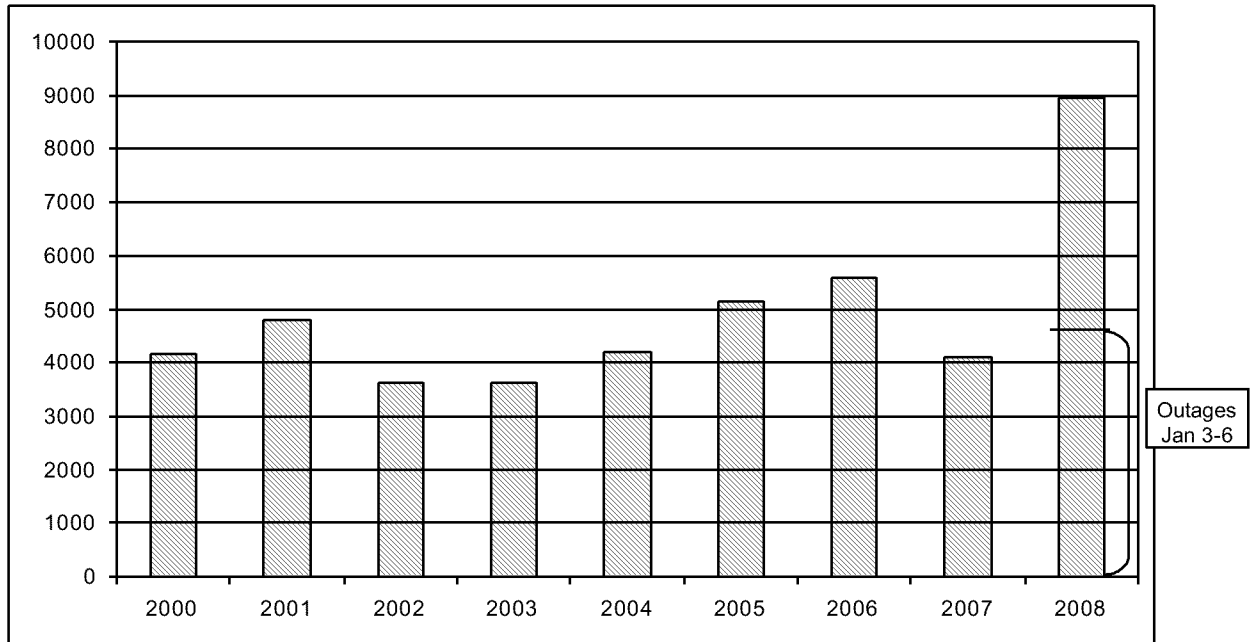
**TABLE 4
PACIFIC GAS AND ELECTRIC COMPANY
SYSTEM OUTAGE VOLUME JANUARY 2000-2008**

During the four days of the January 2008 Storms (January 3-6) PG&E experienced 4,439 sustained outages, which represents 49.6% of the total outages recorded for the month January 2008. As illustrated in the figure above, the outages recorded during this one event is greater than the total number of outages recorded for the entire month of January in five of the eight the preceding years. PG&E experienced more outages during January 2008 than it has in each of the past eight years for this same period.

The wind, snow and heavy rain caused outage volume for January 2008 to increase dramatically. Table 4 shows the outage volume by year for the month of January from 2000 through 2008.

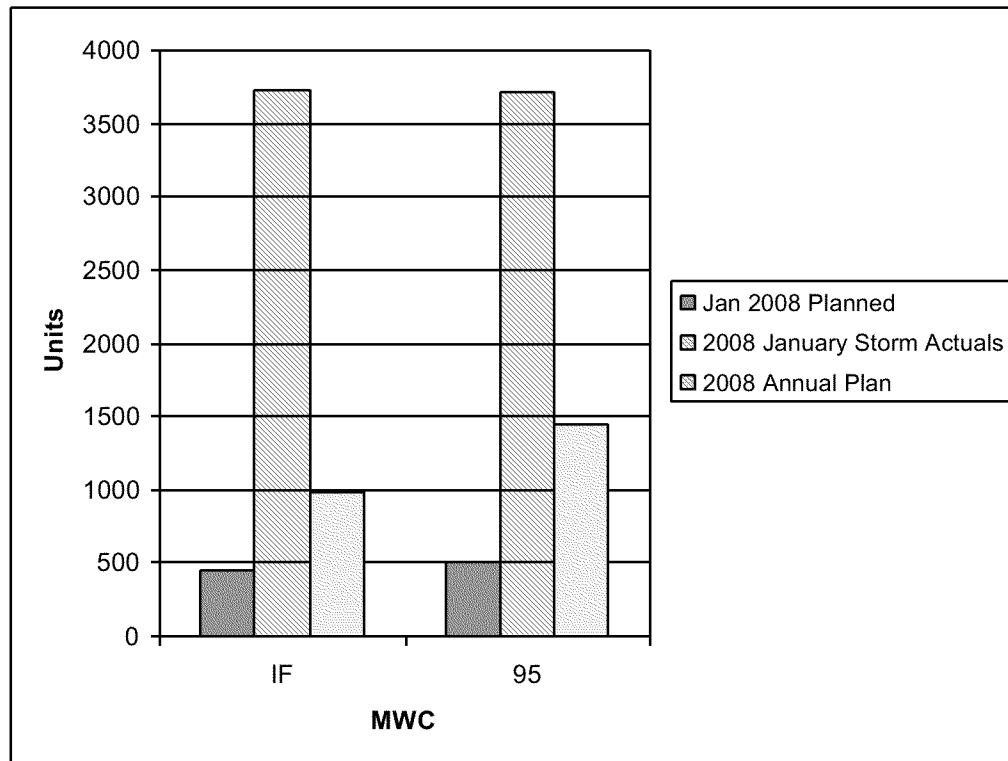
**TABLE 5
PACIFIC GAS AND ELECTRIC COMPANY
PLANNED AND ACTUAL WORK UNITS FOR MWC IF AND 95
JANUARY 2008 STORMS**

Before the storms, the forecasted the 2008 unit volume of electric maintenance expense work (MWC IF) based on historic average workloads for January was 450 units. However, actual units completed in response to the January 2008 Storms were 3,731 units – an 829% increase above the forecast. Similarly, the forecasted unit volume for electric capital work (MWC 95) for January 2008 was 502 units; however, the actual units required and completed during the January 2008 Storms were 3,717 units – a 740% increase above the forecast.
