# **Asbestos Abatement Work Plan for Boiler Units 1, 2, 3 and 4 Kern Power Plant Demolition Project**

2401 Coffee Road  
Bakersfield, California 93308

June 25, 2014  
Revision 0

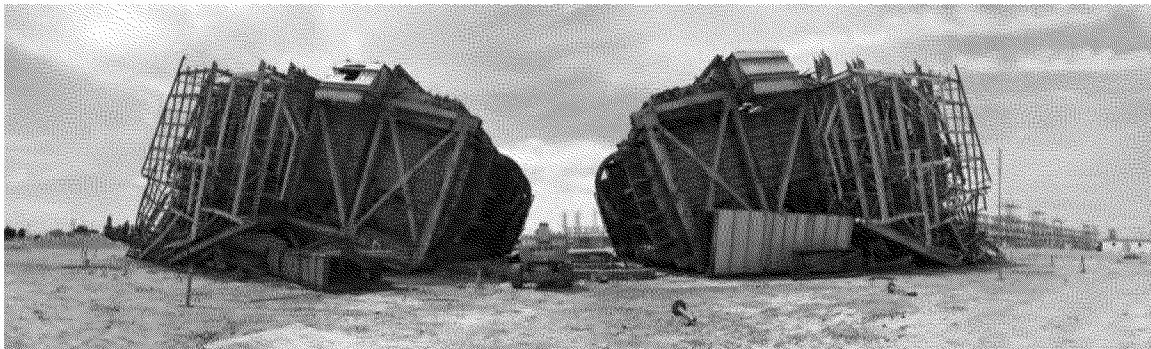
Felled Boiler Structures  
(View Looking South)

The post-implosion rubble pile currently consists of the two felled boiler structures lying on their sides with their former bottoms opposing one another in the center of the rubble pile. Each of the boiler structures contains two boiler units located side-by-side (north-south) within a heavy structural steel frame. The boiler structures also contain appurtenant structures such as ductwork, stairwells and catwalks, piping systems within a light structural steel framework surrounding the boiler units.

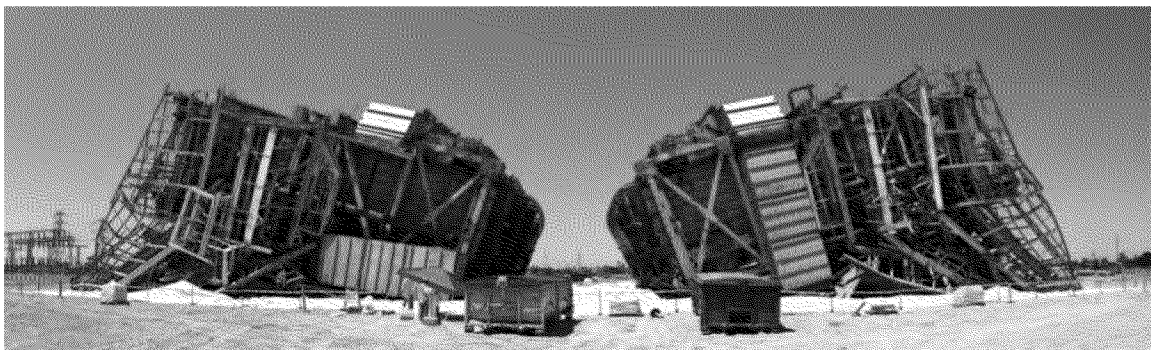
Felled Boiler Structures  
(View Looking North)

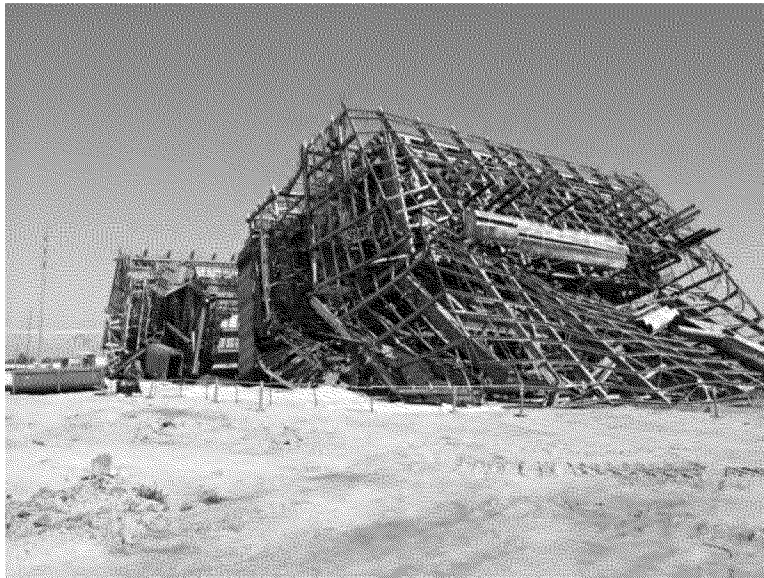
Northwest Corner of Boiler Structures  
(View Looking SW)

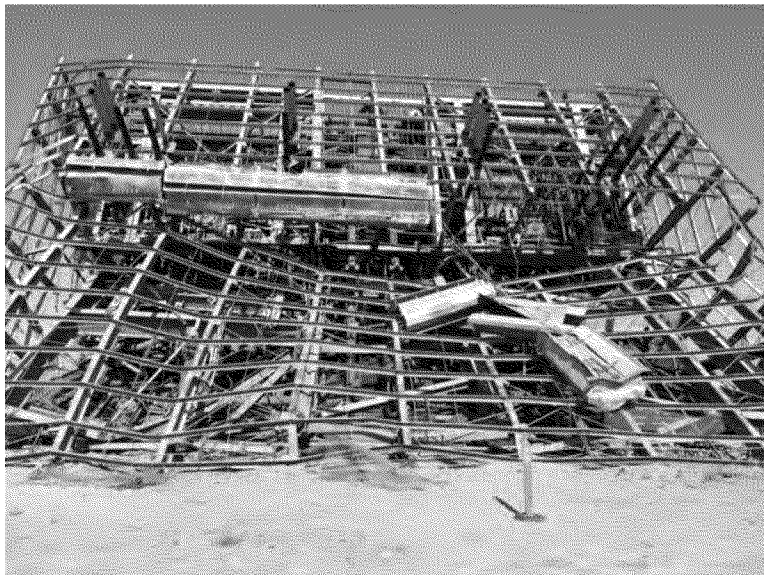
Former Top of Boiler Structures  
(East End, View Looking West)

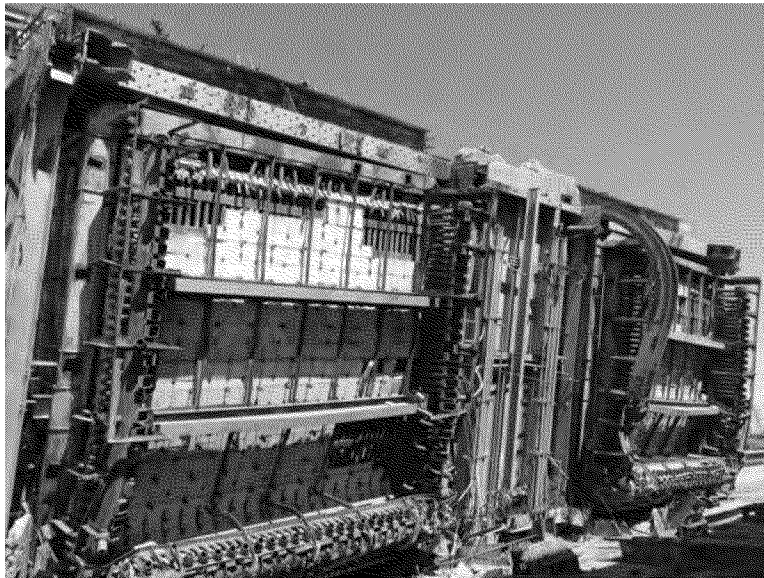
Former Bottom of Boiler Structures  
(East Structure, View Looking Southeast)

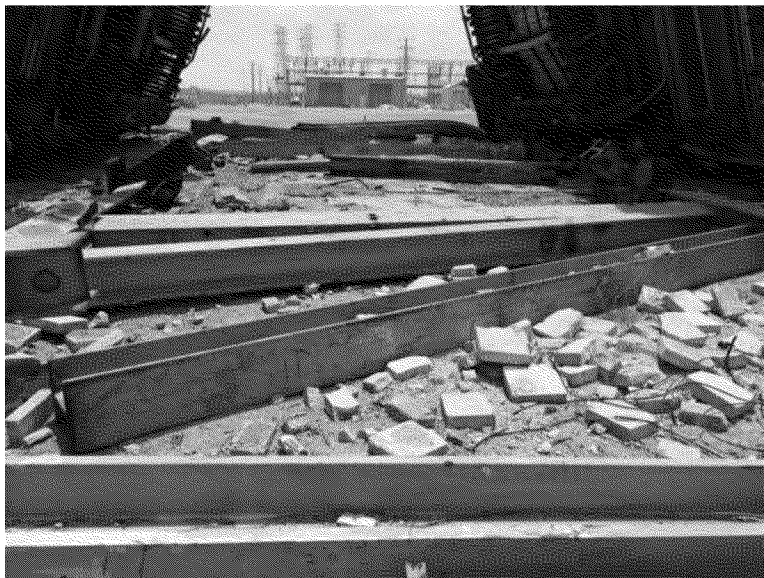
Debris Between Boiler Structures  
(View Looking South)

The majority of debris that will be encountered will consist of nondescript remnants of demolition debris composed of refractory debris, small pieces of metal, small concrete debris, rust, soil, wood and other similar materials (see photographs, above). This material will be collected using HEPA vacuums and shovels. Debris will be placed directly into waste bins or dispensed into wheelbarrows or totes prior to dumping into bins. If necessary, a skid-steer loader will be used to collect debris or to shuttle material from the work area to the waste bins.

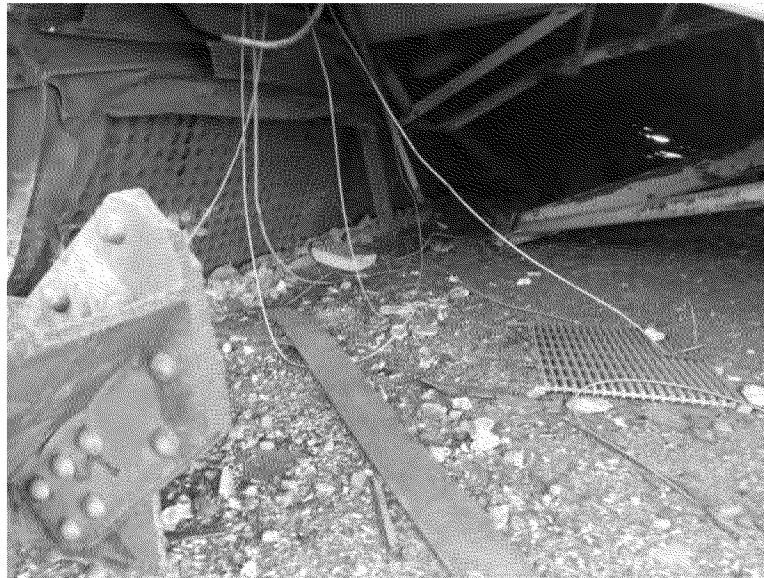
Debris Under Boiler Structures  
(Under NW Boiler Near Bottom)

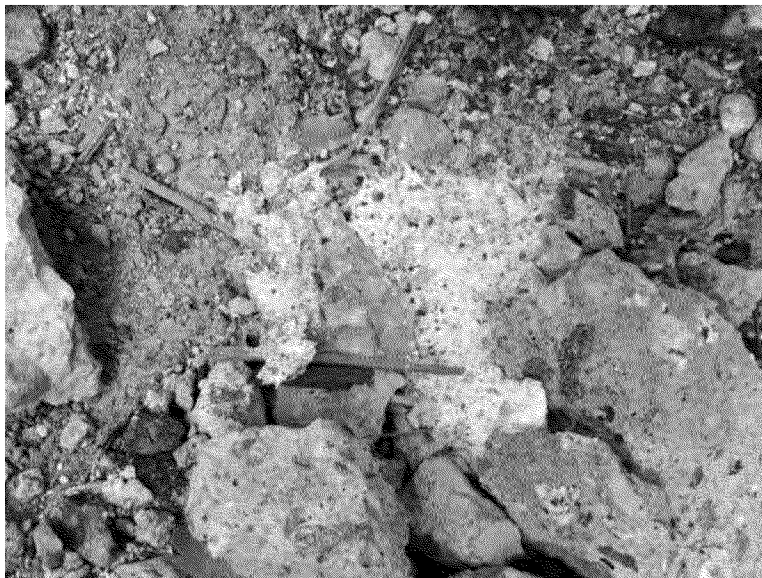
TSI Debris Between Boiler Structures  
(Closeup View)

The TSI debris found in and around the boilers are not present in significant quantities or frequencies and do not appear to consist of gross accumulations of installed insulating materials. Rather, the presence of TSI debris appears to be the result of small amounts of materials not found during the original, pre-implosion abatement project becoming dislodged during the implosion. Samples of TSI debris collected by RGA were found to contain >1% asbestos.

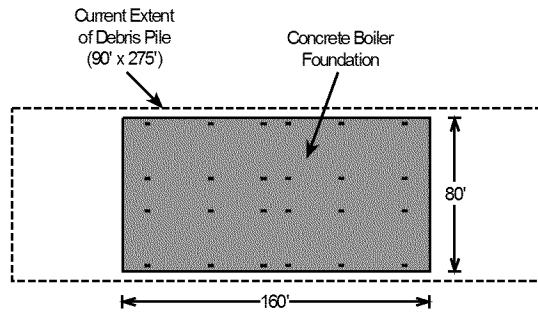
Figure 1A  
Current Conditions

The work area currently consists of the post-implosion debris pile and collapsed boiler structures (see Figure 1, Detail A). The periphery of the boiler structures consists of loose and potentially unstable metal structures on the outside of the main structural steel framework surrounding the boiler units. This peripheral material includes light structural steel assemblies, ductwork, staircases, catwalks, piping and other miscellaneous metal assemblies. The presence of this loose material prevents safe access to the portions of the boiler structure that contains the subject asbestos-containing materials. Furthermore, the peripheral material prevents access to the concrete boiler foundation slab and therefore interferes with the construction of the decontamination pad areas.

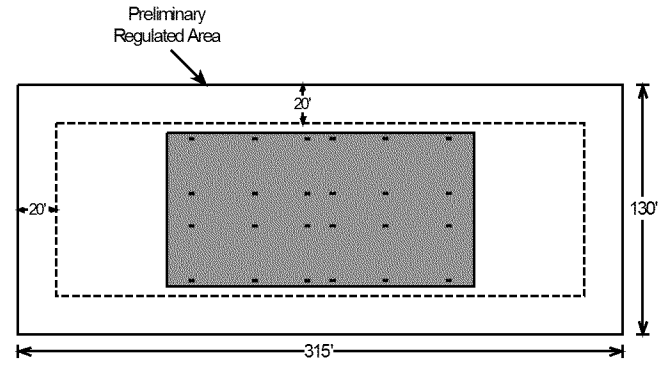
Figure 1B  
Regulated Area Configuration  
Preliminary Dismantlement Phase

accessible. Salvageable materials will be removed and decontaminated prior to pass-out from the Regulated Area as described above. Rather than performing decontamination on the gravel-lined decontamination pad, work will be performed on impermeable drop cloths (10-mil reinforced polyethylene). Steel plate will be employed as needed to prevent damage to the drop cloths. Damage such as rips and tears in the drop cloth will be repaired immediately. Figure 1, Detail B illustrates the details of the work area layout during the Preliminary Dismantlement phase.

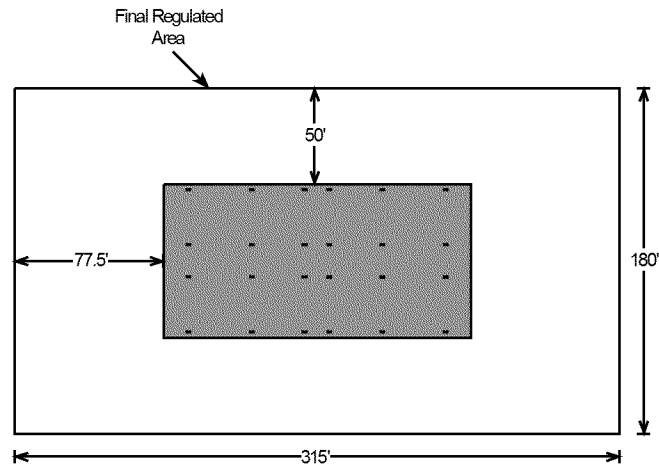
Figure 1C  
Regulated Area Configuration  
Main Demolition Phase

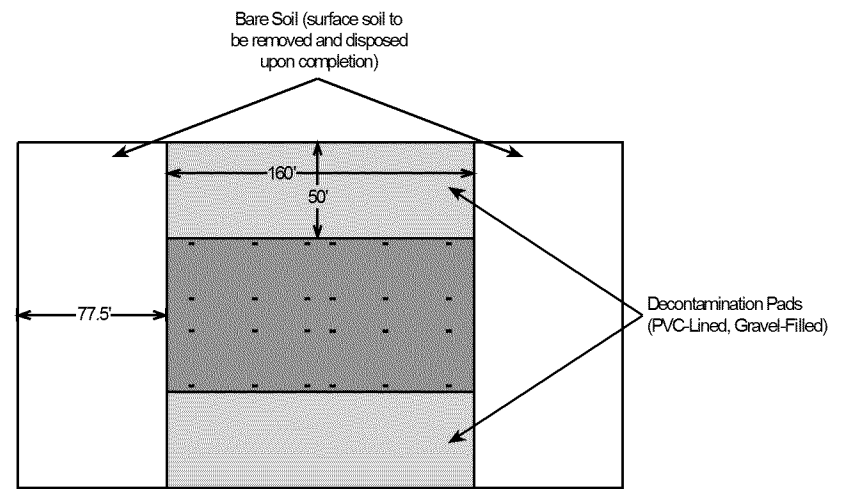
Figure 1D  
Decontamination Pads  
Main Demolition Phase

Once perimeter debris cleanup has been accomplished, the construction of the decontamination basins described above will commence. The top 2" to 4" of soil will be removed and disposed as asbestos waste to alleviate concerns regarding possible cross-contamination of surface soils during the Preliminary Dismantlement work. The remaining soil excavated during the construction of the basins will be stockpiled nearby for subsequent replacement at the completion of the project. Figure 1, Detail D shows the configuration of the decontamination areas.

Upon completion of demolition and abatement visual inspections will be conducted and the decontamination basins will be cleared as described below. Additionally, the east and west portions of the Regulated Area surrounding the concrete paved boiler foundation area (outside of the footprint of the decontamination basins) will undergo surface soil removal as described above (2" to 4") to mitigate possible cross-contamination of surface soils during the main demolition phase (see Figure 1, Detail D).
