Figure 3.14-22b
Visual Simulation
for KOP-Center-7
Northbound Upper Big
Tujunga Canyon Road
(Alternative 2, Segment 6)

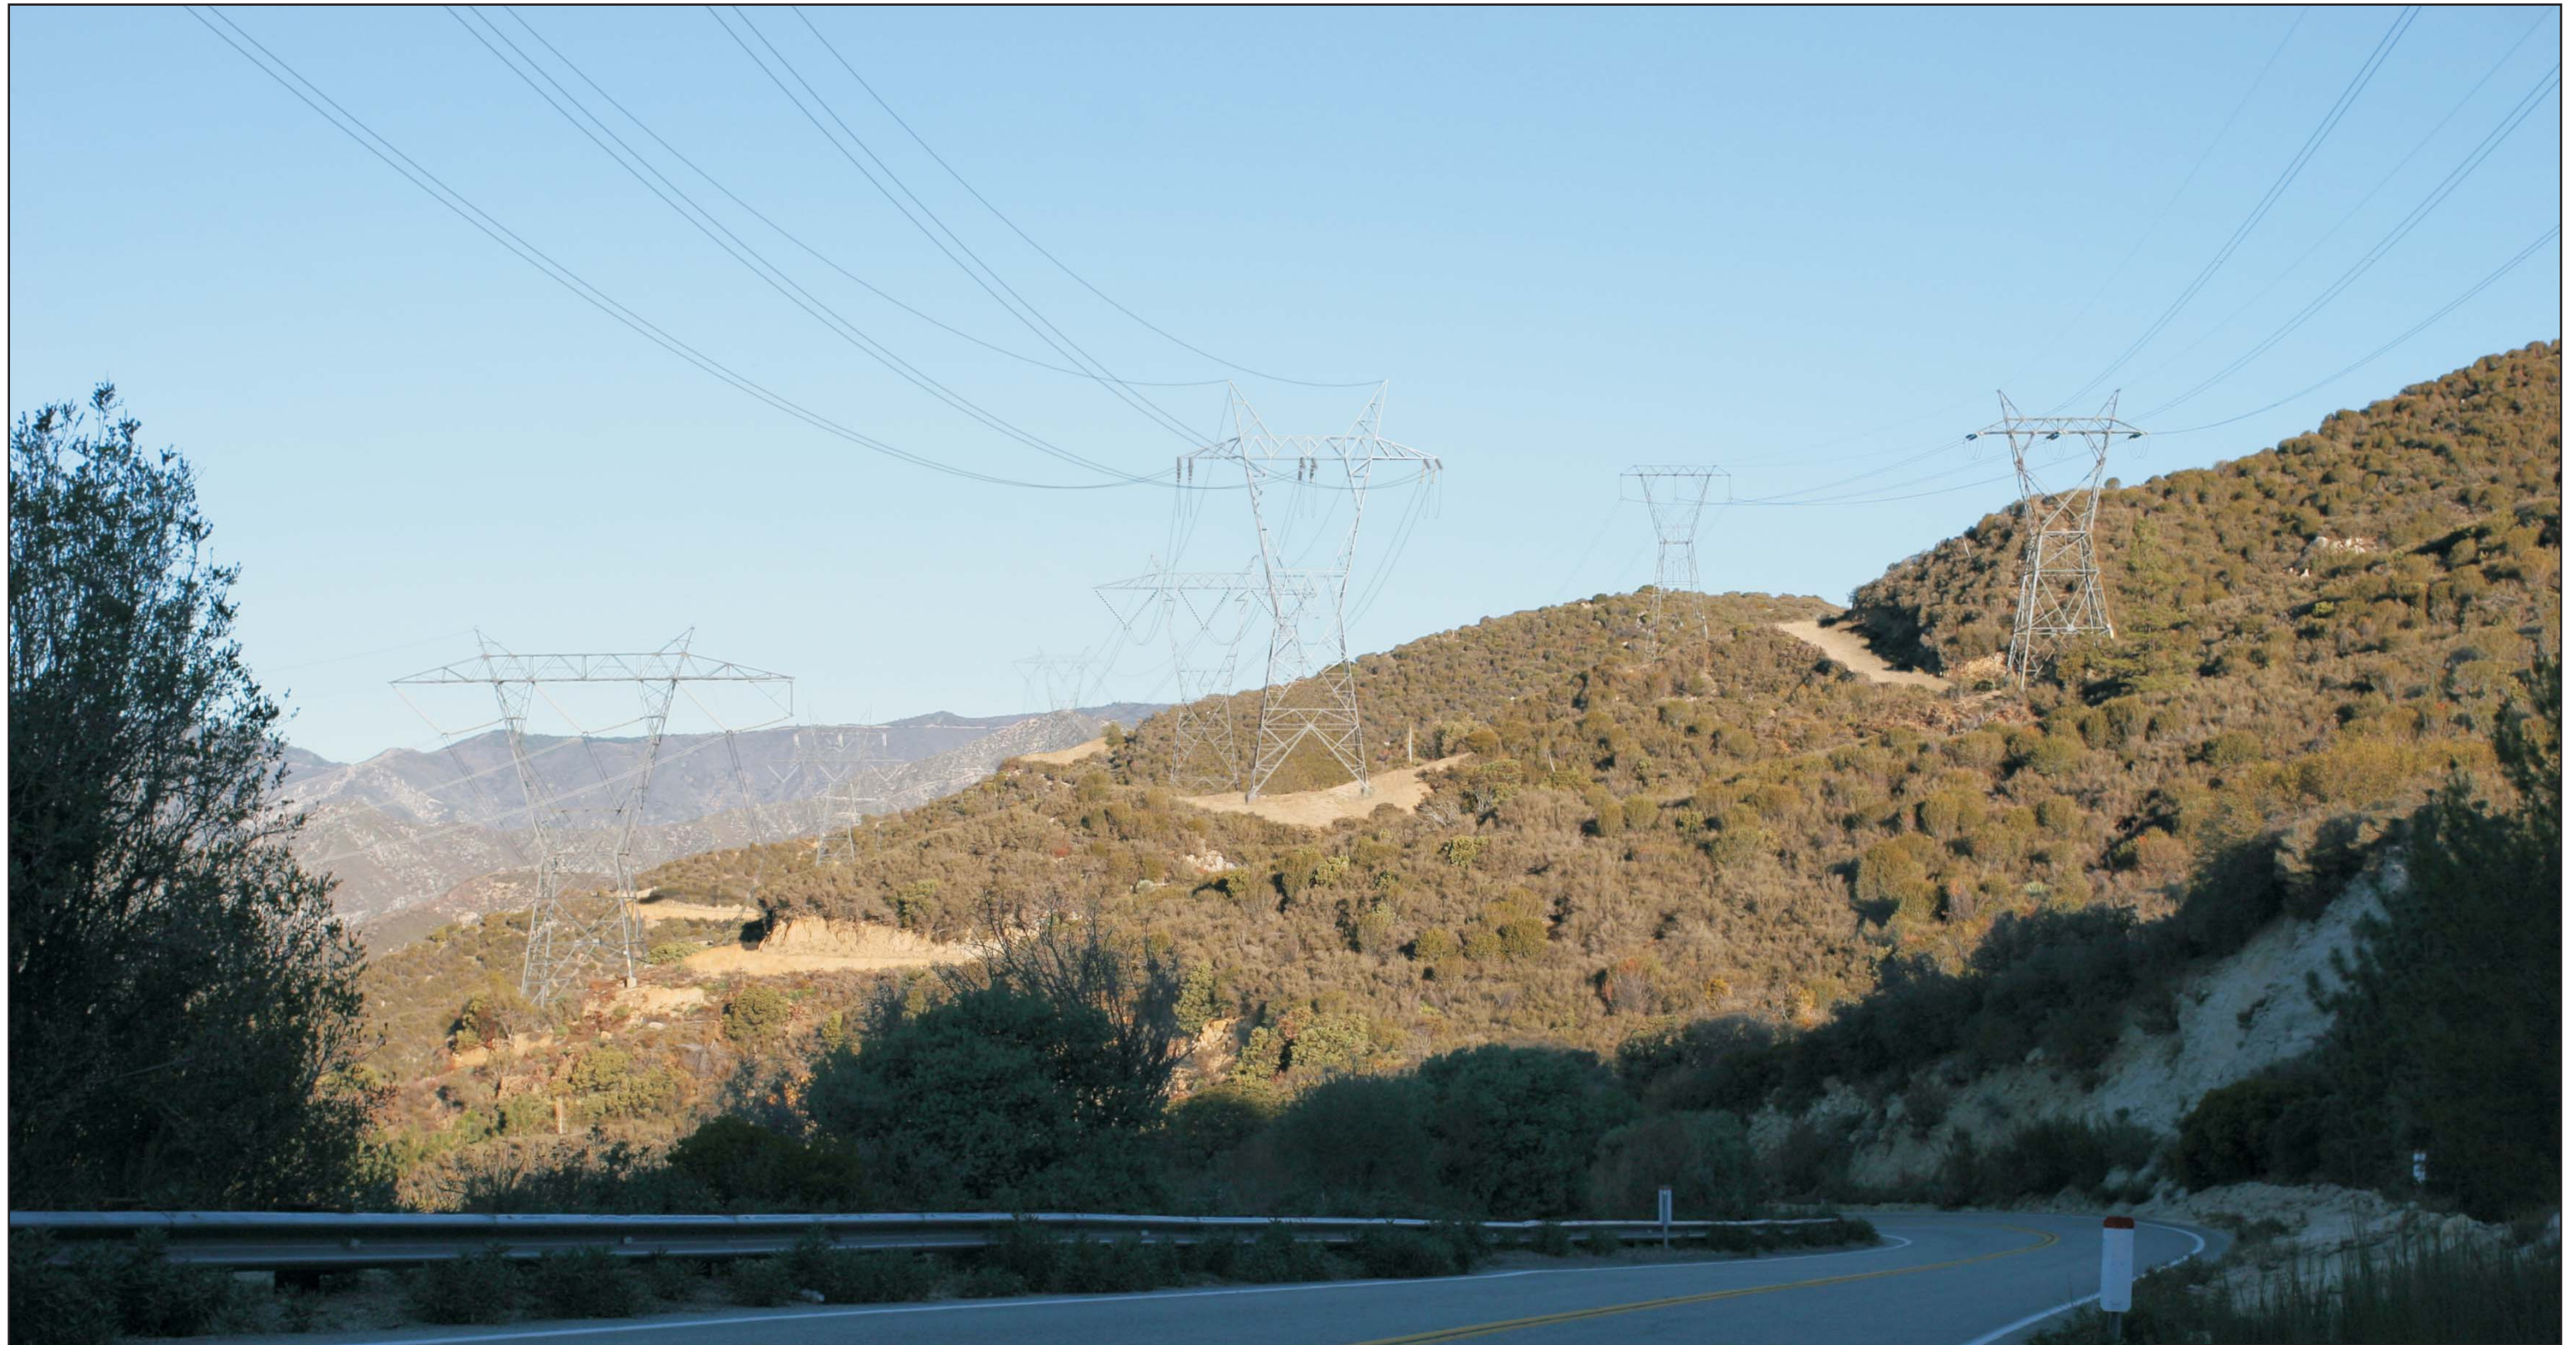
Future Scenic Integrity: High, with Areas of Unacceptably Low. SCE's proposed action (Alternative 2, Segment 6) would replace the middle of three existing transmission lines with new 500-kV LSTs in most of the same footprint areas. New 500-kV LSTs would be 85-to-220-foot tall with 96-foot-wide arms. In this area, Segment 6 transmission lines, taller LSTs, re-opened access/spur roads would be seen in the foreground of this road for approximately 2 miles, and would achieve unacceptably low scenic integrity in an otherwise predominantly natural-appearing existing landscape character. Access and spur roads are simulated based on Road Permit Plans provided by SCE in August 2008.

Adverse Visual Impacts. In the vicinity of KOP-Center-7, implementation of the Project would result in adverse visual impacts V-1, V-3, V-4, V-5, and V-7, as detailed in Table 6-1.

Mitigation Measures. Implementation of Mitigation Measures (MMs) would reduce adverse visual impacts to a certain degree, but the Project would create strong adverse contrasts of form, line, color, texture, and scale. It would continue to not meet the High SIO established for this area. MMs would include: V-1 – Clean up staging areas, storage areas, marshalling yards, access and spur roads, and structure locations on a regular periodic basis; V-2b – Treat surfaces with appropriate colors, textures, and finishes; V-3a – Match spans of existing transmission structures; V-3b – On NFS lands, provide restoration/compensation for impacts to landscape character and visual quality; V-4a – Construct, operate, and maintain the Project with existing access and spur roads where feasible; V-4c – Avoid locating new roads in bedrock on NFS lands; and, V-4d – Dispose of excavated materials as prescribed.
