Figure 3.14-38a
Existing Conditions
for KOP-South-3
Linard Street/Kayann Place
Intersection, South El Monte
(Alternative 2, Segment 7)
Source: SCE, 2007.

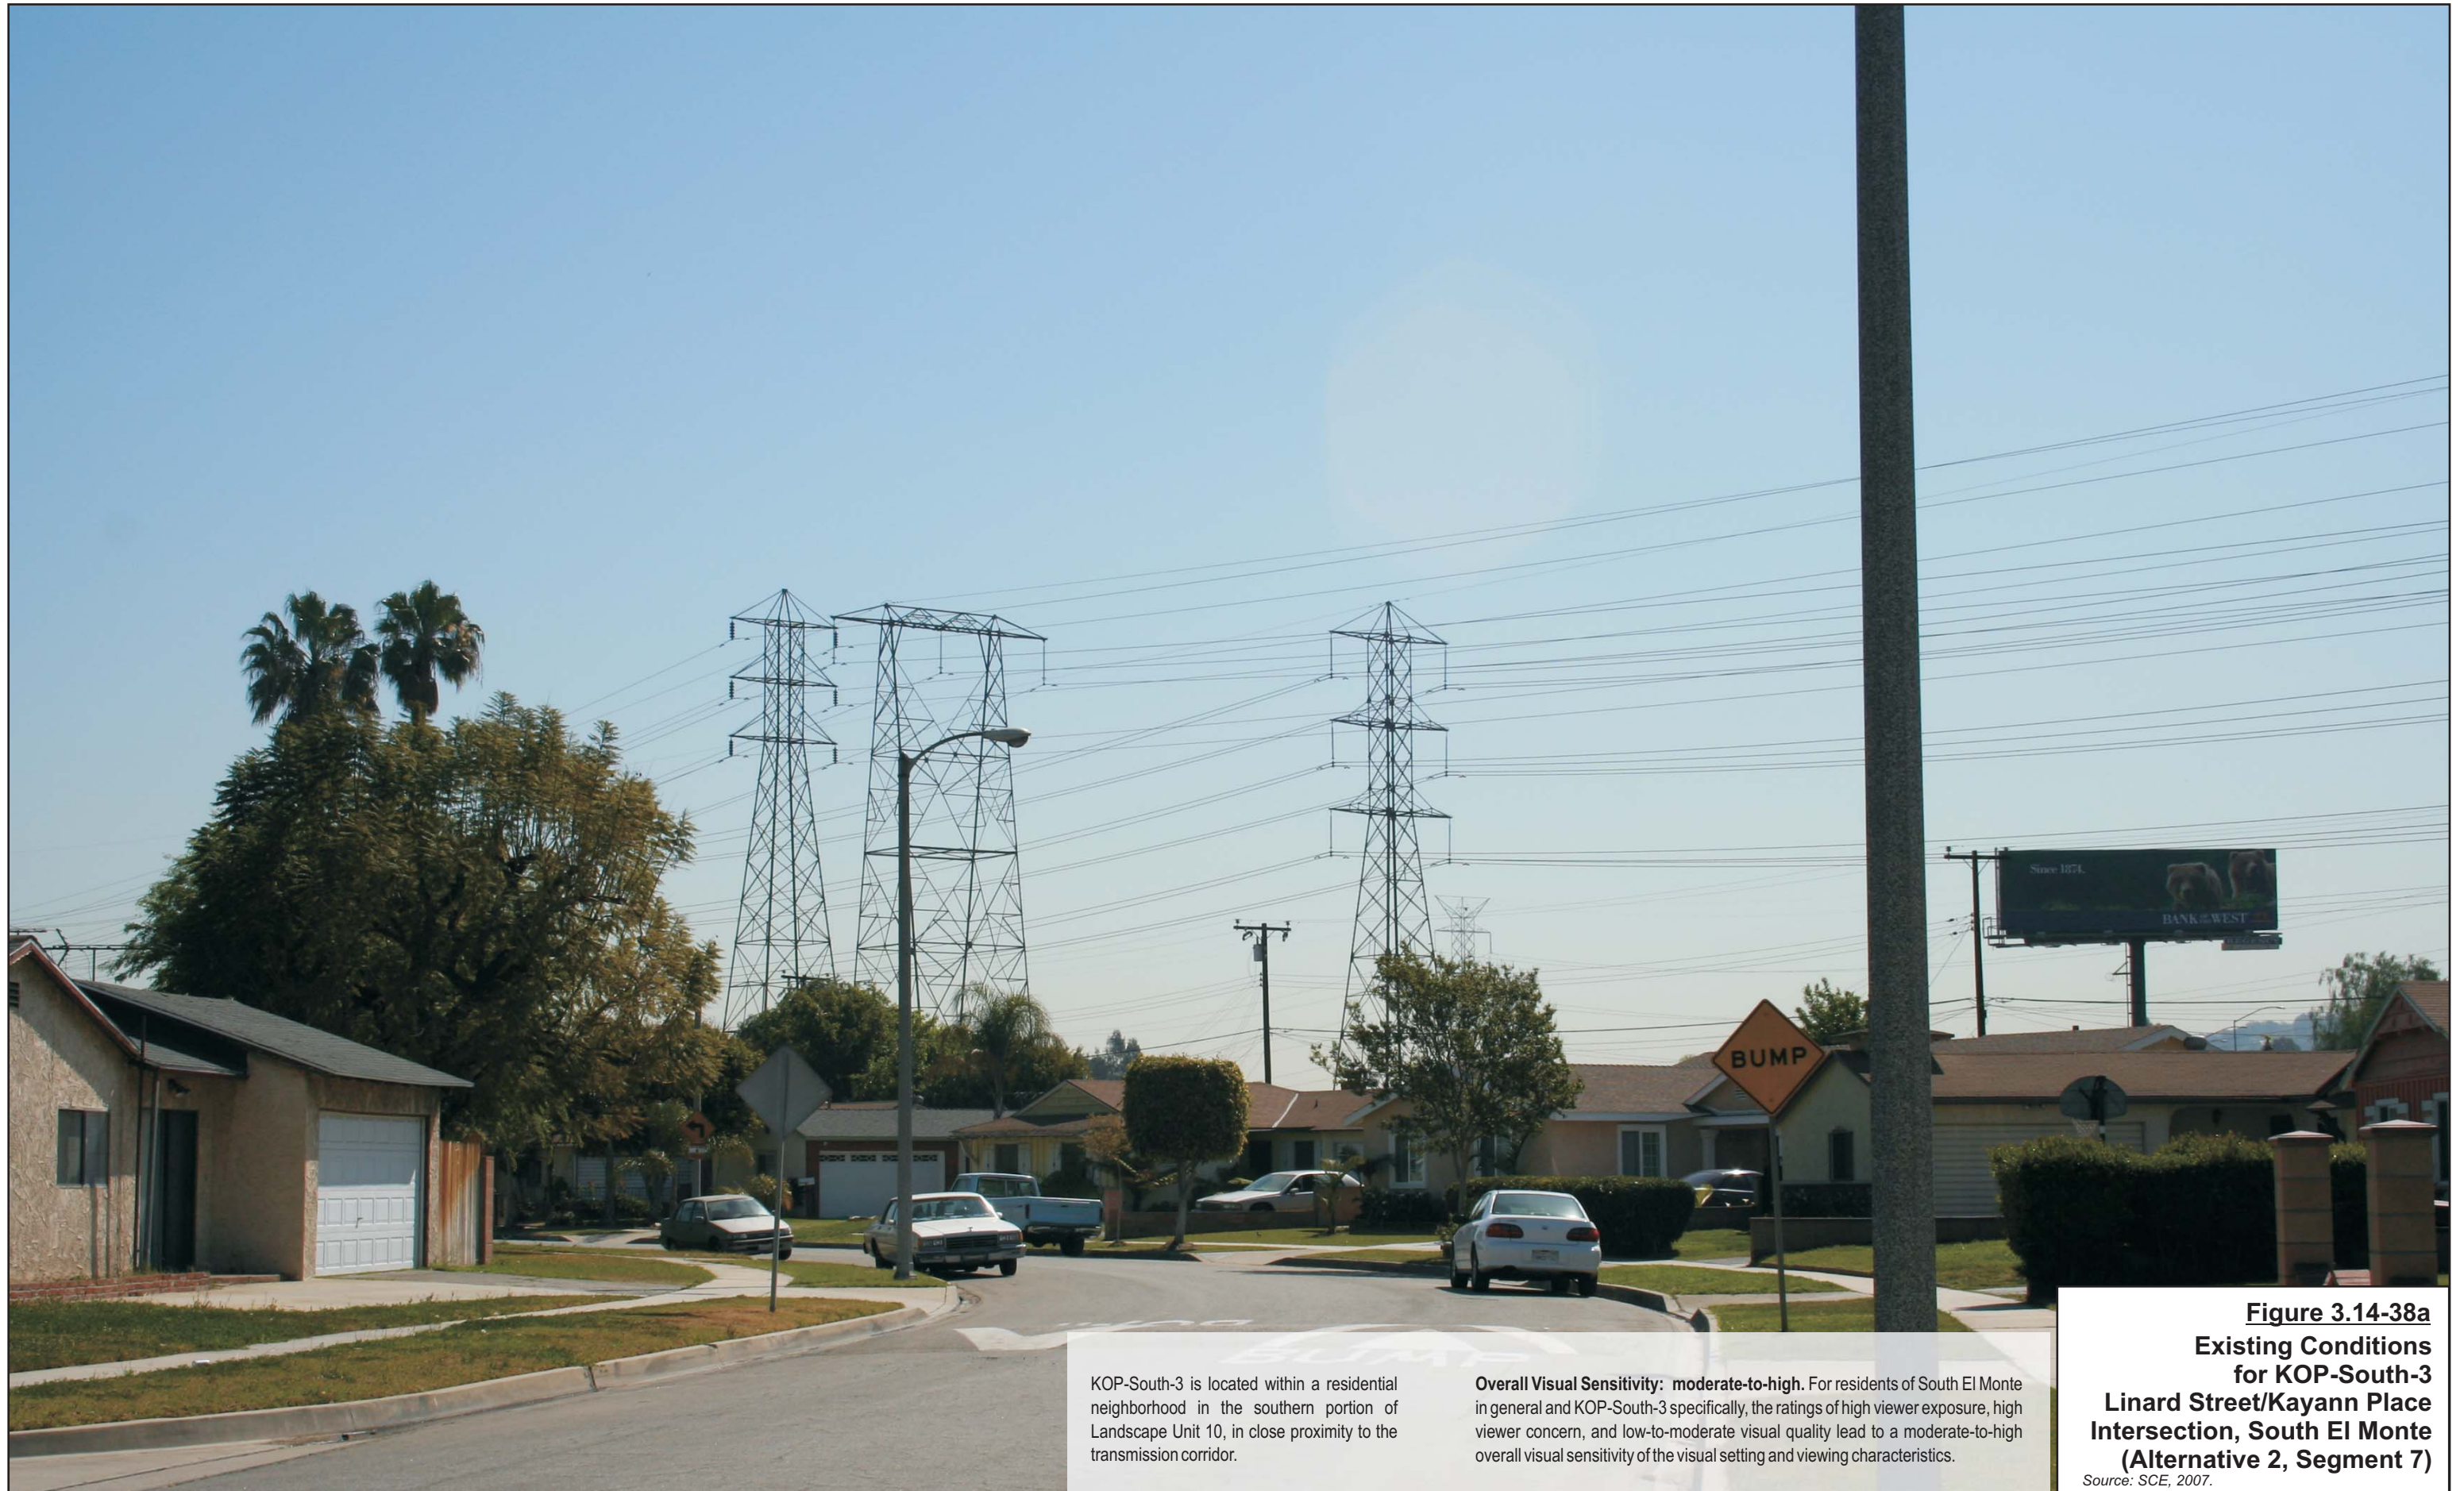
KOP-South-3 is located within a residential neighborhood in the southern portion of Landscape Unit 10, in close proximity to the transmission corridor.

Overall Visual Sensitivity: moderate-to-high. For residents of South El Monte in general and KOP-South-3 specifically, the ratings of high viewer exposure, high viewer concern, and low-to-moderate visual quality lead to a moderate-to-high overall visual sensitivity of the visual setting and viewing characteristics.
