Figure 3.14-40a
Existing Conditions
for KOP-South-5
Montebello Town Center,
Montebello Hills
(Alternative 2, Segment 7)

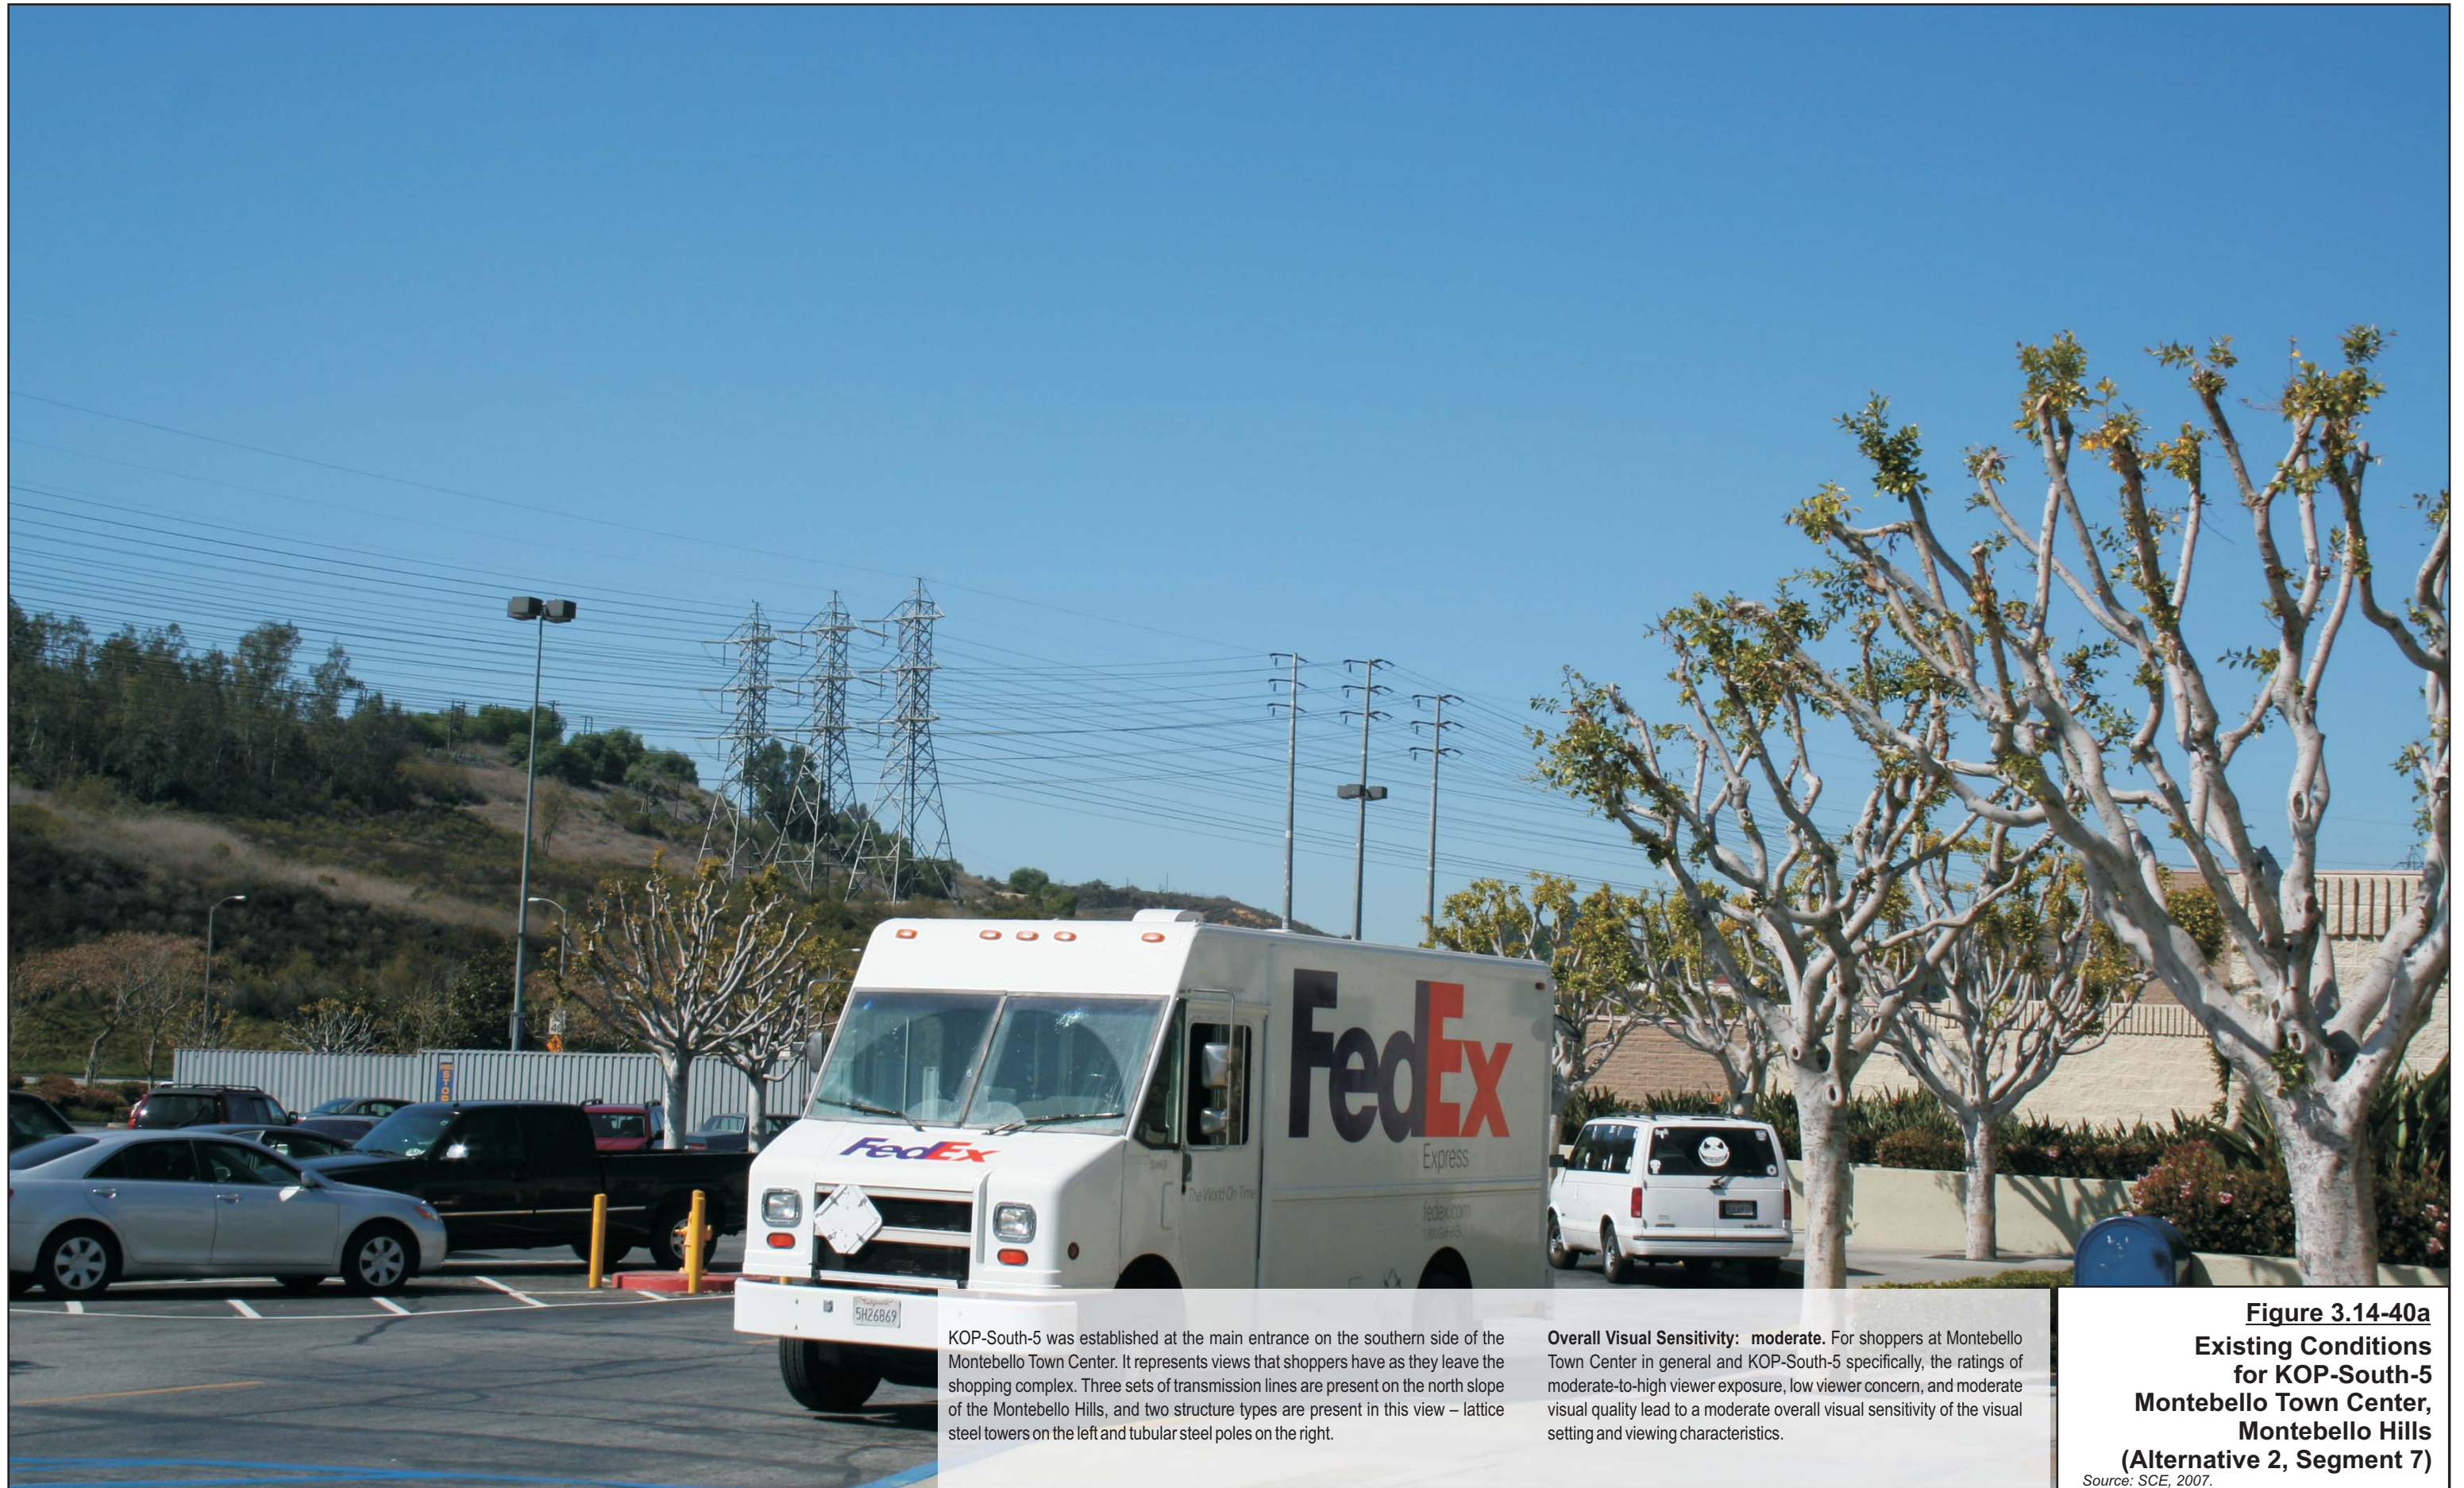
KOP-South-5 was established at the main entrance on the southern side of the Montebello Town Center. It represents views that shoppers have as they leave the shopping complex. Three sets of transmission lines are present on the north slope of the Montebello Hills, and two structure types are present in this view – lattice steel towers on the left and tubular steel poles on the right.

Overall Visual Sensitivity: moderate. For shoppers at Montebello Town Center in general and KOP-South-5 specifically, the ratings of moderate-to-high viewer exposure, low viewer concern, and moderate visual quality lead to a moderate overall visual sensitivity of the visual setting and viewing characteristics.
