Figure 3.14-52a
Existing Conditions
for KOP-South-17
Edison Avenue at
Reuben S. Ayala Community
Park, Chino (Alternative 2,
Segment 8)
Source: SCE, 2007.

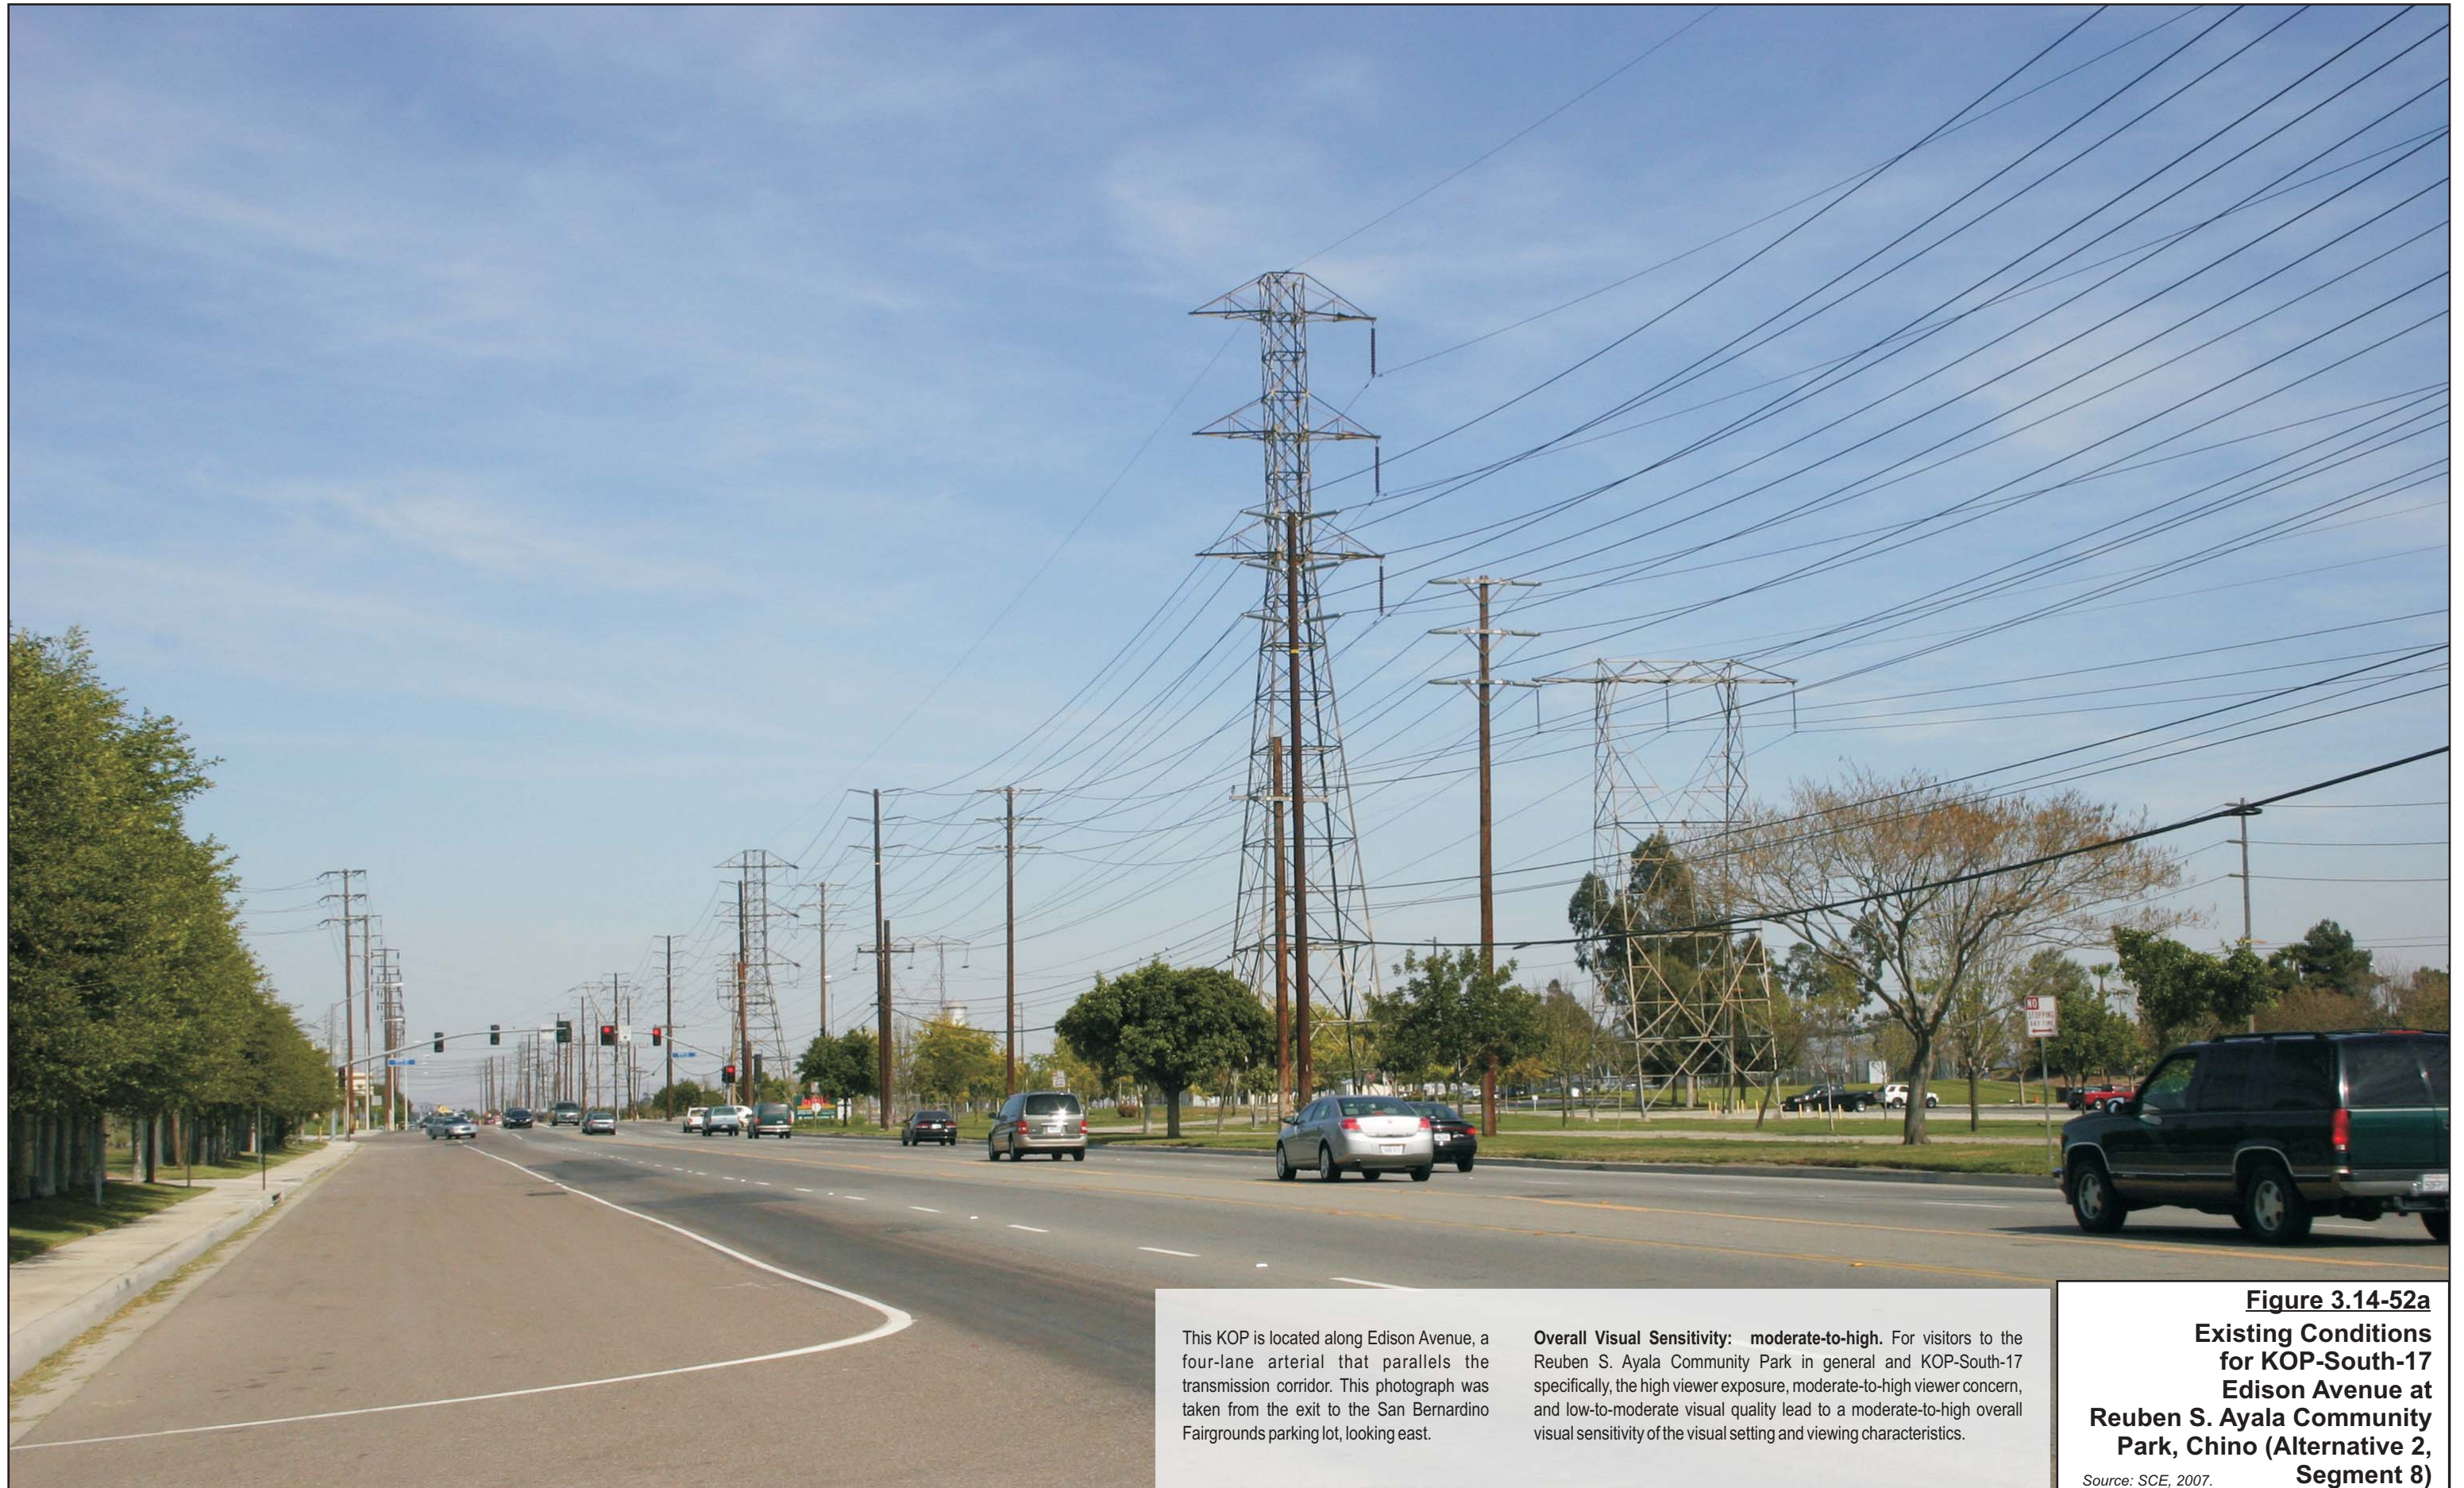
This KOP is located along Edison Avenue, a four-lane arterial that parallels the transmission corridor. This photograph was taken from the exit to the San Bernardino Fairgrounds parking lot, looking east.

Overall Visual Sensitivity: moderate-to-high. For visitors to the Reuben S. Ayala Community Park in general and KOP-South-17 specifically, the high viewer exposure, moderate-to-high viewer concern, and low-to-moderate visual quality lead to a moderate-to-high overall visual sensitivity of the visual setting and viewing characteristics.
