**Figure A-11a**  
**Existing Conditions**  
**for KOP-North-9**  
**Godde Hill Road**  
**(Alternative 2, Segment 5)**

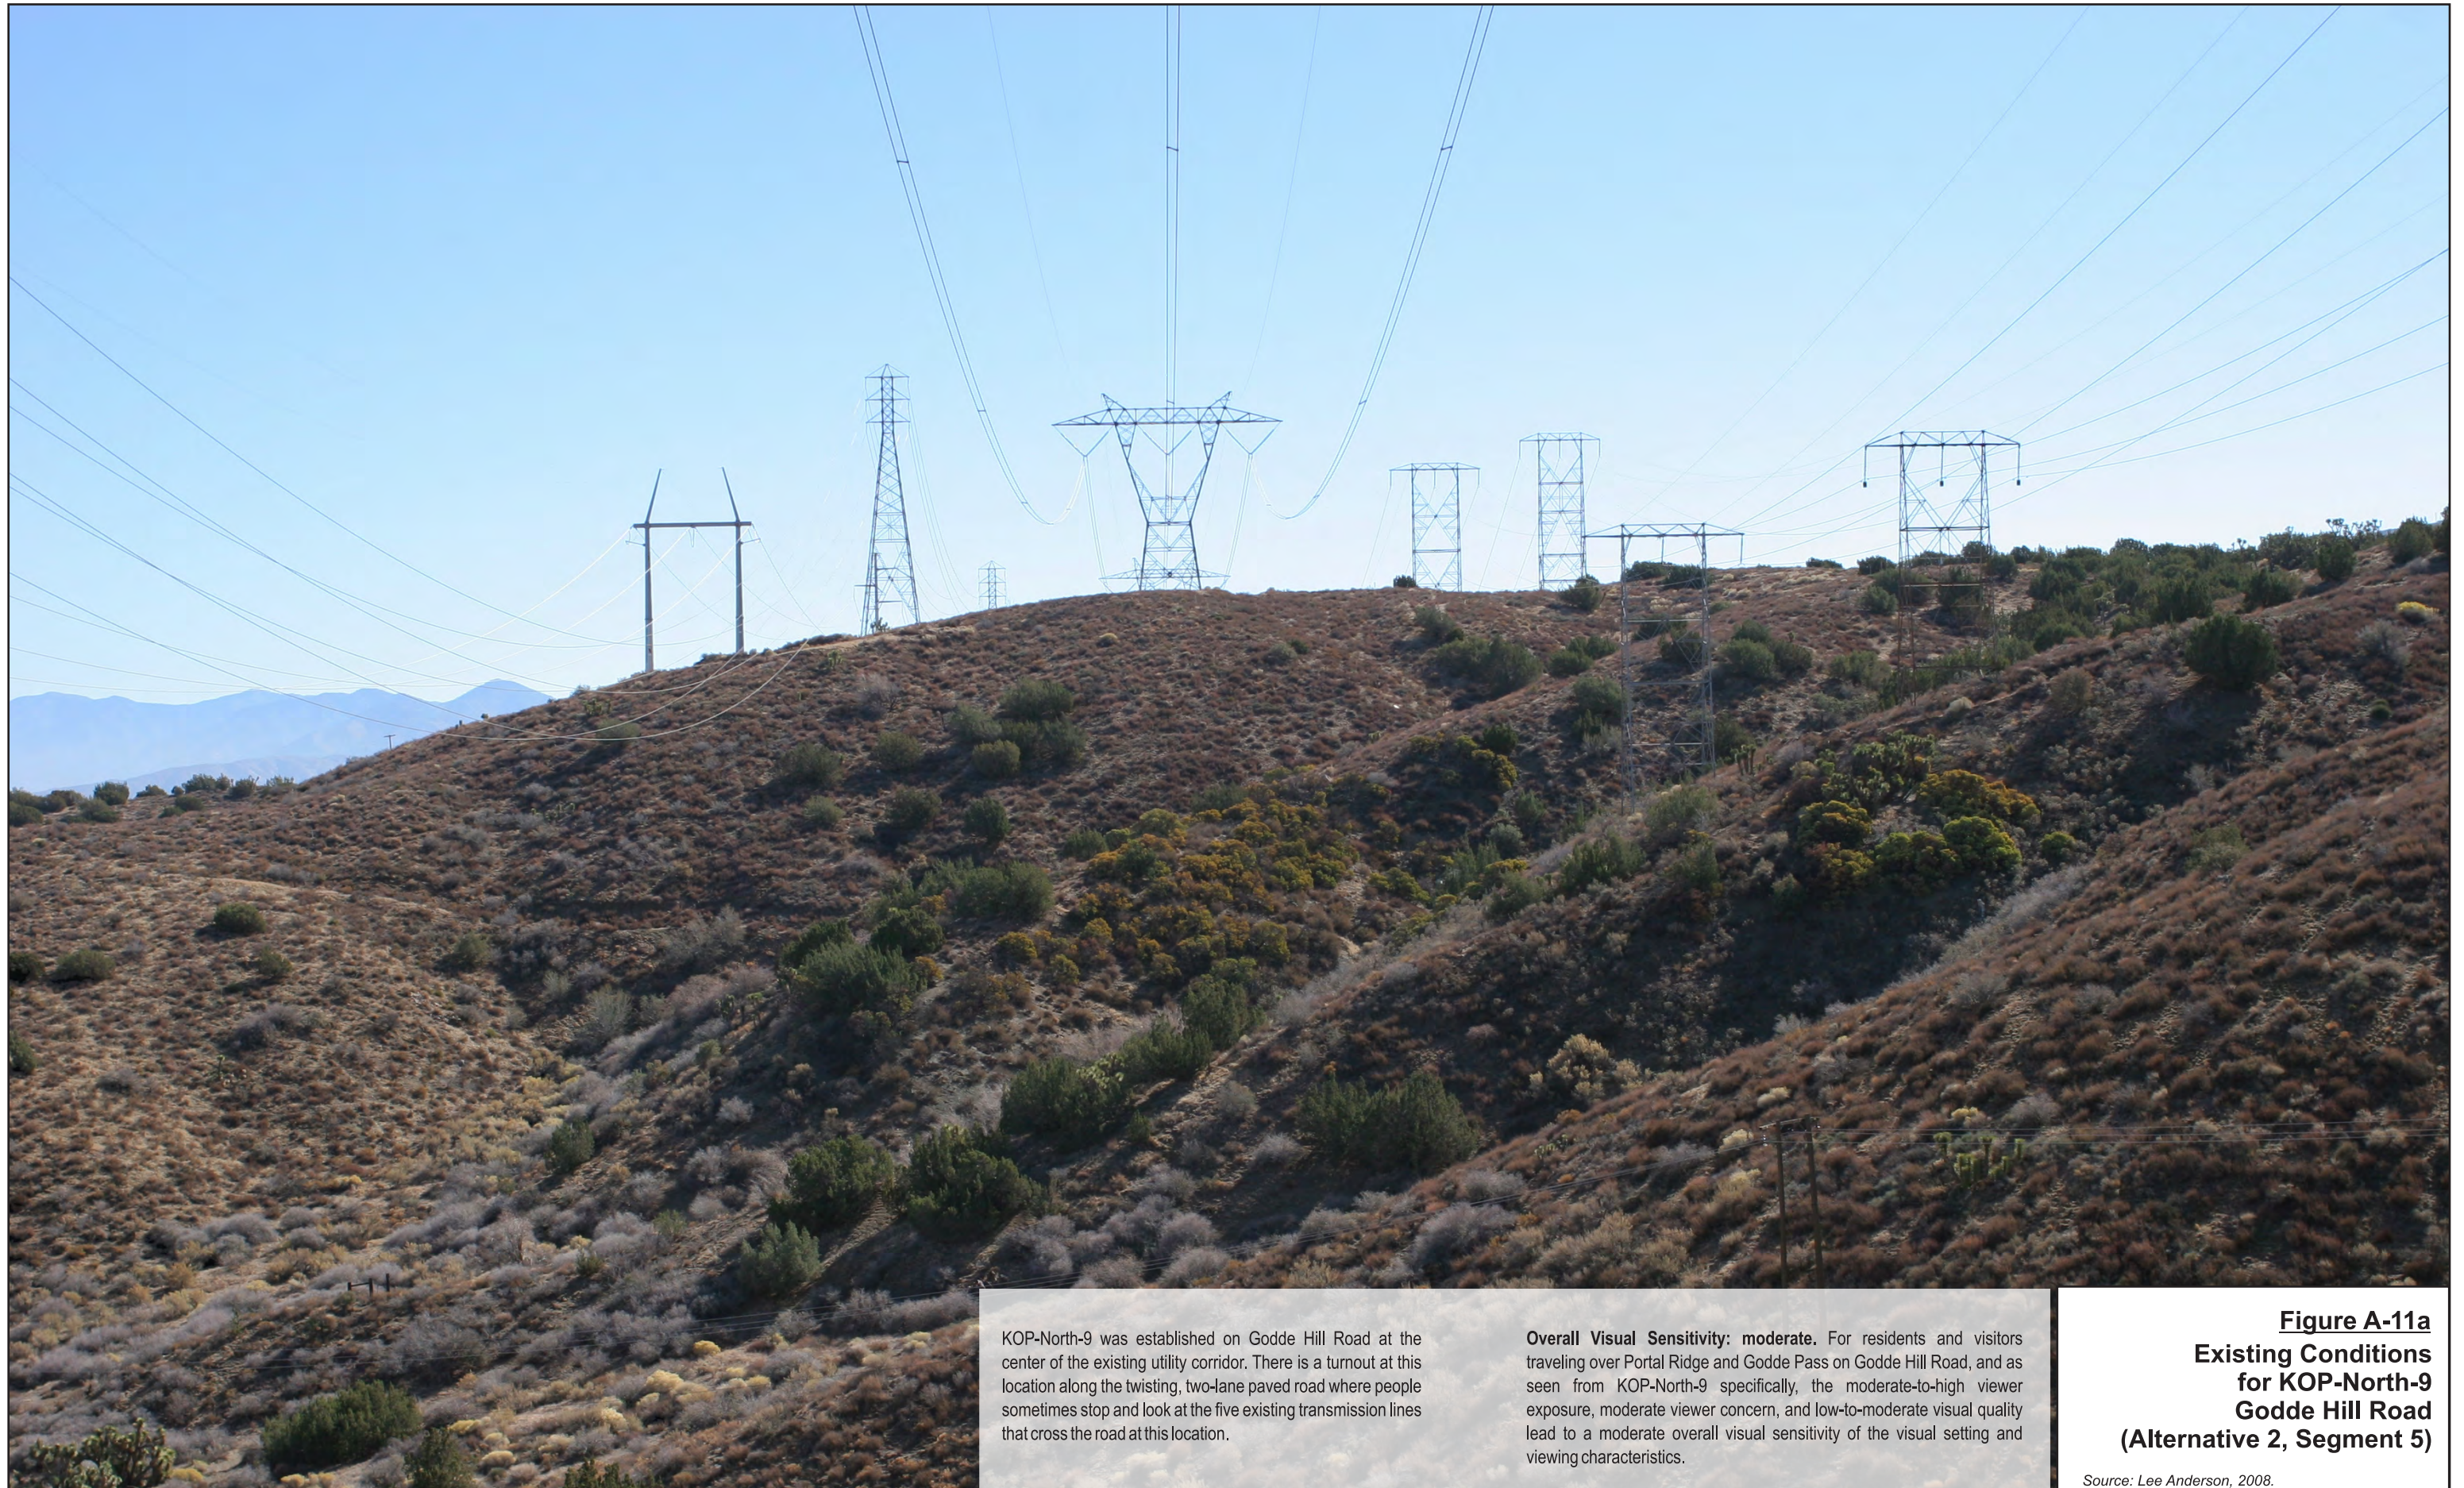
KOP-North-9 was established on Godde Hill Road at the center of the existing utility corridor. There is a turnout at this location along the twisting, two-lane paved road where people sometimes stop and look at the five existing transmission lines that cross the road at this location.

**Overall Visual Sensitivity: moderate.** For residents and visitors traveling over Portal Ridge and Godde Pass on Godde Hill Road, and as seen from KOP-North-9 specifically, the moderate-to-high viewer exposure, moderate viewer concern, and low-to-moderate visual quality lead to a moderate overall visual sensitivity of the visual setting and viewing characteristics.
