**Figure A-23a (Revised)**  
**Existing Conditions**  
**for KOP-Center-8**  
**Vetter Mountain Lookout**  
**(Alternative 2, Segment 6)**

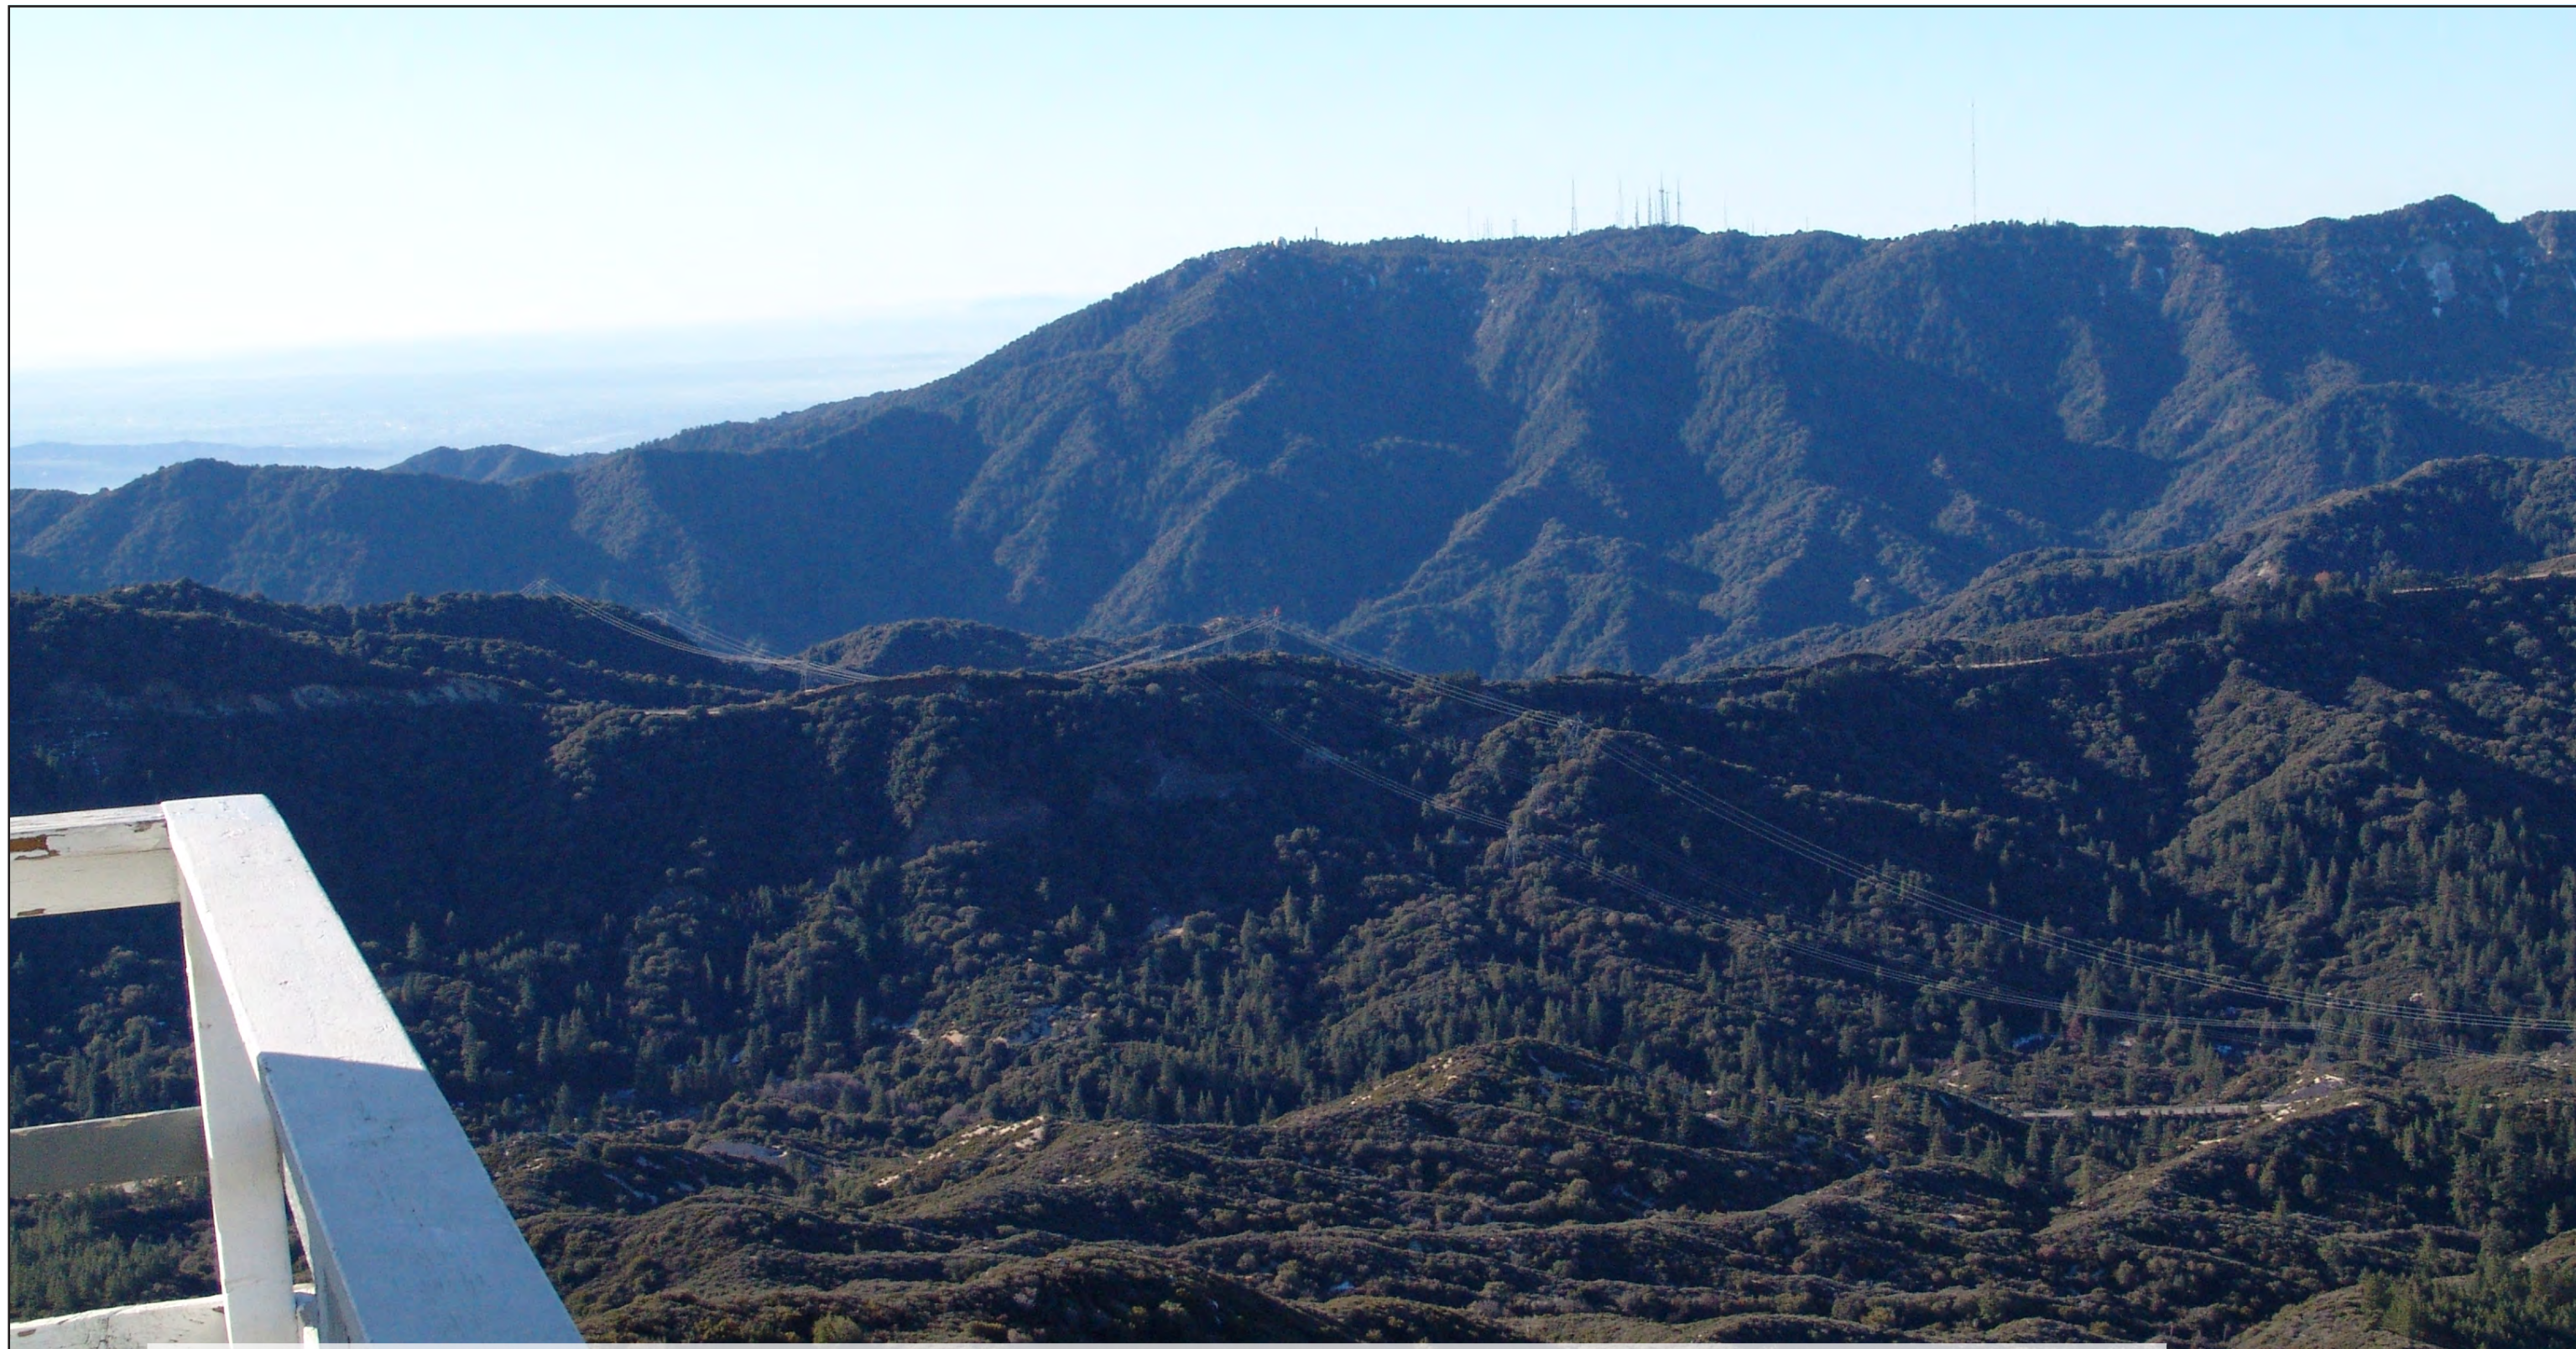
**Existing Scenic Integrity: High, with Areas of Moderate.** This existing landscape view is taken from Vetter Mountain Lookout at an elevation of approximately 5,890 feet, looking southwest toward Mt. Wilson electronic site on the skyline. The landscape visible from Vetter Mountain Lookout (and Charlton Flats) in general, and KOP-Center-8 specifically, is predominantly natural-appearing, consisting of foreground, middleground, and background landscapes with dense, dark green chaparral and evergreen tree-covered mountainsides. There are interesting vegetative patterns in this landscape view that are created by the folded terrain and microclimates. The sun angle and shadows emphasize the ruggedness of the steep slopes and broken terrain. The natural landscape has a coherent form and character with substantial visual variety created by the rugged, folded terrain. On the skyline, electronic facilities at Mount Wilson are visible and attract attention. On the midslope, the existing utility corridor contains 220-kV and 500-kV transmission lines. Also on the midslope, existing highway cutslopes are partially shielded from view by dark shadows. The natural landscape exhibits a high degree of intactness and scenic integrity, except for the visually discordant electronic sites, transmission line structures, and highway cutslopes. Access and spur roads to the existing towers are evident beyond the Angeles Crest Highway, and further detract from scenic integrity, leading to a rating of moderate scenic integrity for the utility corridor.

**Scenic Integrity Objective: High.** In the 2005 Forest Plan, the entire landscape in this vicinity is mapped as High SIO, where the management direction states that human activities should not be visually evident. Human-caused deviations may be present but must repeat the form, line, color, texture, and pattern common to the natural landscape character so completely and at such a scale that they are not evident.
