PROJECT MEMORANDUM

TEHACHAPI RENEWABLE TRANSMISSION PROJECT

To: John Boccio, CPUC Project Manager
From: Vida Strong, Aspen Project Manager
Date: February 24, 2017
Subject: TRTP Post-Construction Monthly Report #1, January 2017

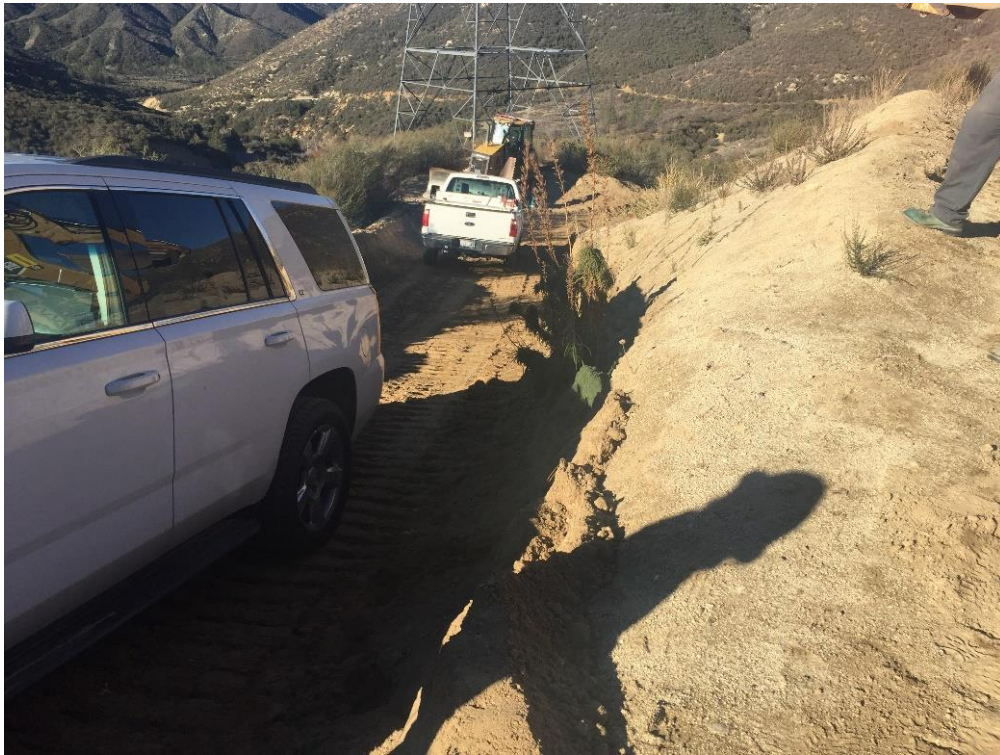
Figure 1: Grading crews restoring access road near Tower 59 “give back area,” Segment 6.

3. Hydroseeding occurred at 3 sites on Segment 11.
4. Weed abatement (hand pulling and herbicide use) occurred at 12 sites on Segment 11.
5. Grading crews completed restoration grading at Segment 6 Tower 59 "give-back" area (see Figure 1).
6. No container planting occurred on Segments 6 and 11 during the month of January. Container plant installation on the Angeles National Forest (ANF) is on hold pending the U.S. Forest Service (USFS) decision on whether to allow SCE to install container plants given the risk of *Phytophthora sp.* introduction (see below).

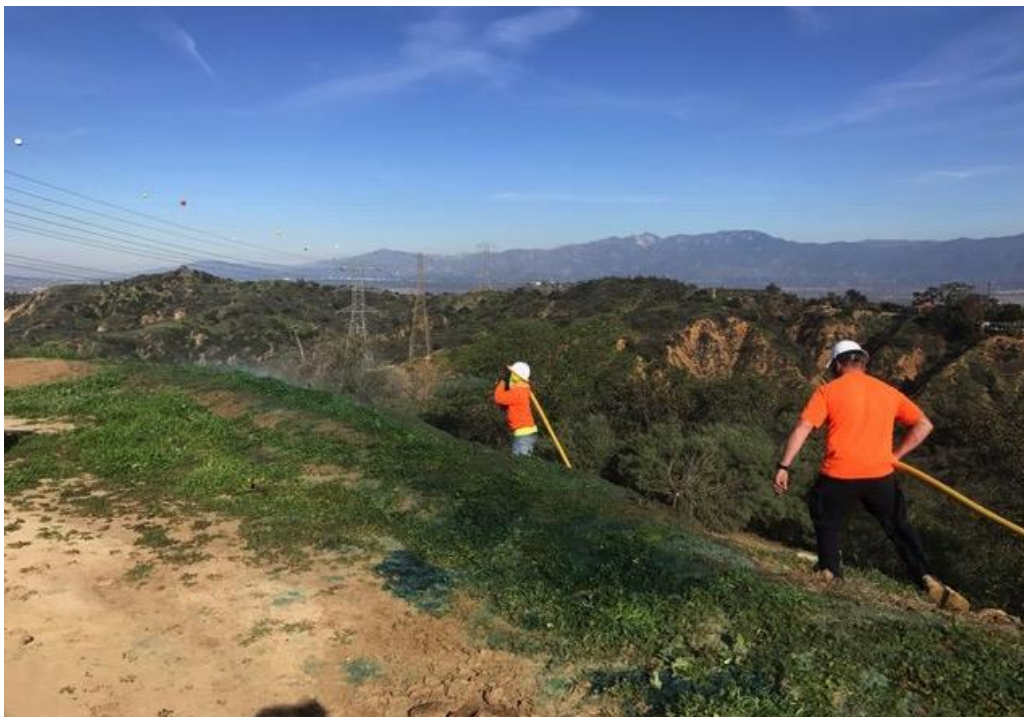
Figure 2: Hydroseeding at Segment 8 Restoration Site 023. Photo courtesy of SCE.

1. Hydroseeding occurred at 12 restoration sites on Segment 8 Overhead (see Figure 2).
2. Weed abatement (hand pulling and herbicide use) occurred at 21 sites on Segment 8 Overhead.

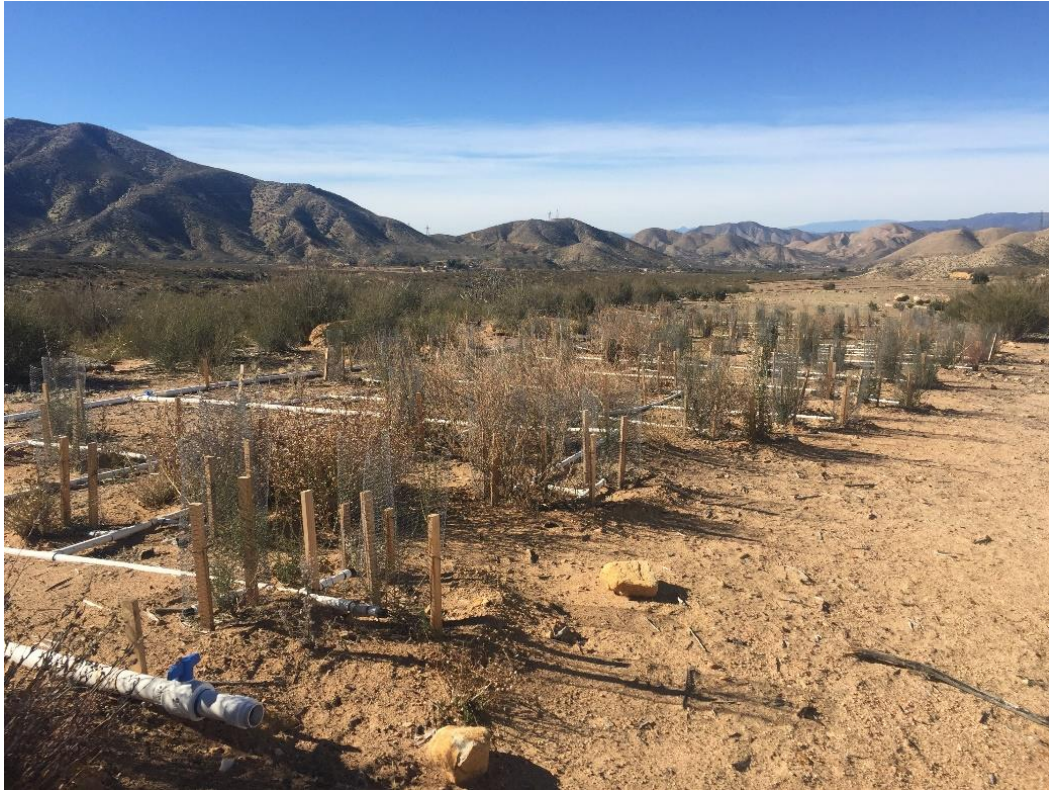
Figure 3: Container plants installed and monitored at Aliso Helicopter Assembly Yard, Segment 11.

Monitoring was conducted at 30 total sites in January, including ANF lands, during the Plant Establishment Period (PEP) (see Figure 3). Due to inclement weather and poor road conditions, monthly site visits for four hydroseed sites and one bi-weekly site visit for nine container plants and or mitigation tree sites were not completed in January. SCE reported the following results and observations of the sites surveyed during the month of January:

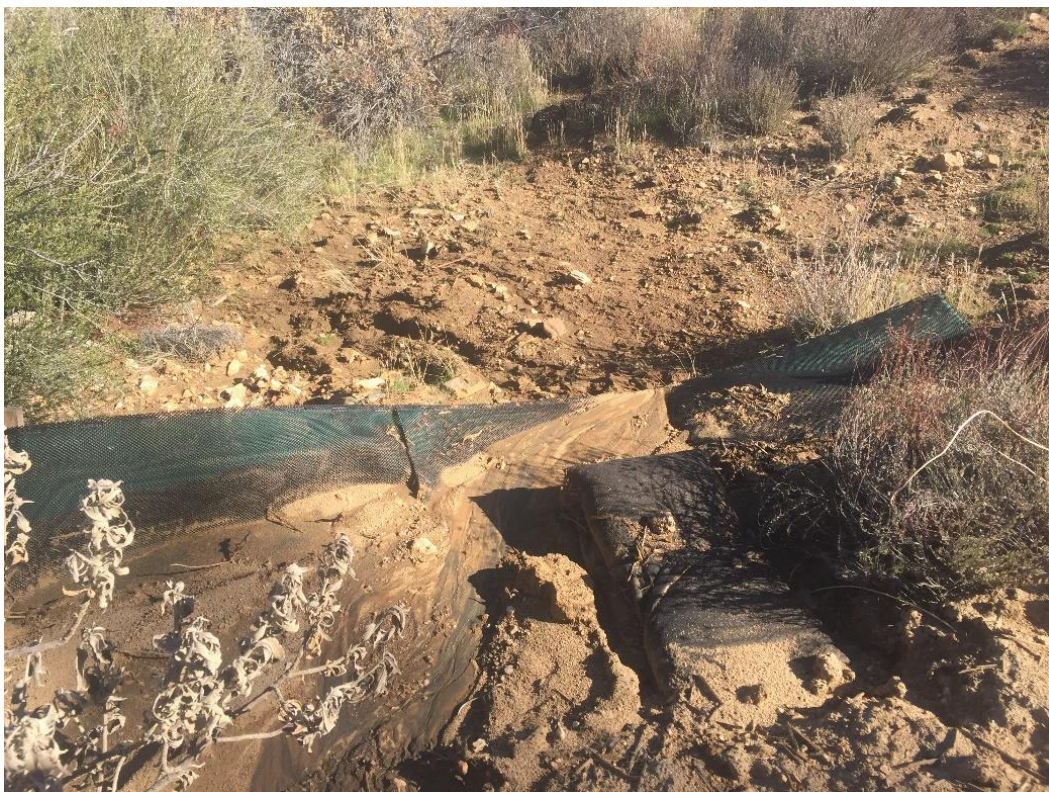
Figure 4: Off-site sedimentation and BMP failure observed at Tower 16, Segment 11.

2. Rainfall totals for the month of January were as follows: Segment 6A – 4.66", Segment 6B – 6.98", Segment 6C – 12.69", and Segment 11C – 8.75".
3. Pre- and post-storm SWPPP inspections took place in accessible areas (approximately 14% of the Segment 6 towers were inaccessible). BMP maintenance and repairs are being conducted by crews on a daily basis as weather conditions allow (see Figures 4–6).
4. Due to mudslides on Van Tassel Parkway, access to Segment 6C between Towers 85 and 113 is not possible. SCE is requesting a Variance to the USFS to allow use of alternate access roads and is investigating if SCE Operations and Maintenance can assist in clearing Van Tassel Parkway.

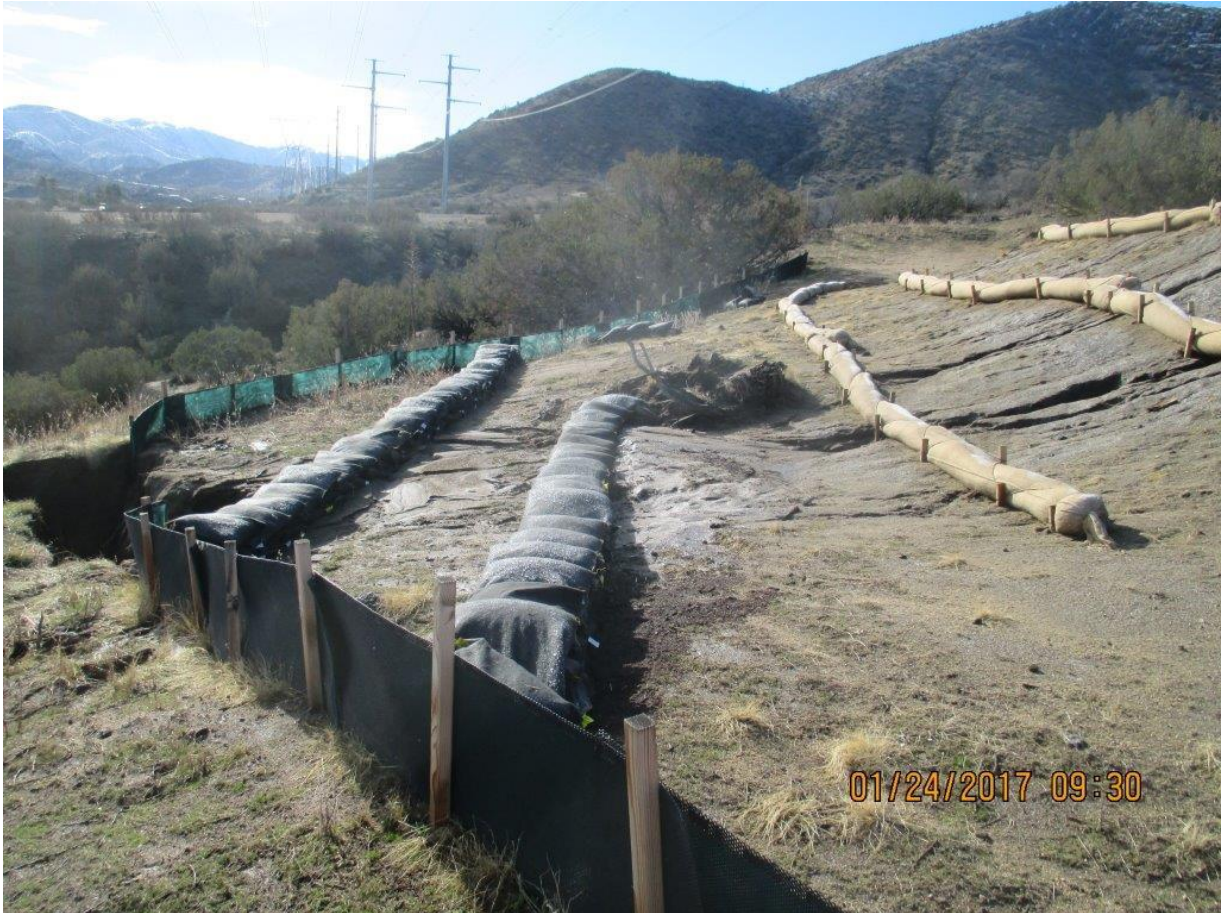
Figure 5: Rilling, gully, and sediment buildup at Tower 6 before maintenance, Segment 6. Photo courtesy of SCE.

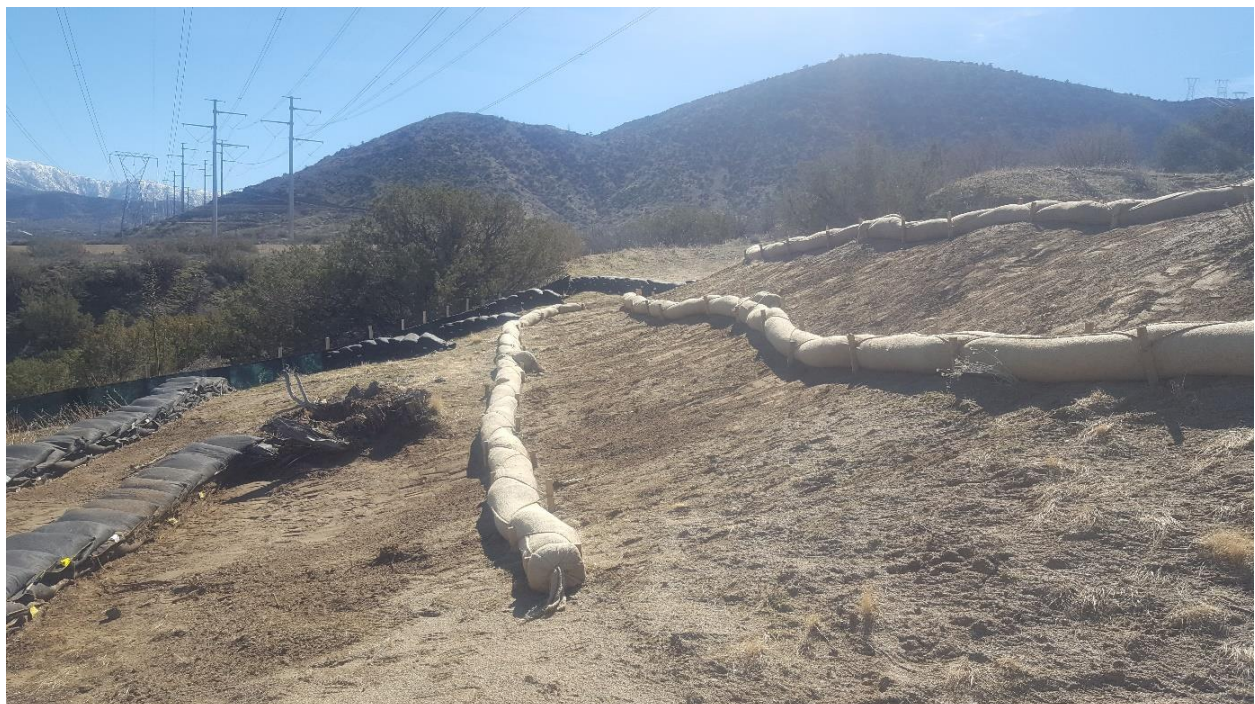
Figure 6: Tower 6 after BMP maintenance, Segment 6. Photo courtesy of SCE.

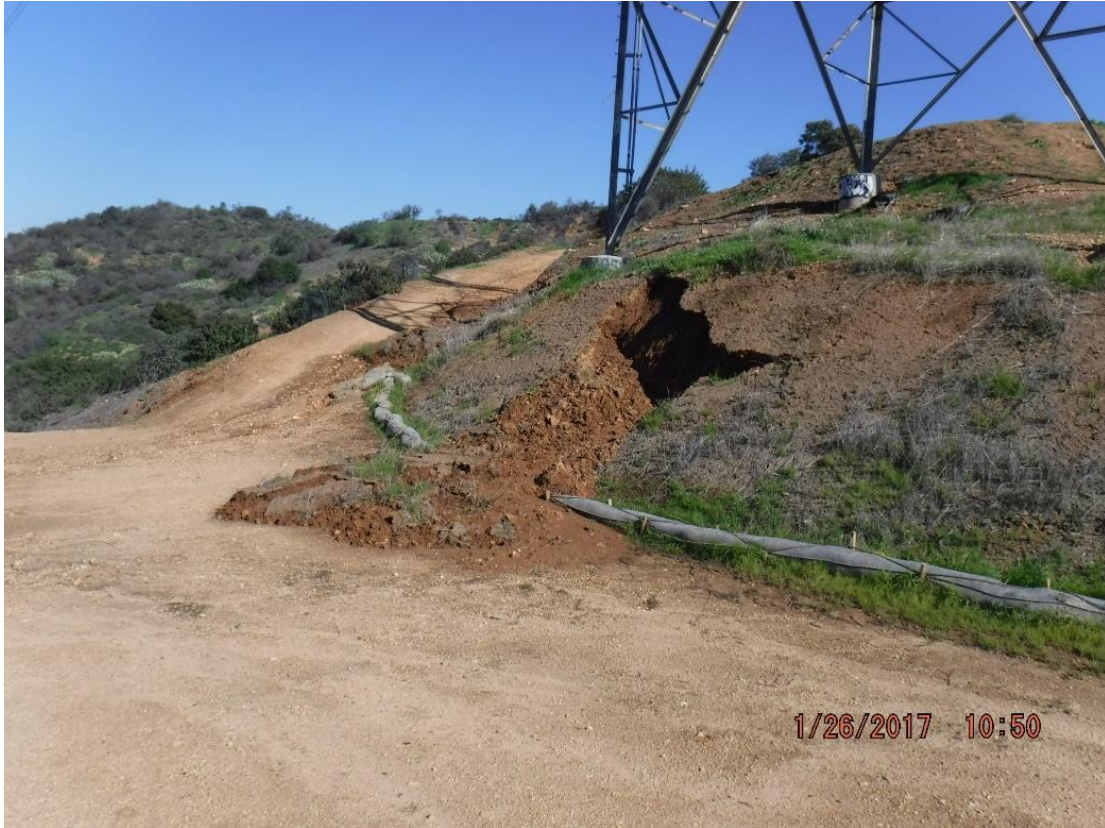
Figure 7: Erosion at Tower 45-T5, Segment 8 Overhead. Photo courtesy of SCE.

2. Rainfall totals for the month of January were as follows: Segment 7 – 12.69", Segment 8 Phase 4 – 8.75", and Segment 8 Phase 1 (includes Underground) – 9".
3. Pre and post-storm SWPPP inspections took place for the majority of the Segment 7 and 8 towers (approximately 2% of the Segment 7 towers were inaccessible). BMP maintenance and repairs are being conducted by crews on a daily basis as weather conditions allow (see Figures 7 and 8).

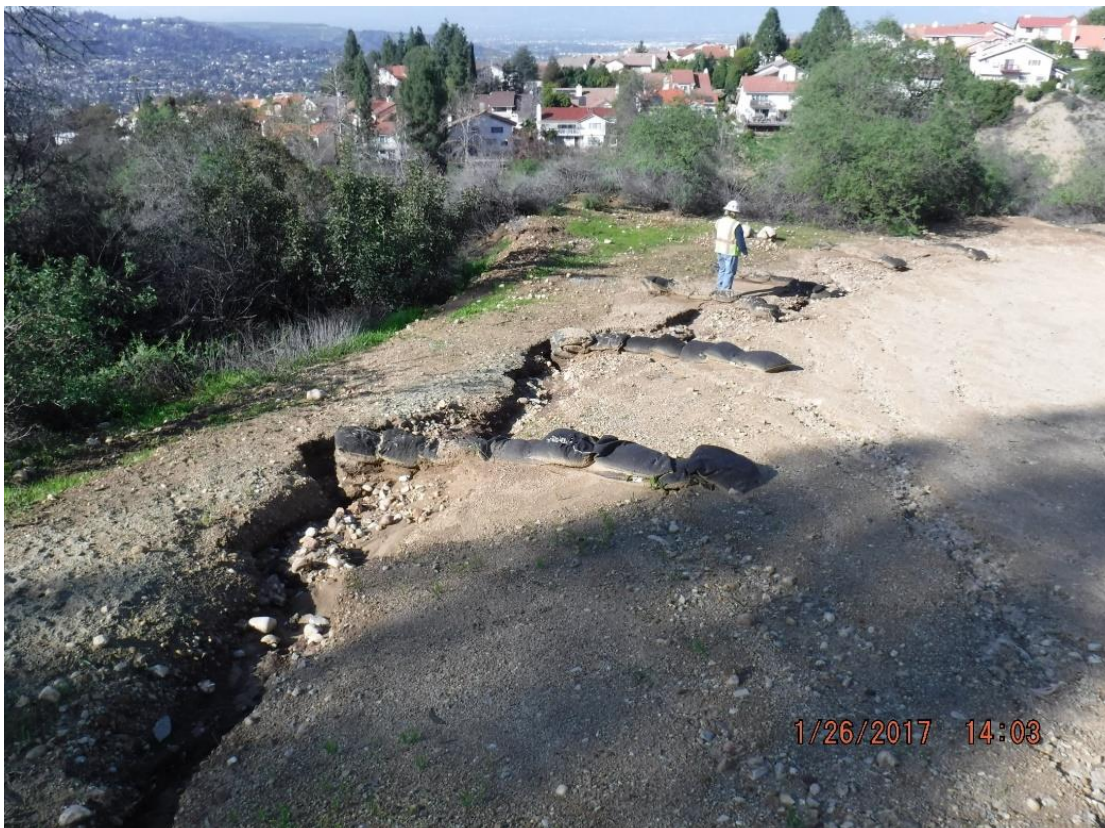
Figure 8: Erosion of access road at Tower 49-T2, Segment 8 Overhead. Photo courtesy of SCE.
