**IN-FIELD SERVICES**  
**GEIS Pipeline Integrity Team NDE**

**Pacific Gas & Electric Company**  
**Hydrostatic Test Dig from November 8, 2011 to January 0, 1900**  
**T30\_L132\_Leak\_MP-15.0029**  
**Documents Contained Within:**

H-Form Report T30\_L132\_Leak MP-15.0029  
NDE Reports of T30\_L132\_Leak MP-15.0029  
Photo Report of T30\_L132\_Leak MP-15.0029

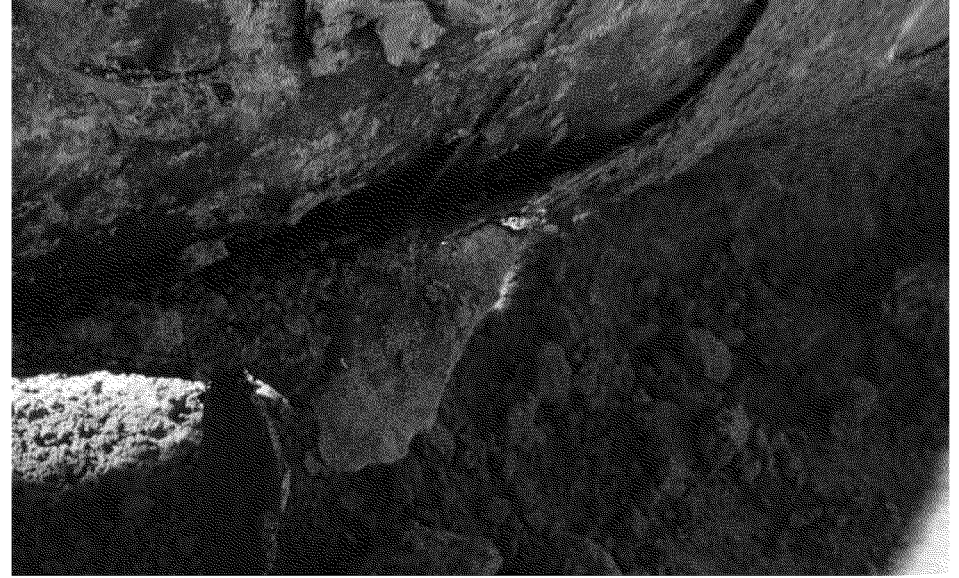
Overview of soil stratification

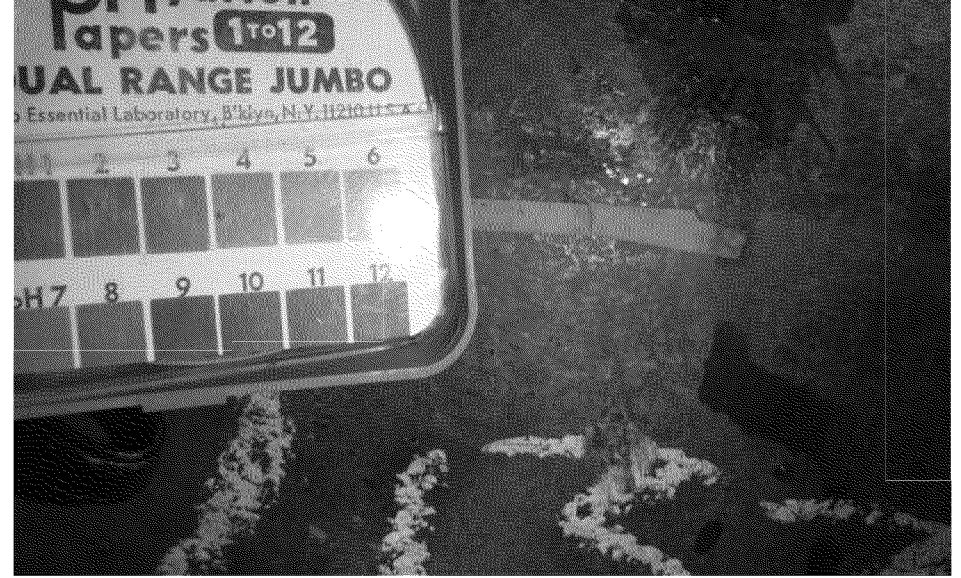
Close up of DEP-01

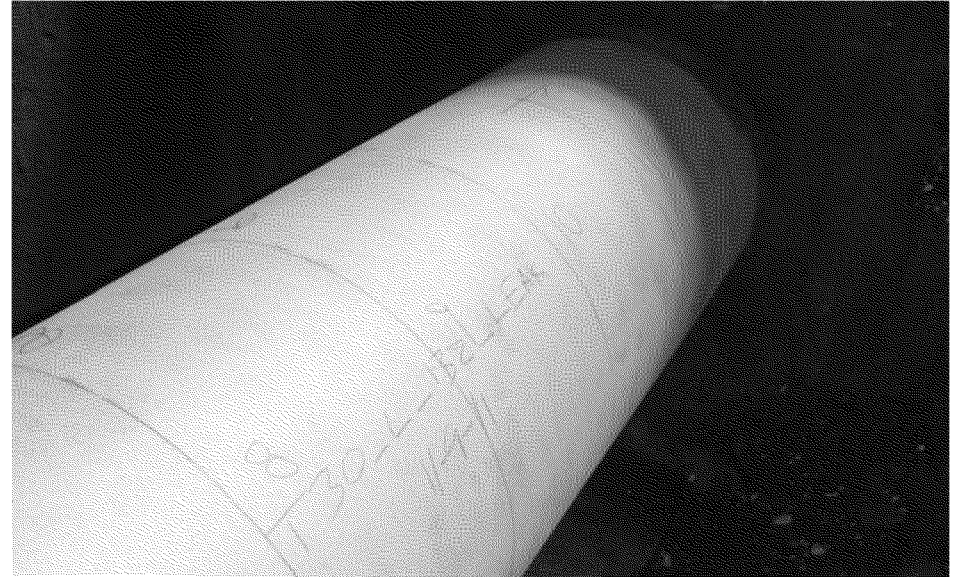
Overview of MPI layout 8.00ft to 12.35ft, 3:00 position

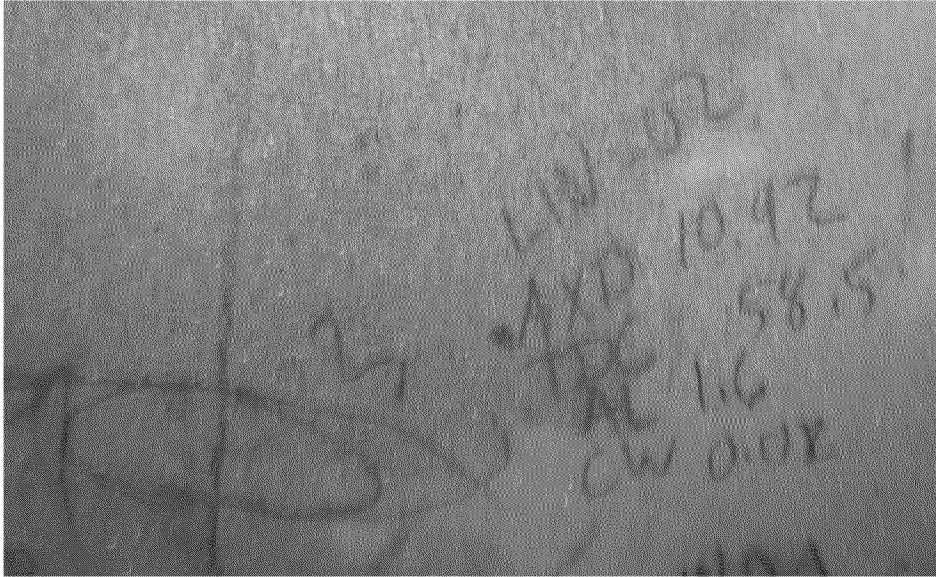
Close up of MT Indications of LIN-01

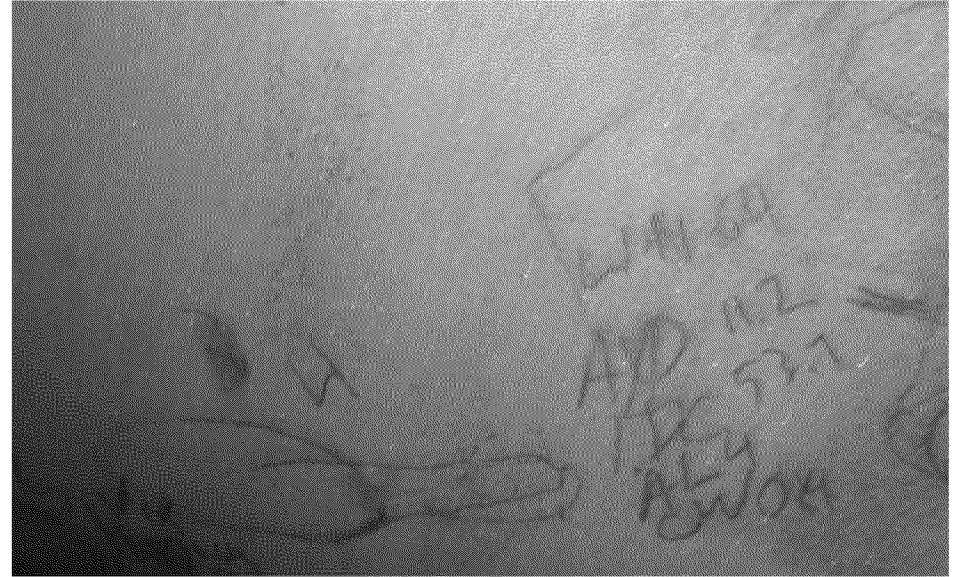
Overview of LIN-01, 02 and 03 that were cover by B-Sleeve

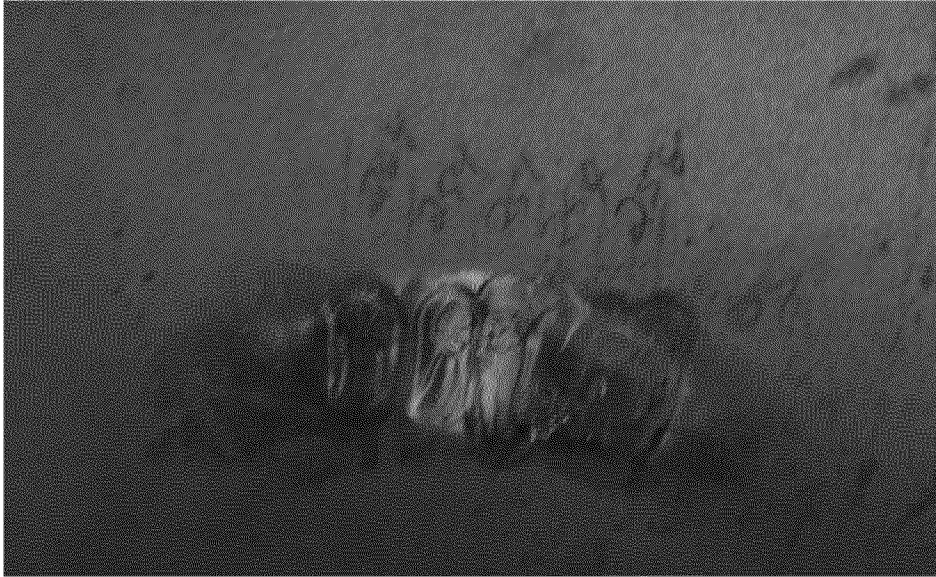
Overview post grind (MPIOK) of LIN-07

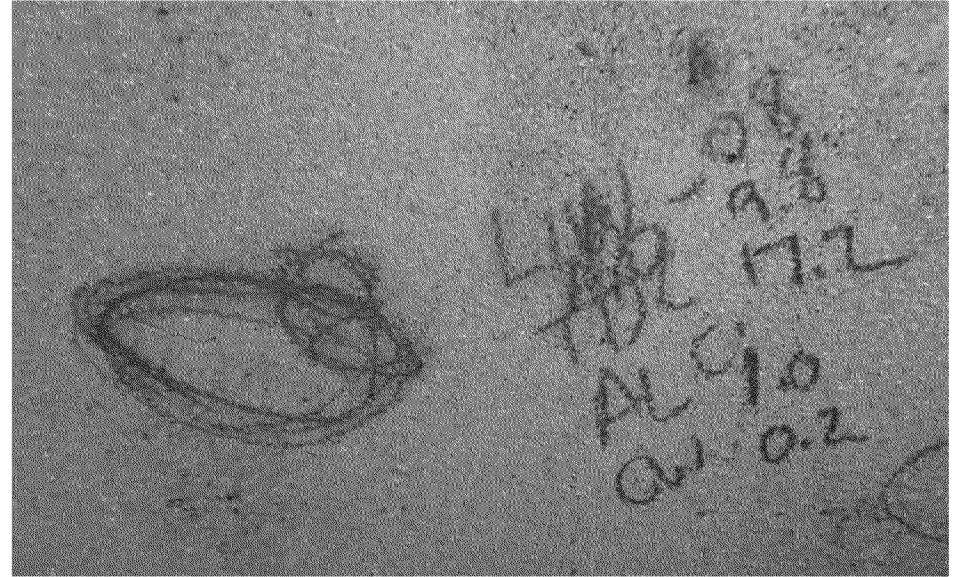
Overview of pre buff area (RWT) LIN-07

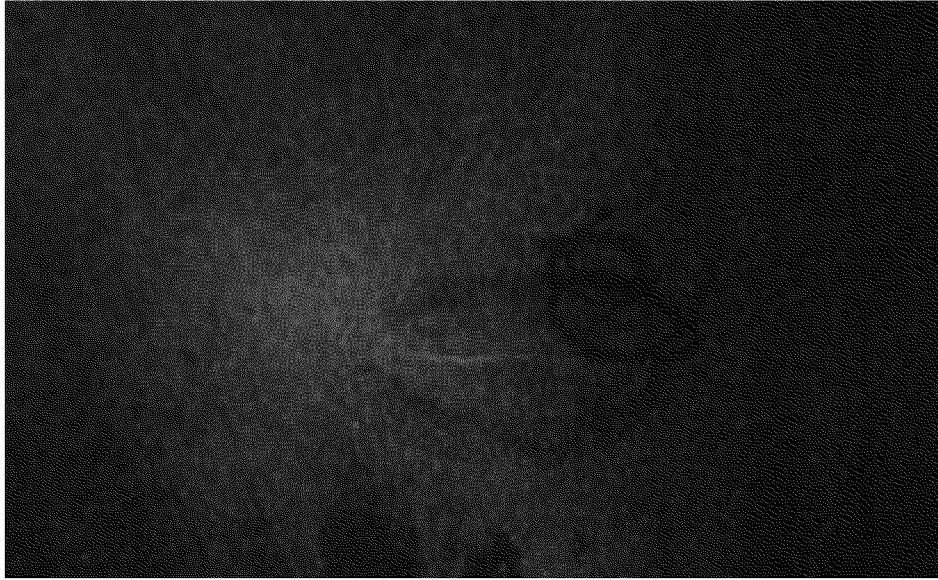
Overview of MT Indications of LIN-08

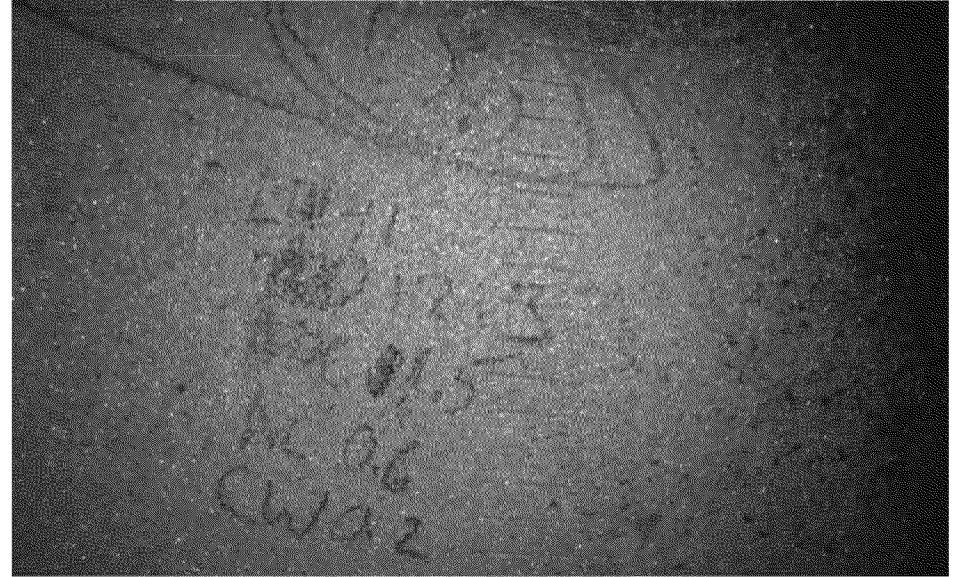
Close up of MT Indications of LIN-10

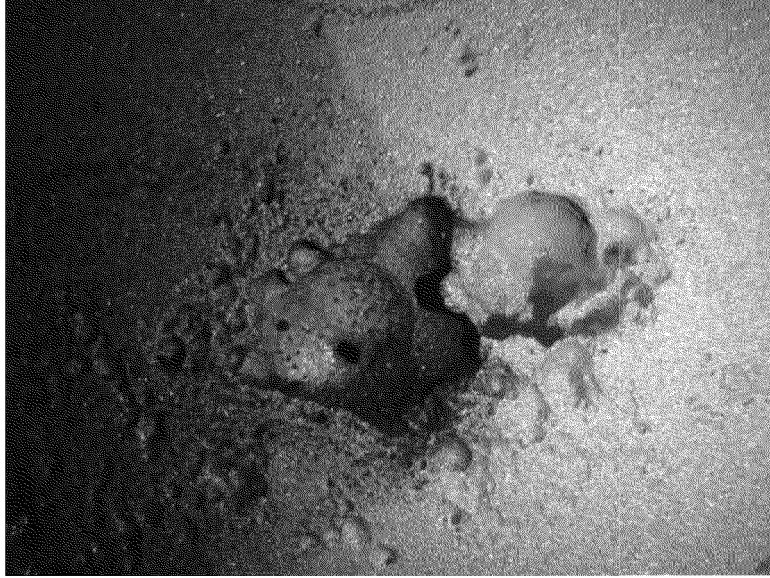
Overview (with measurements) of VOL-01
