Form H: Direct Examination Data Sheet - Page 1 of 10

<u>DA/ILI</u>		<u>DA</u>		<u>ILI</u>	
Route Number:	T47_L153_A	N-Segment:	NA	ILI Log Distance:	NA
Date of Excavation:	7/9/2011	IMA Number:	NA	RMP-11 Ref. Section:	Table 5.6.2
Mile Point:	Redacted	Region Number:	NA	Reference Girth Weld:	NA
Examination Performed By:	Redacted	Subregion # (ICDA):	NA	Distance From Girth Weld:	NA
PG&E Project Manager:	Redacted	Stationing:	NA		
Approved By:	NA				
Order Number:	NA

MAGNETIC PARTICLE EXAMINATION REPORT							<input type="checkbox"/> Nuclear	<input checked="" type="checkbox"/> Non-Nuclear	
To: Pacific Gas & Electric Company				From: Redacted		Date: 7/9/2011			
Project: T-47-L153-A									
Purchase Order No:				GEIS Job No: LAPI0005

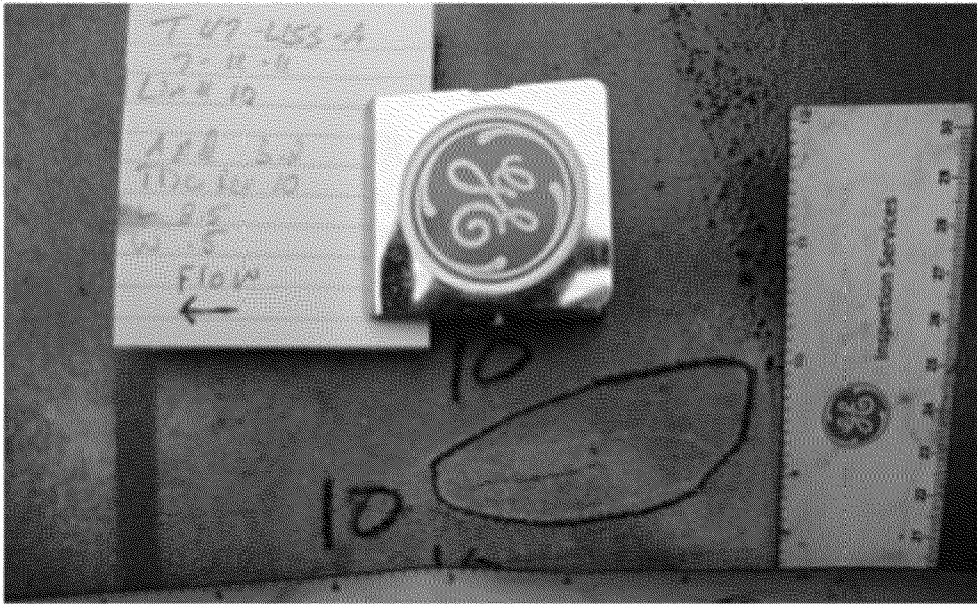
Overview of MT Indications of LIN-10

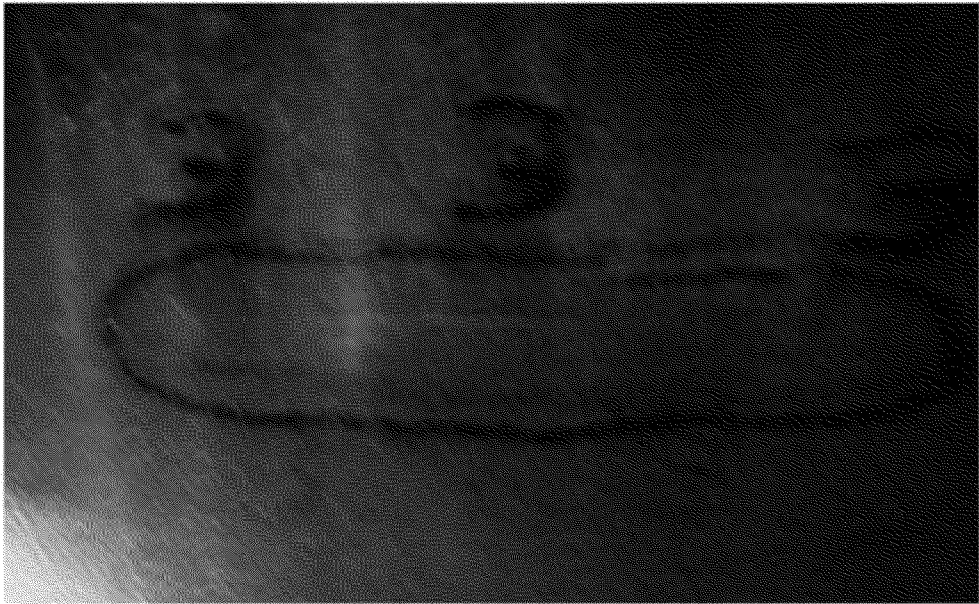
Overview of MT Indications of down stream LIN-03
