Order Instituting Rulemaking on the
Commission's Own Motion to Adopt New
Safety and Reliability Regulations for Natural
Gas Transmission and Distribution Pipelines
and Related Ratemaking Mechanisms

**DECLARATION OF SUMEET SINGH
SUPPLEMENTING THE VERIFIED STATEMENT OF
PACIFIC GAS AND ELECTRIC COMPANY'S VICE
PRESIDENT OF GAS TRANSMISSION MAINTENANCE
AND CONSTRUCTION IN RESPONSE TO RULING OF
ASSIGNED COMMISSIONER AND ASSIGNED
ADMINISTRATIVE LAW JUDGE.**

Report No. 5004.9268

**METALLURGICAL EVALUATION OF A SECTION FROM
L-147 MP 2.2 BRITTAN AVE. AND ROGERS AVE., SAN CARLOS**

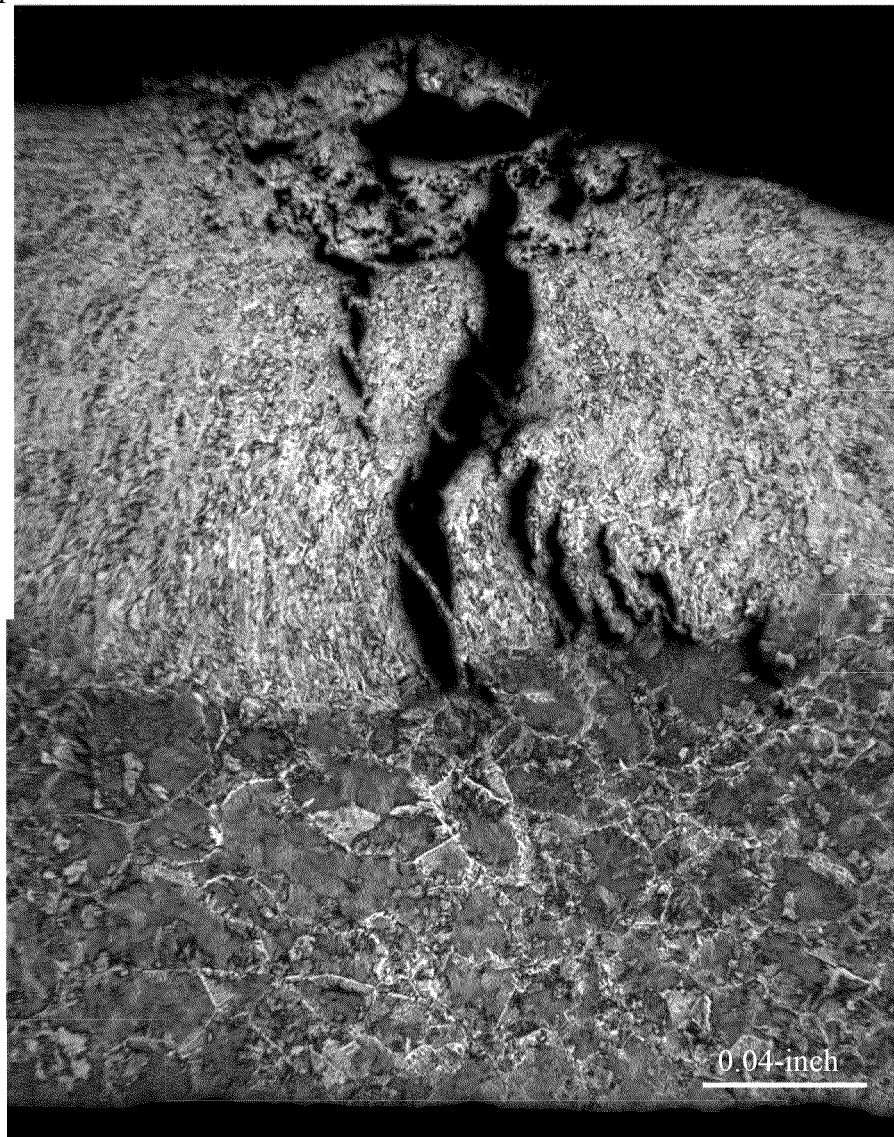
Figure 19 Photograph and composite micrograph of section 2. Etched with 2% nital.
