Order Instituting Rulemaking on the
Commission's Own Motion to Adopt New
Safety and Reliability Regulations for Natural
Gas Transmission and Distribution Pipelines
and Related Ratemaking Mechanisms

**DECLARATION OF SUMEET SINGH
SUPPLEMENTING THE VERIFIED STATEMENT OF
PACIFIC GAS AND ELECTRIC COMPANY'S VICE
PRESIDENT OF GAS TRANSMISSION MAINTENANCE
AND CONSTRUCTION IN RESPONSE TO RULING OF
ASSIGNED COMMISSIONER AND ASSIGNED
ADMINISTRATIVE LAW JUDGE.**

Report No. 5004.9268

**METALLURGICAL EVALUATION OF A SECTION FROM
L-147 MP 2.2 BRITTAN AVE. AND ROGERS AVE., SAN CARLOS**

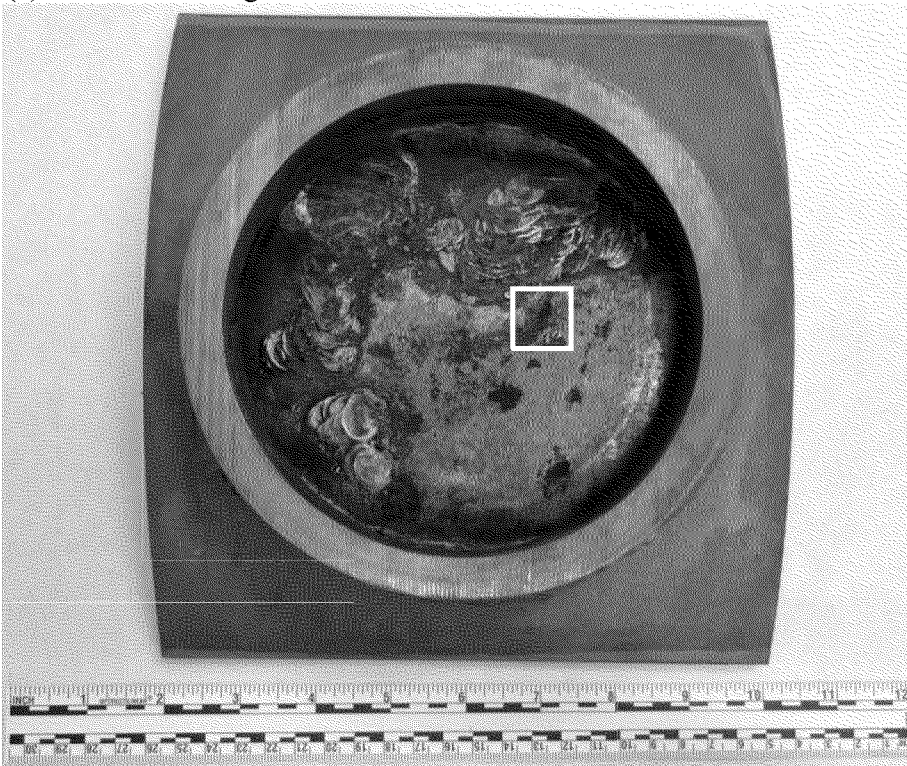
Figure 6 Photographs of the PLIDCO cap area after sectioning.

Both sides of the cap sample shown in Figure 6 were thoroughly cleaned with acetone and dried with compressed air. A liquid penetrant test was performed by applying developer to the inside surface, and penetrant was liberally applied to the outside surface in the area covered by the cap. After 1.5-hours, no indication of penetrant was visible on the inside surface.

The sample shown in Figure 6 was returned to PG&E for radiography. A digital radiograph of the sample is shown in Appendix A along with a photograph of the sample. A crack indication was found that corresponded to the crack-like feature detected visually on the inside surface, shown in Figure 8b.
