**BEFORE THE PUBLIC UTILITIES COMMISSION
OF THE STATE OF CALIFORNIA**

Order Instituting Rulemaking on the
Commission's Own Motion to Adopt New
Safety and Reliability Regulations for Natural
Gas Transmission and Distribution Pipelines
and Related Ratemaking Mechanisms

**DECLARATION OF SUMEET SINGH SUPPLEMENTING THE VERIFIED
STATEMENT OF PACIFIC GAS AND ELECTRIC COMPANY'S VICE
PRESIDENT OF GAS TRANSMISSION MAINTENANCE AND CONSTRUCTION
IN RESPONSE TO RULING OF ASSIGNED COMMISSIONER AND ASSIGNED
ADMINISTRATIVE LAW JUDGE**

**PG&E Line 147 Britton
and Rogers Avenue Leak:
Metallurgical Analysis**

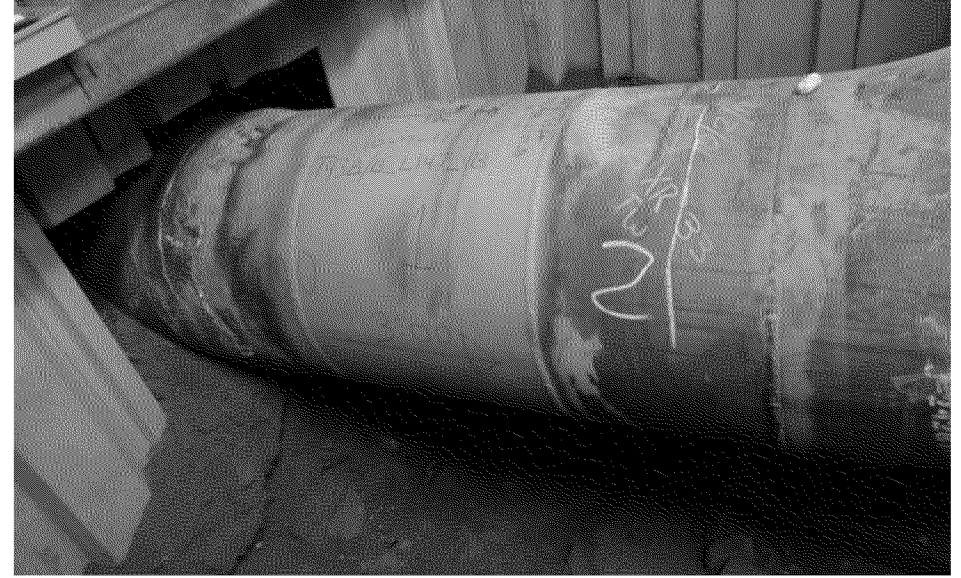
Overview of coating condition -1ft to 2ft, 3:00 position

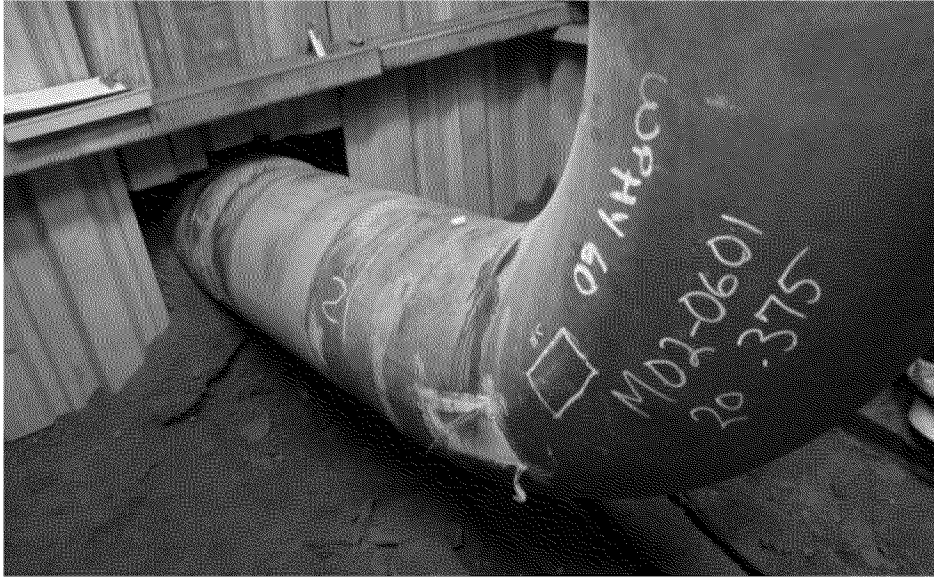
Overview of coating condition -1ft to 2ft, 3:00 position

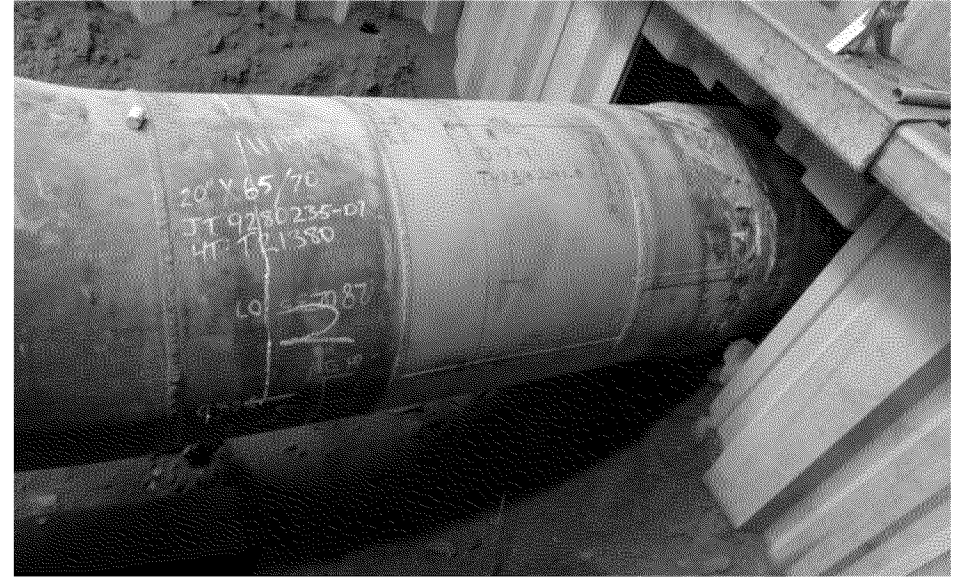
Overview of coating condition -1ft to 2ft, 9:00 position

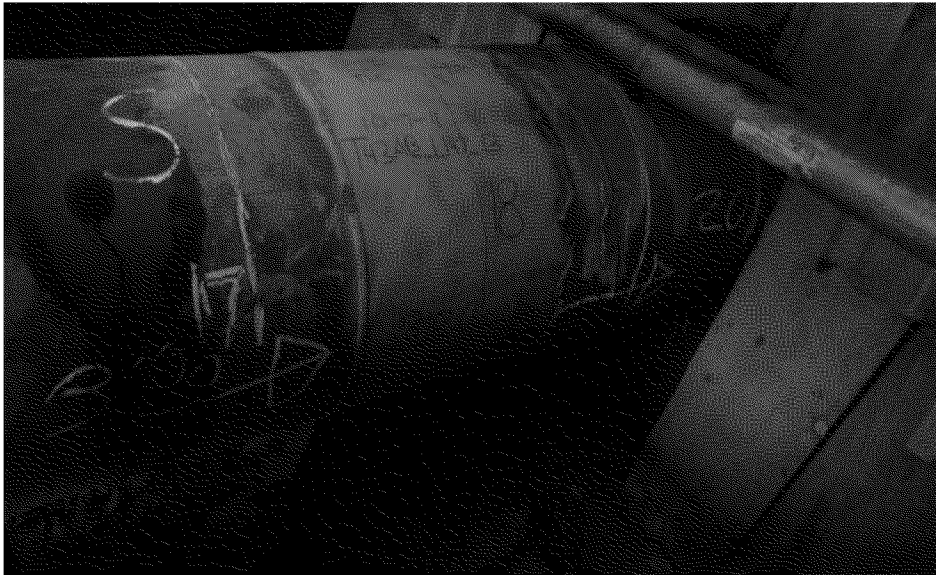
Overview of coating condition 17ft to 20ft, 3:00 position

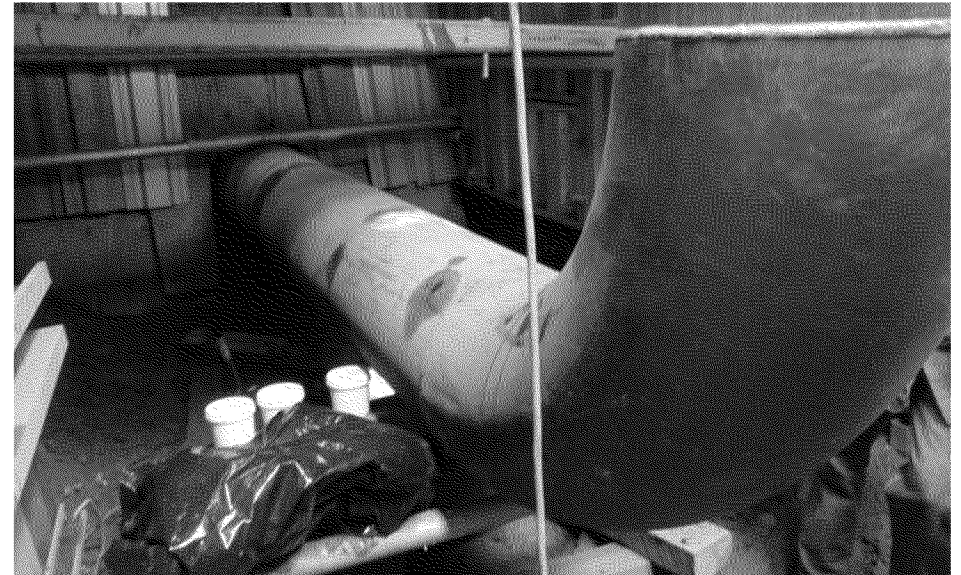
Overview of coating condition 17ft to 20ft, 9:00 position

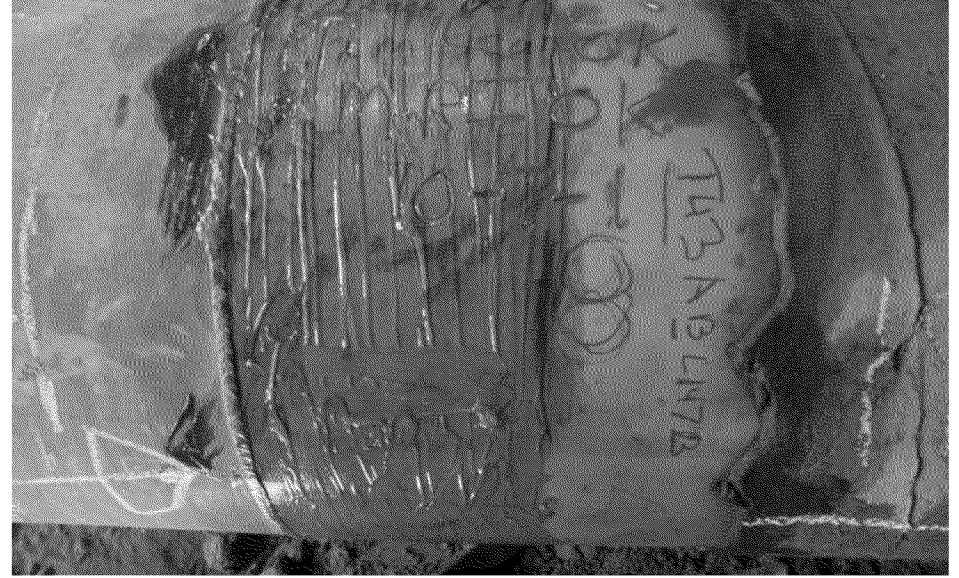
Overview DS of MPIOK and Lamination scan OK.

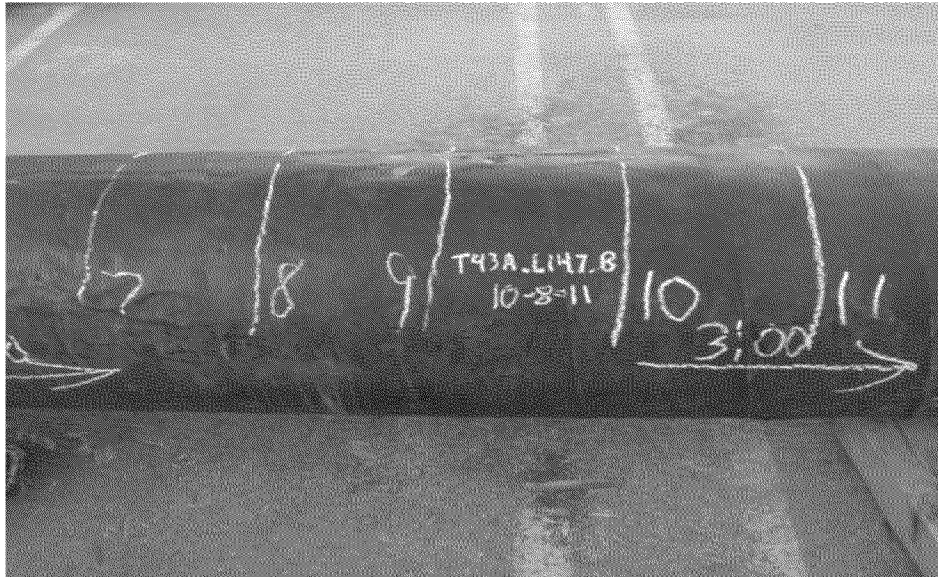
Overview of coating condition 3:00 position

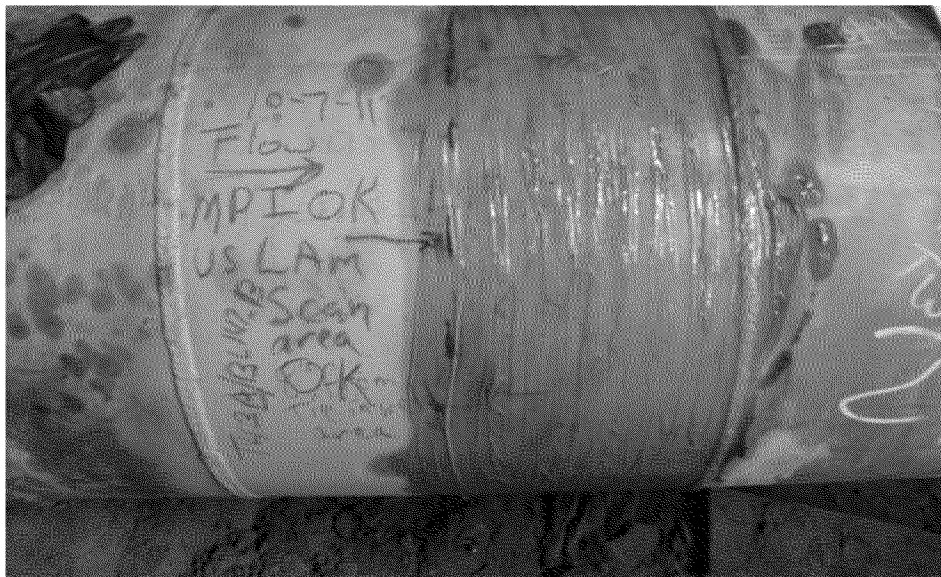
Overview of US MPIOK and Lamination scan OK.

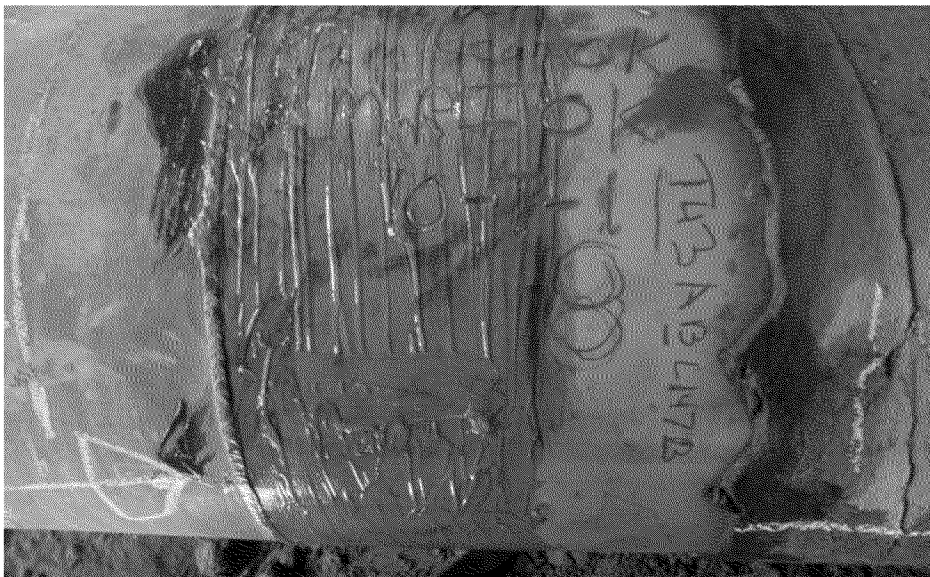
Overview DS of MPIOK and Lamination scan OK.
