R.11-02-019
(Filed February 24, 2011)

**DECLARATION OF SUMEET SINGH SUPPLEMENTING THE VERIFIED
STATEMENT OF PACIFIC GAS AND ELECTRIC COMPANY'S VICE
PRESIDENT OF GAS TRANSMISSION MAINTENANCE AND CONSTRUCTION
IN RESPONSE TO RULING OF ASSIGNED COMMISSIONER AND ASSIGNED
ADMINISTRATIVE LAW JUDGE**

**PG&E Line 147 Britton
and Rogers Avenue Leak:
Metallurgical Analysis**

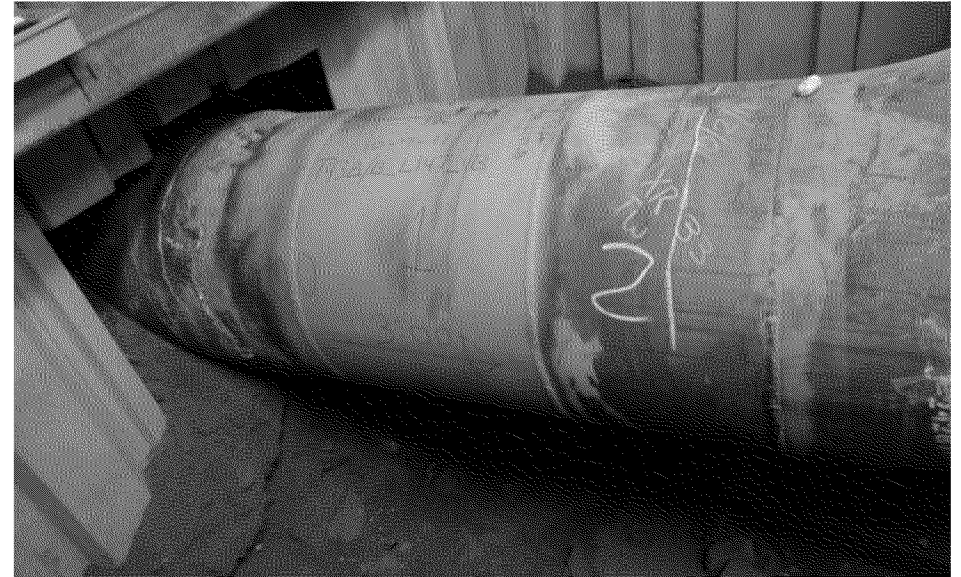
Overview of coating condition -1ft to 2ft, 3:00 position

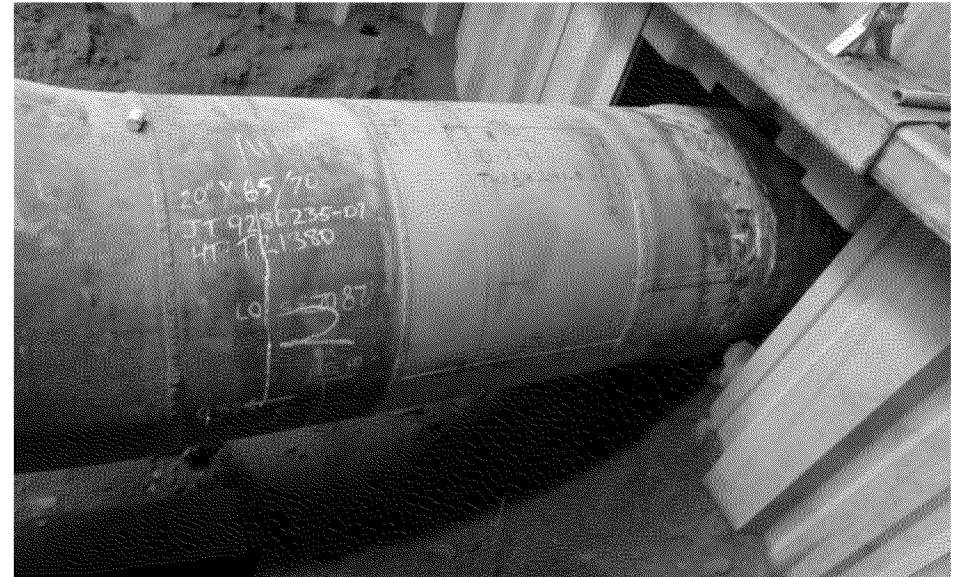
Overview of coating condition -1ft to 2ft, 9:00 position

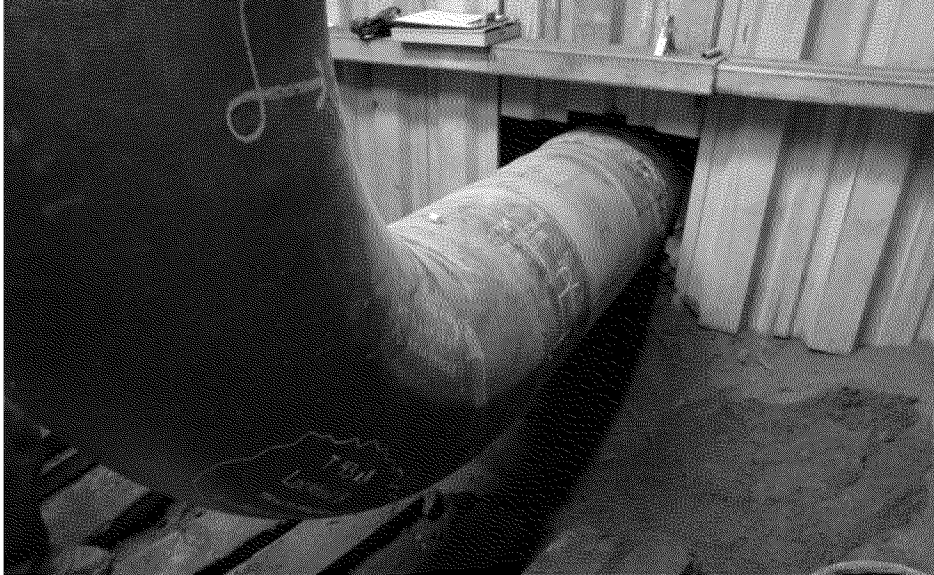
Overview of coating condition -1ft to 2ft, 9:00 position

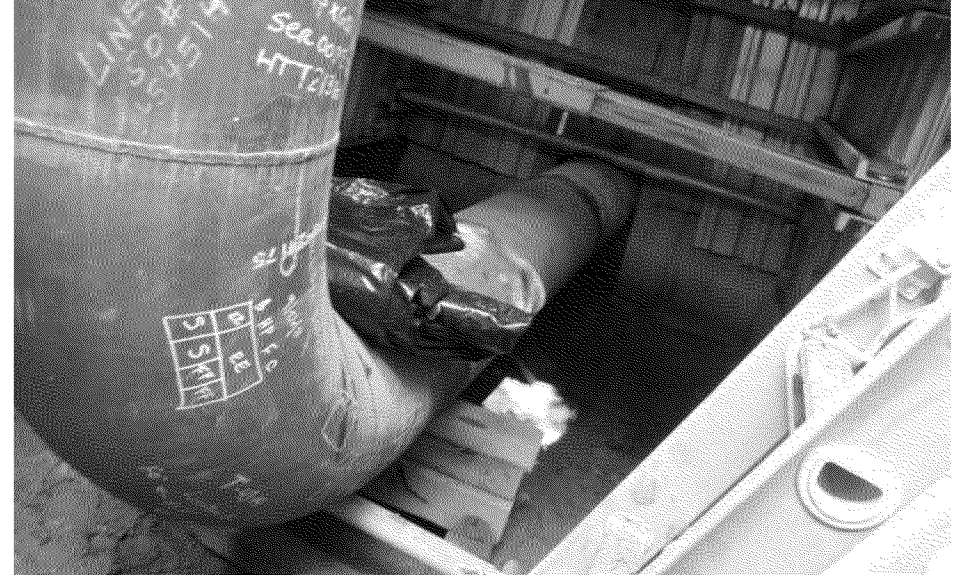
Overview of coating condition 17ft to 20ft, 3:00 position

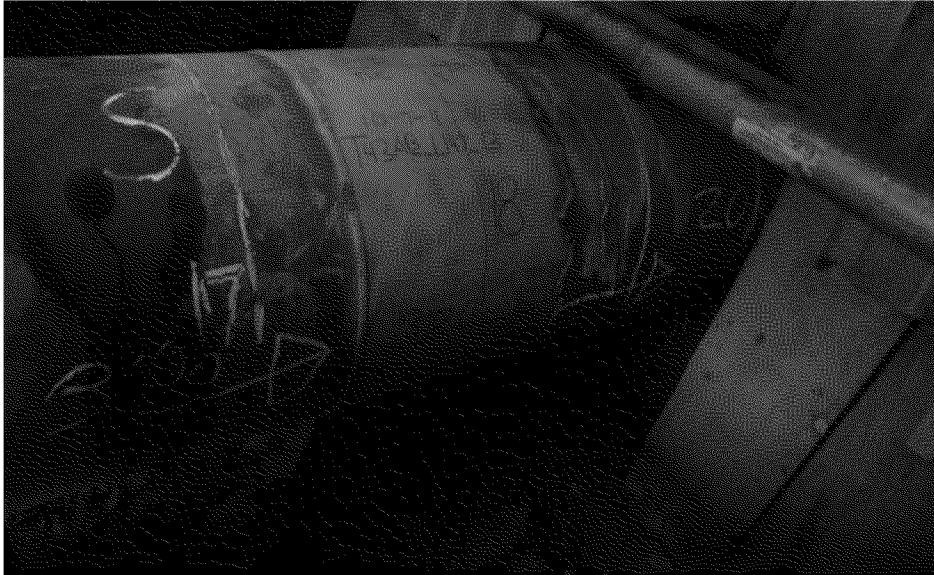
Overview of coating condition 17ft to 20ft, 3:00 position

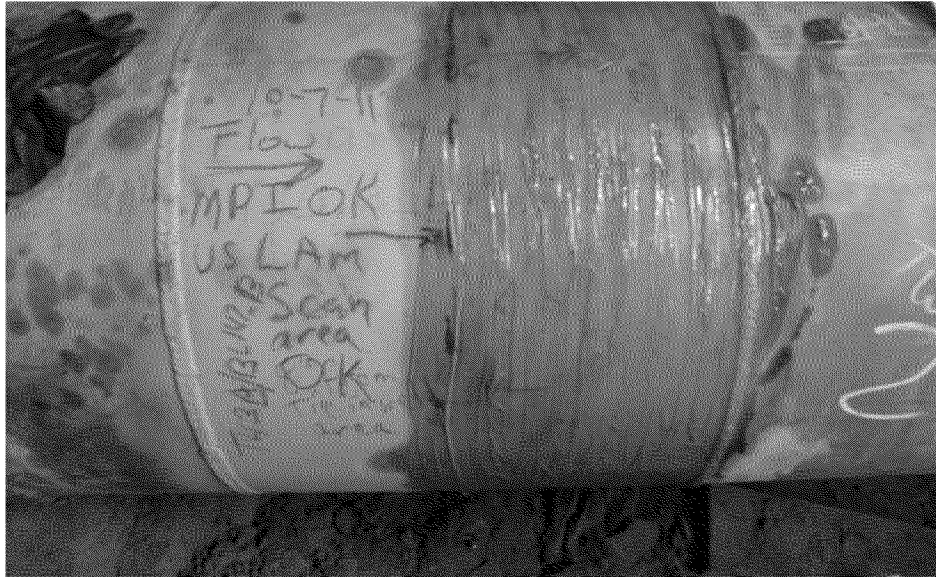
Overview of US MPIOK and Lamination scan OK.

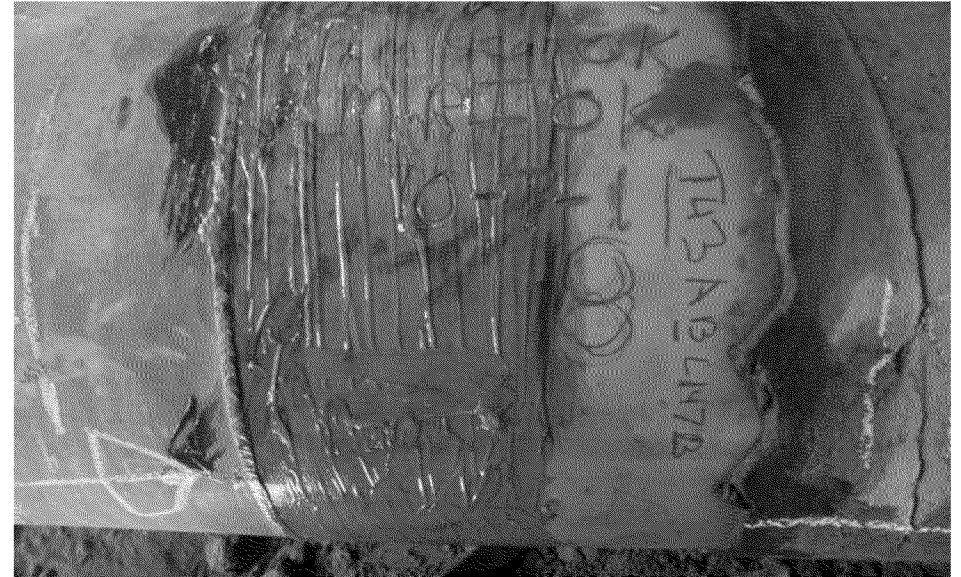
Overview DS of MPIOK and Lamination scan OK.

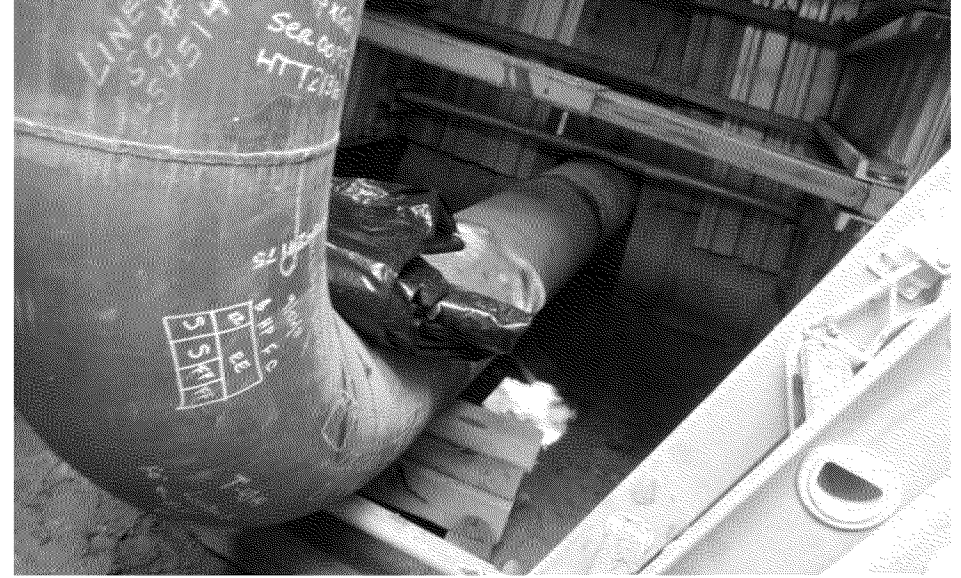
Overview of coating condition 17ft to 20ft, 3:00 position

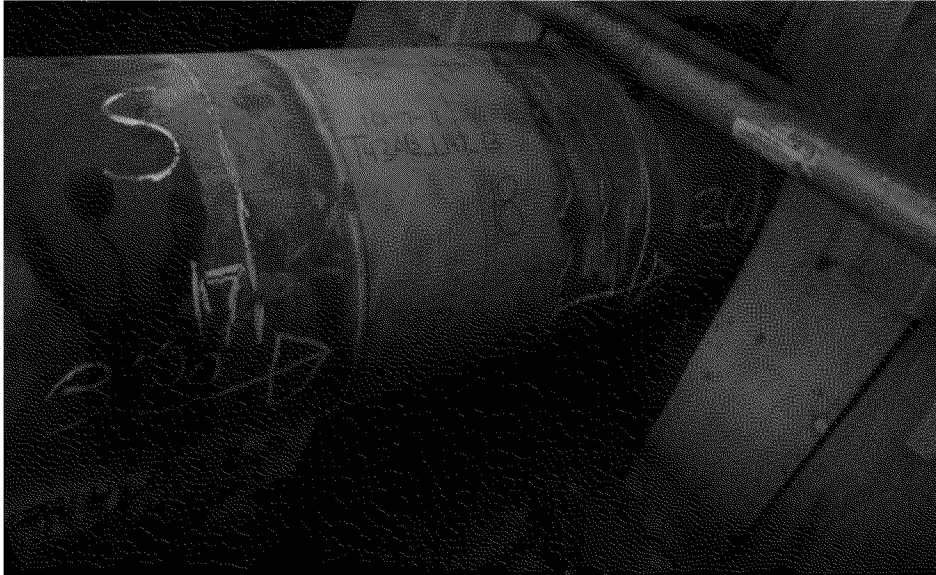
Overview of coating condition 17ft to 20ft, 3:00 position

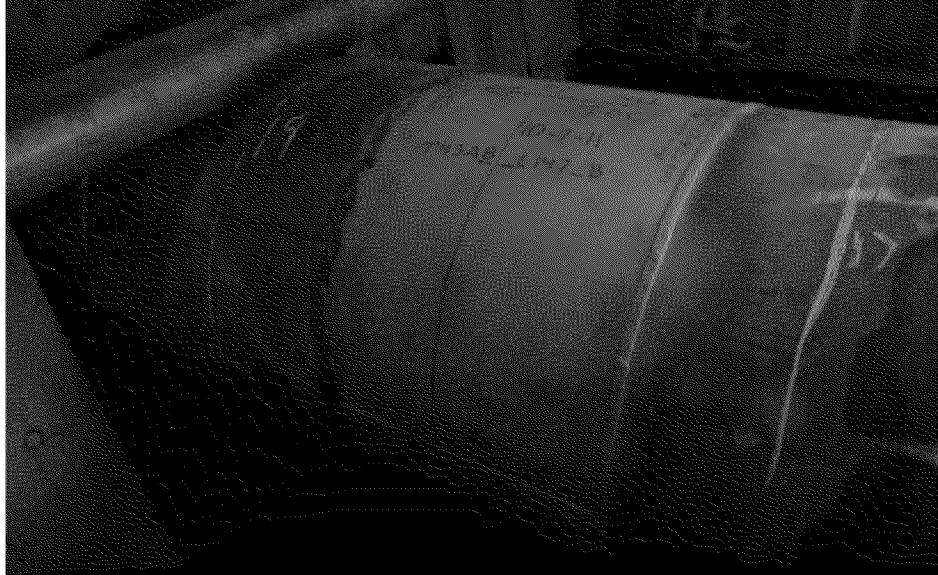
Overview of coating condition 17ft to 20ft, 9:00 position

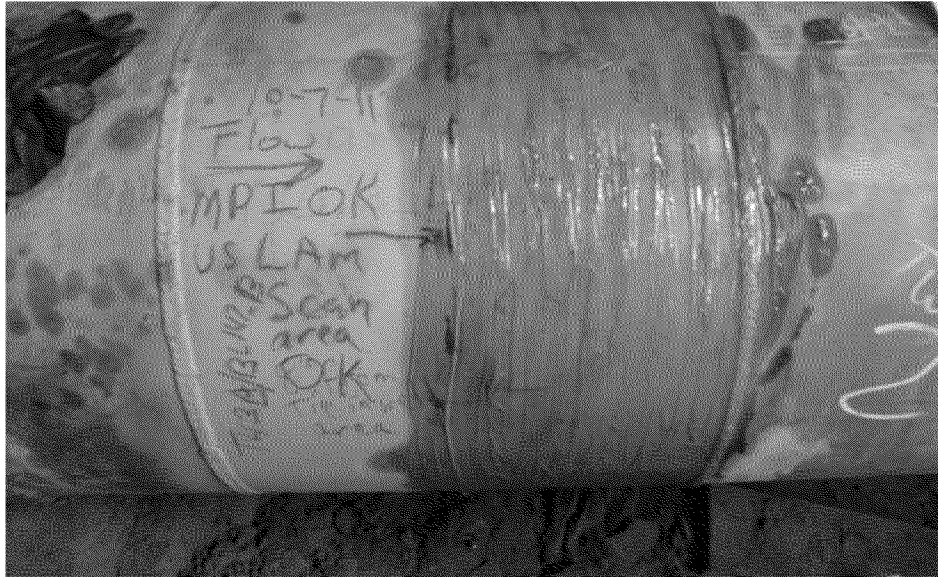
Overview of US MPIOK and Lamination scan OK.

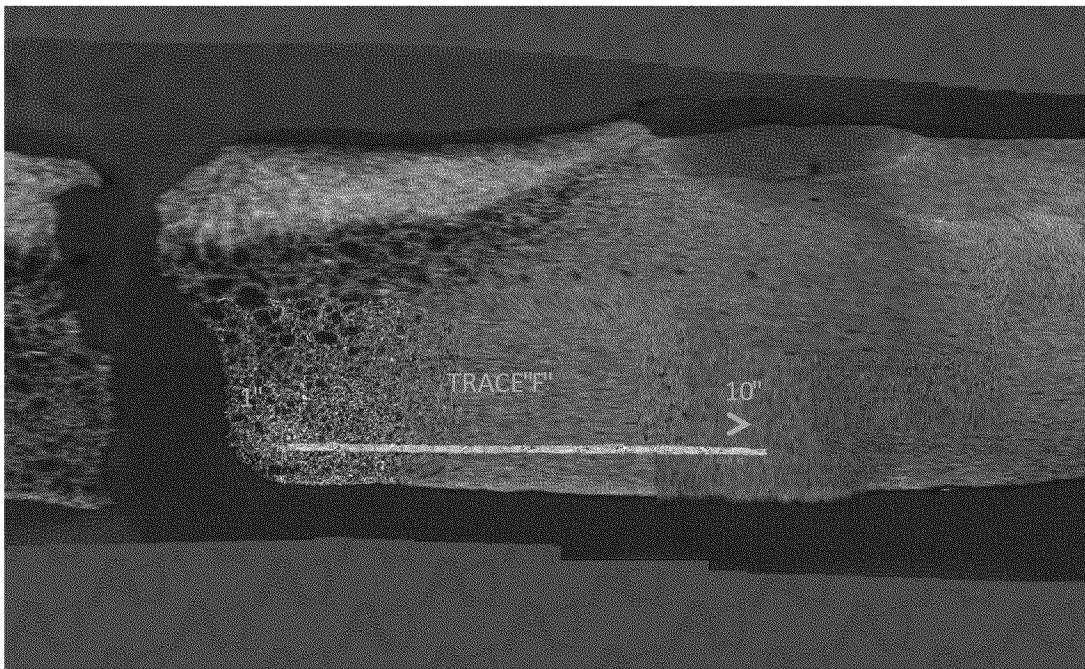
Trace F Loc	Mean Length	Hardness (HV)
1	70.9	184
2	75.3	164
3	74.6	167
4	75.6	162
5	74.9	165
6	80.1	144
7	81.8	139
8	81.8	139
9	82.7	136
10	84.3	130
	Avg:	153
	Max:	184
	Min:	130
