**BEFORE THE PUBLIC UTILITIES COMMISSION
OF THE STATE OF CALIFORNIA**

R.11-02-019
(Filed February 24, 2011)

**DECLARATION OF SUMEET SINGH SUPPLEMENTING THE VERIFIED
STATEMENT OF PACIFIC GAS AND ELECTRIC COMPANY'S VICE
PRESIDENT OF GAS TRANSMISSION MAINTENANCE AND CONSTRUCTION
IN RESPONSE TO RULING OF ASSIGNED COMMISSIONER AND ASSIGNED
ADMINISTRATIVE LAW JUDGE**

**PG&E Line 147 Britton
and Rogers Avenue Leak:
Metallurgical Analysis**

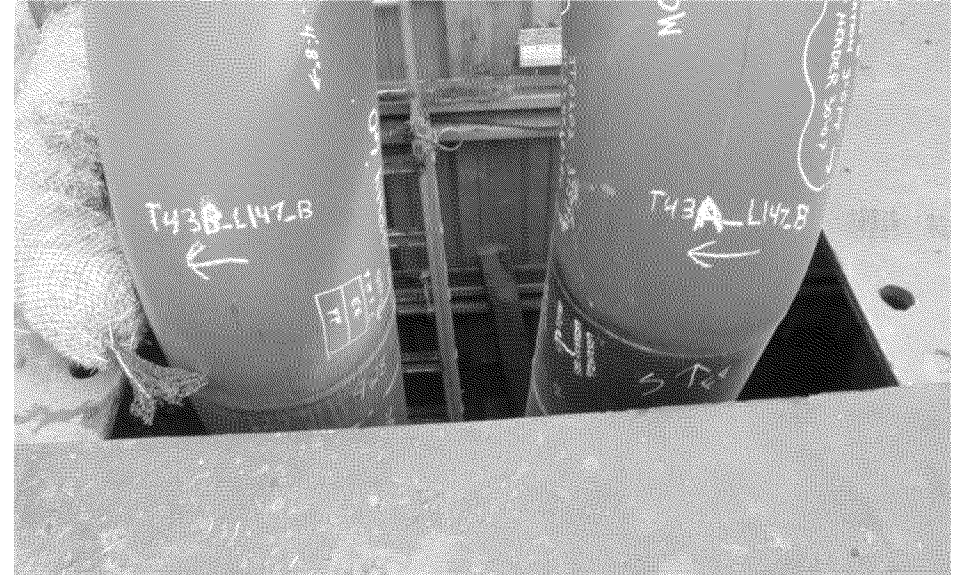
Closeup of T43A(US) & T43B(DS) in same excavation.

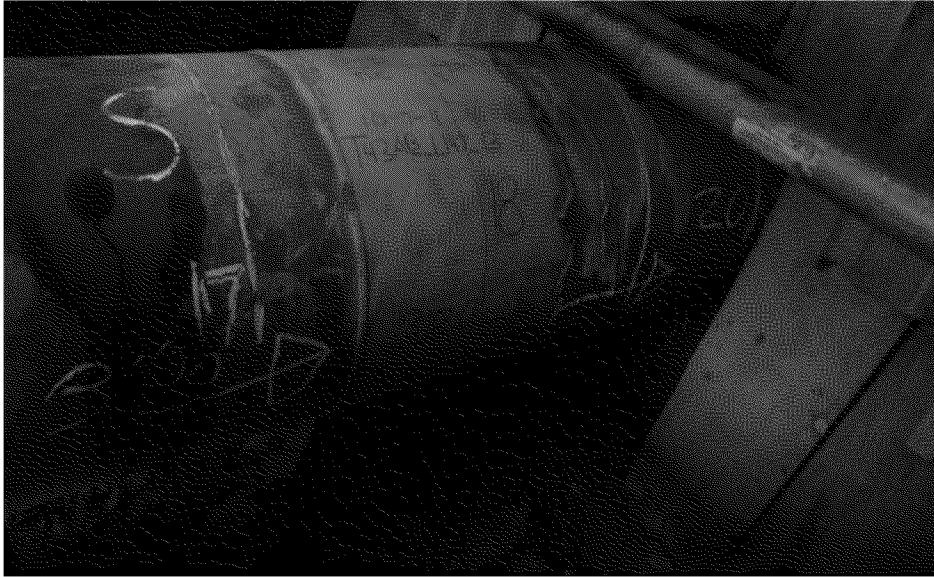
Overview of coating condition 17ft to 20ft, 3:00 position

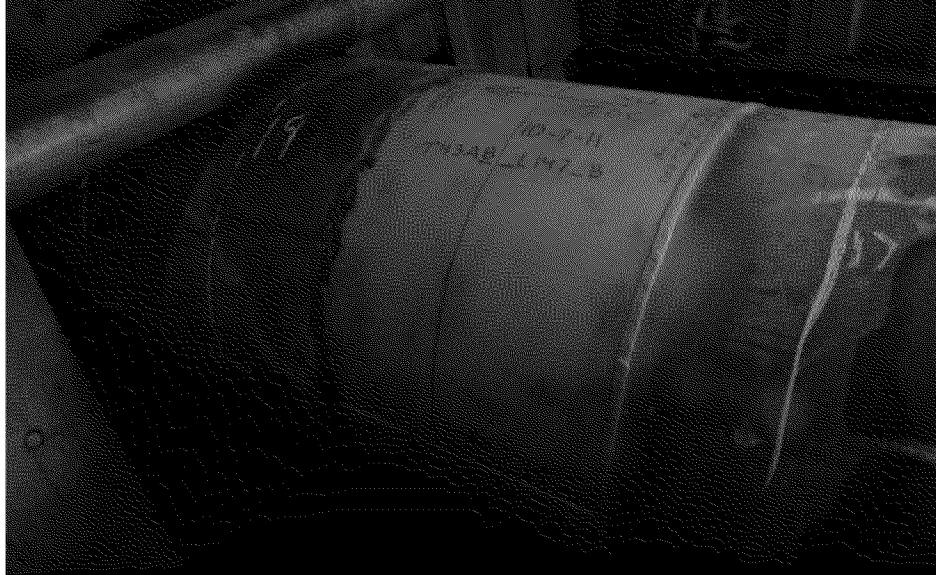
Overview of coating condition 17ft to 20ft, 9:00 position

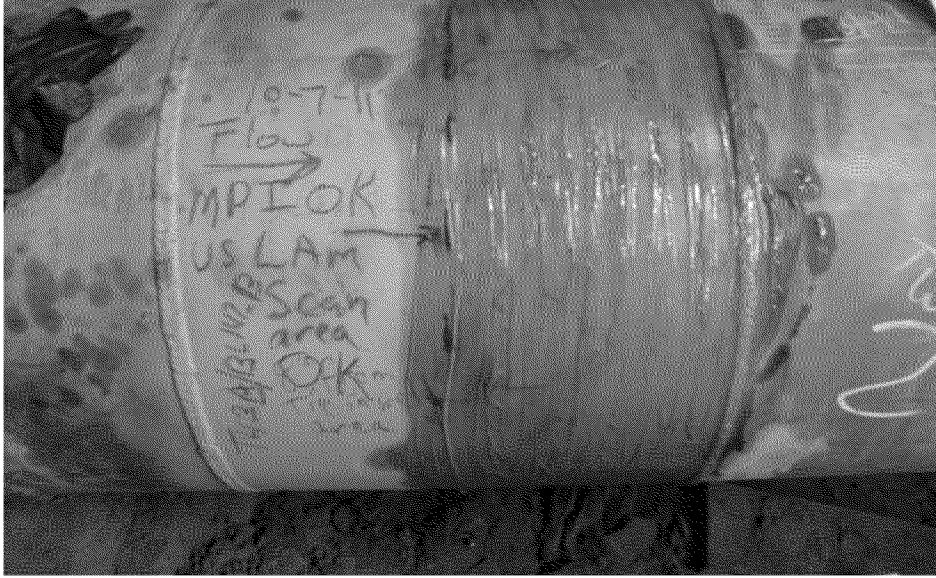
Overview of US MPIOK and Lamination scan OK.

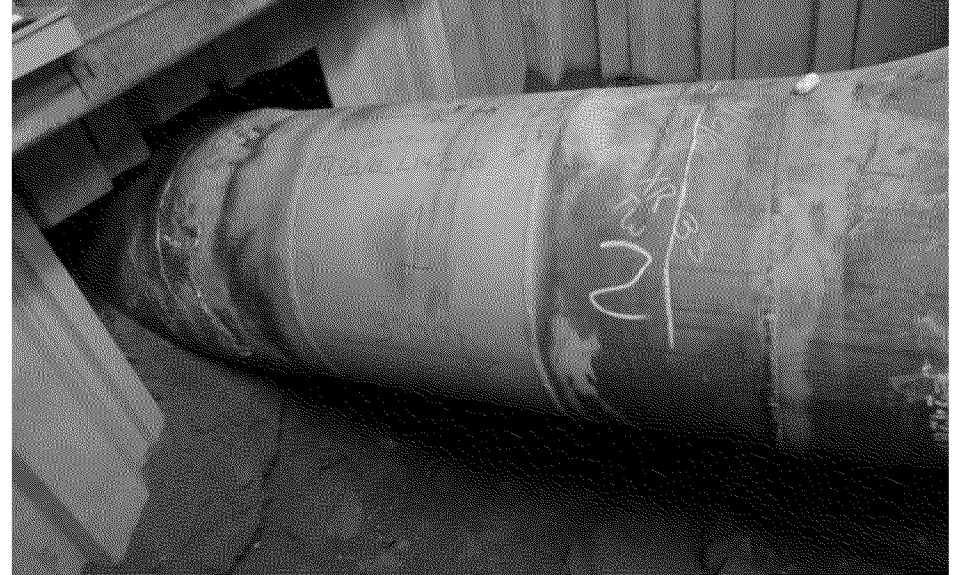
Overview of coating condition -1ft to 2ft, 3:00 position

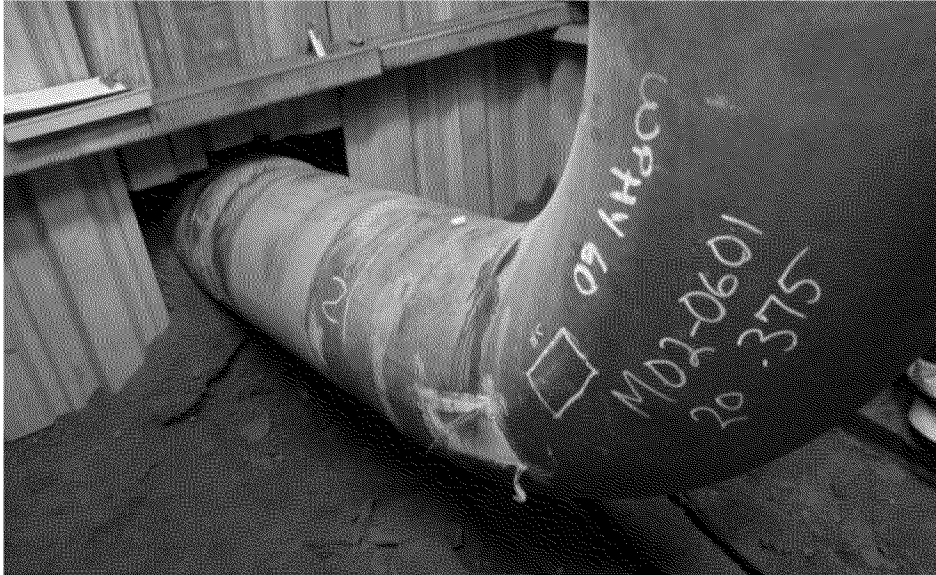
Overview of coating condition -1ft to 2ft, 3:00 position

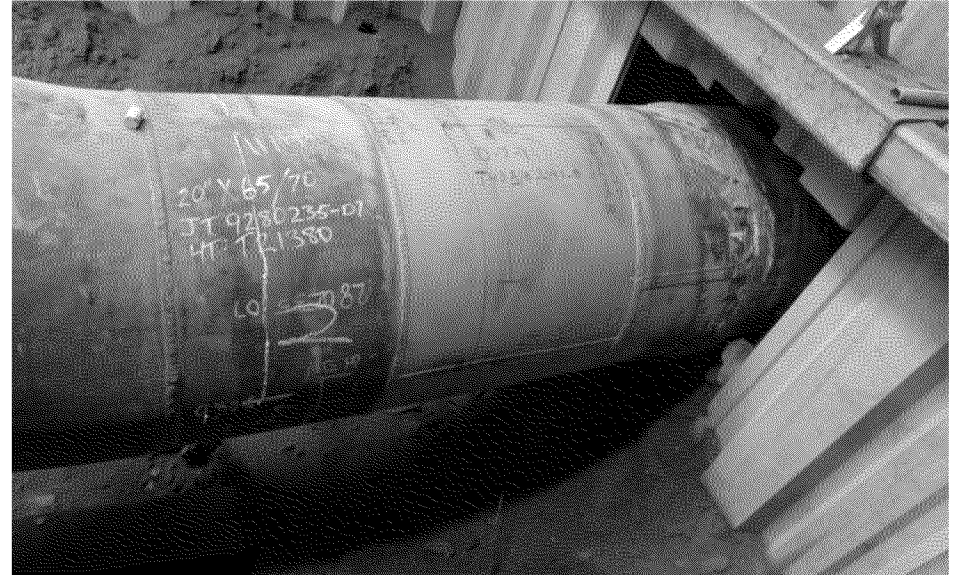
Overview of coating condition -1ft to 2ft, 9:00 position

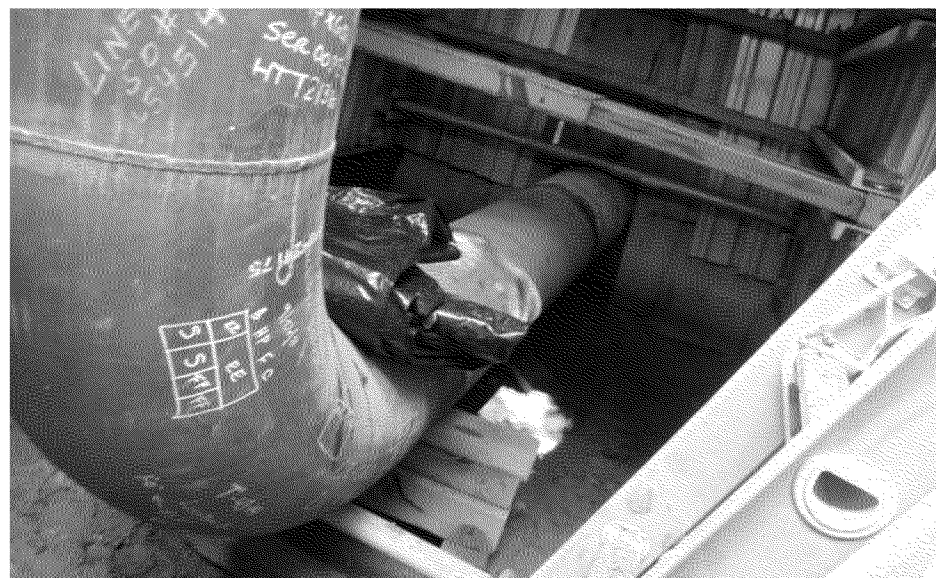
Overview of coating condition 17ft to 20ft, 3:00 position

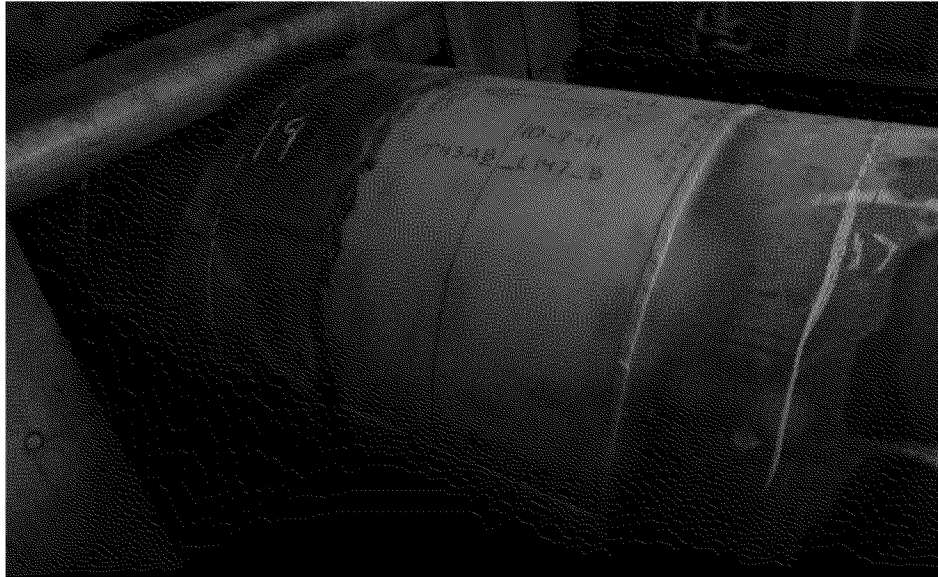
Overview of coating condition 17ft to 20ft, 9:00 position

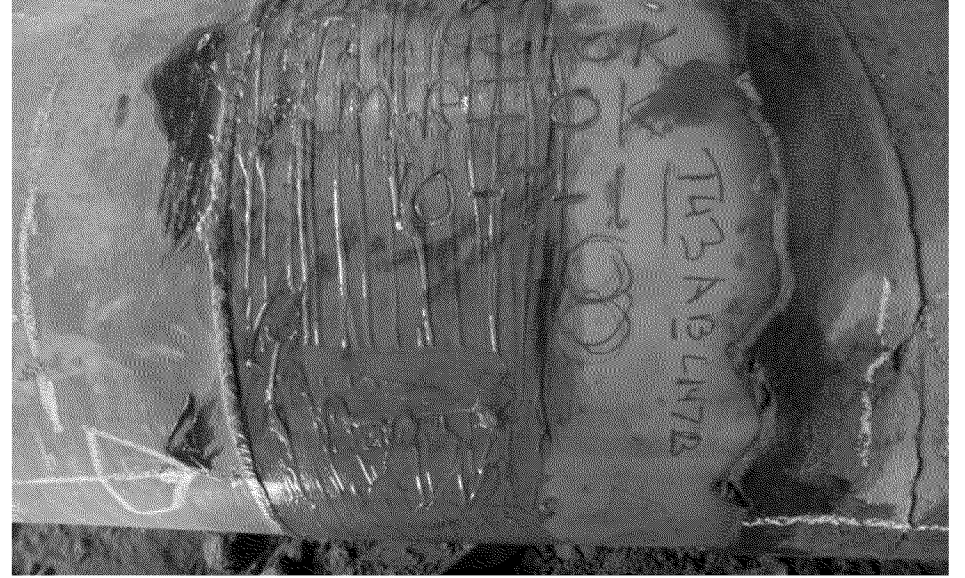
Overview DS of MPIOK and Lamination scan OK.
