**BEFORE THE PUBLIC UTILITIES COMMISSION
OF THE STATE OF CALIFORNIA**

**DECLARATION OF SUMEET SINGH SUPPLEMENTING THE VERIFIED
STATEMENT OF PACIFIC GAS AND ELECTRIC COMPANY'S VICE
PRESIDENT OF GAS TRANSMISSION MAINTENANCE AND CONSTRUCTION
IN RESPONSE TO RULING OF ASSIGNED COMMISSIONER AND ASSIGNED
ADMINISTRATIVE LAW JUDGE**

**PG&E Line 147 Britton
and Rogers Avenue Leak:
Metallurgical Analysis**

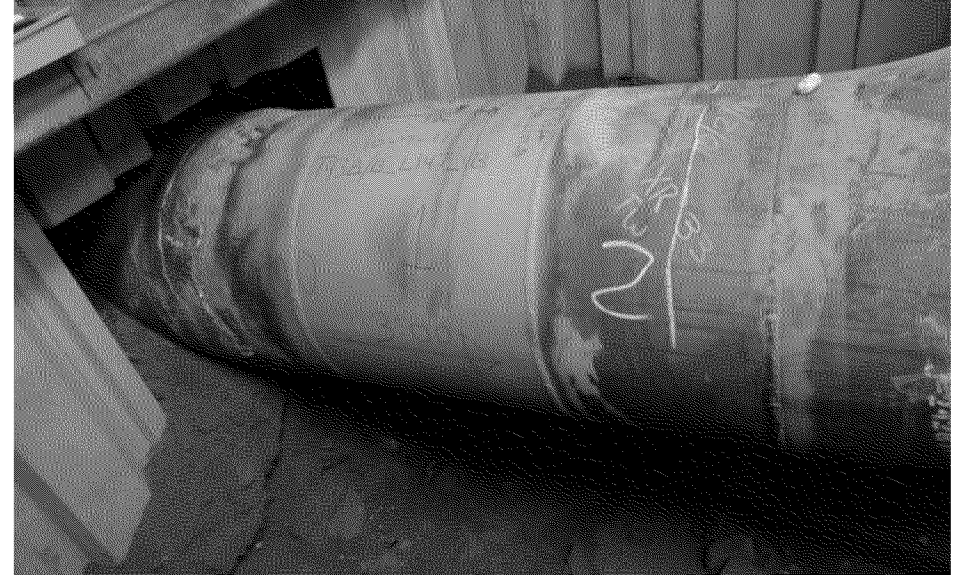
Overview of coating condition -1ft to 2ft, 3:00 position

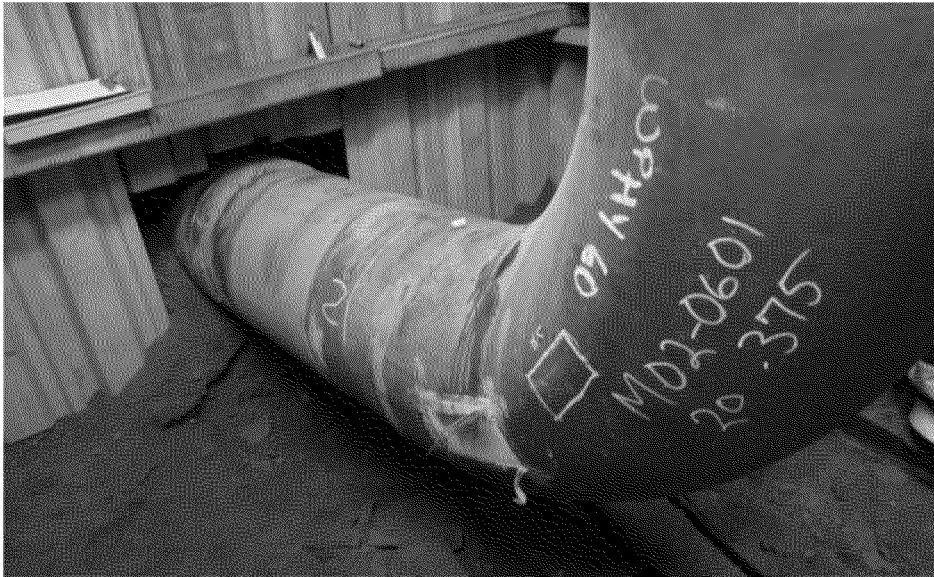
Overview of coating condition -1ft to 2ft, 3:00 position

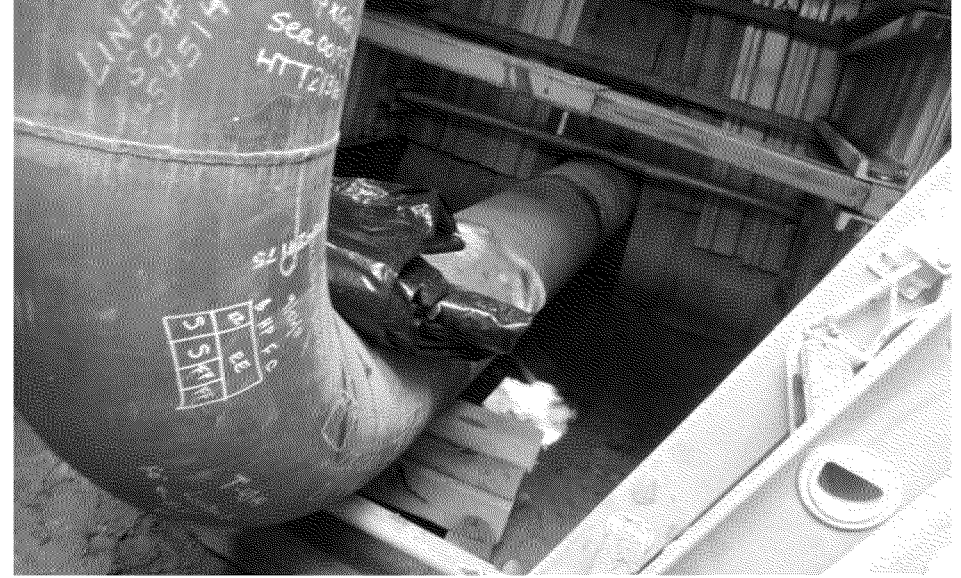
Overview of coating condition 17ft to 20ft, 3:00 position

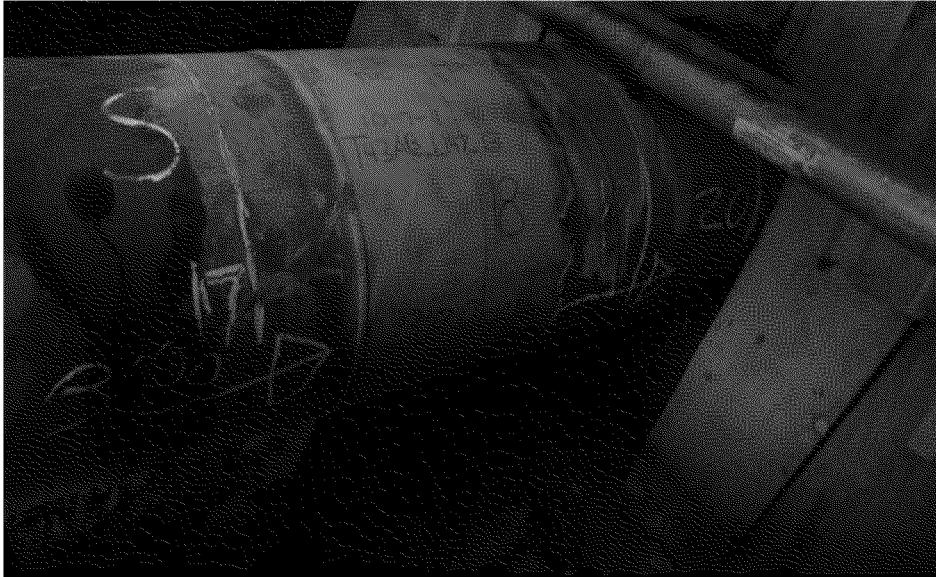
Overview of coating condition 17ft to 20ft, 3:00 position

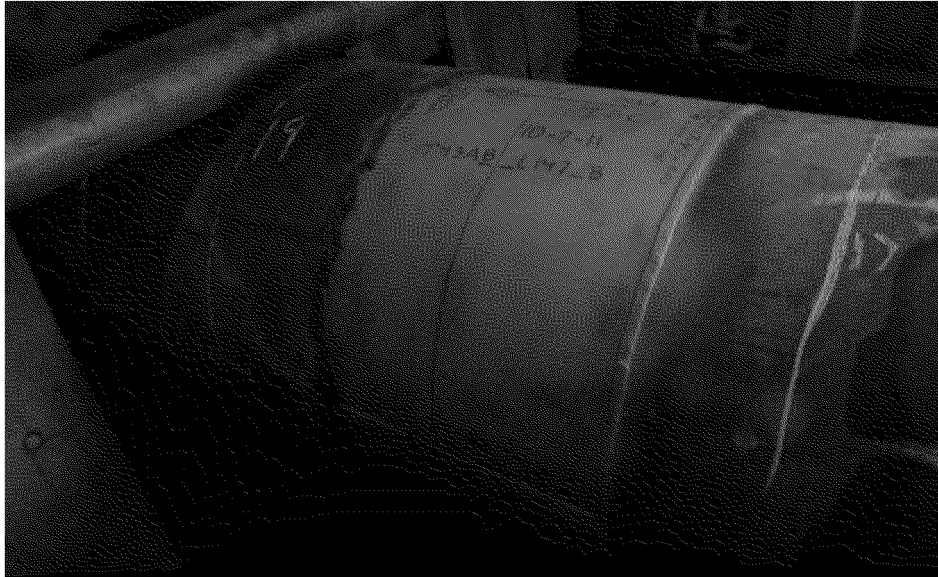
Overview of coating condition 17ft to 20ft, 9:00 position

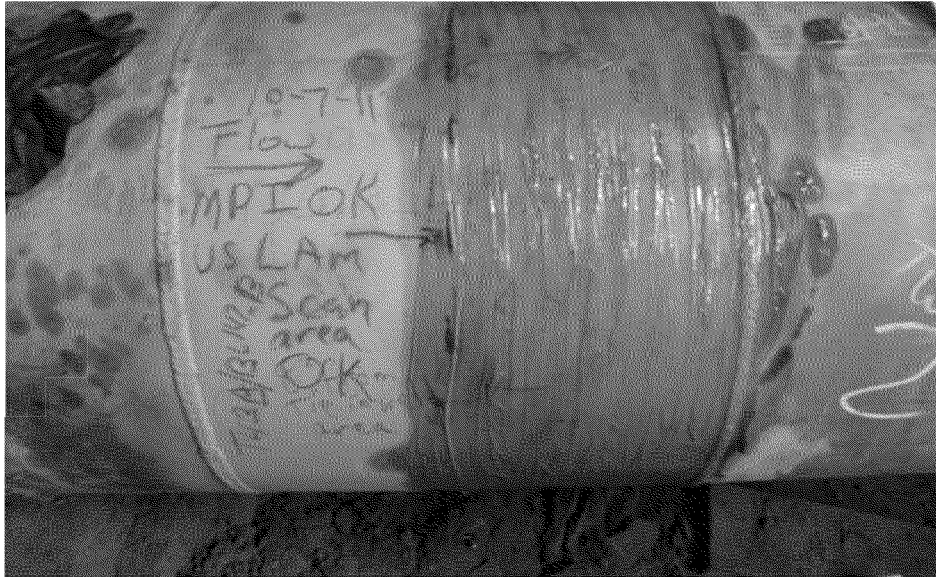
Overview of US MPIOK and Lamination scan OK.

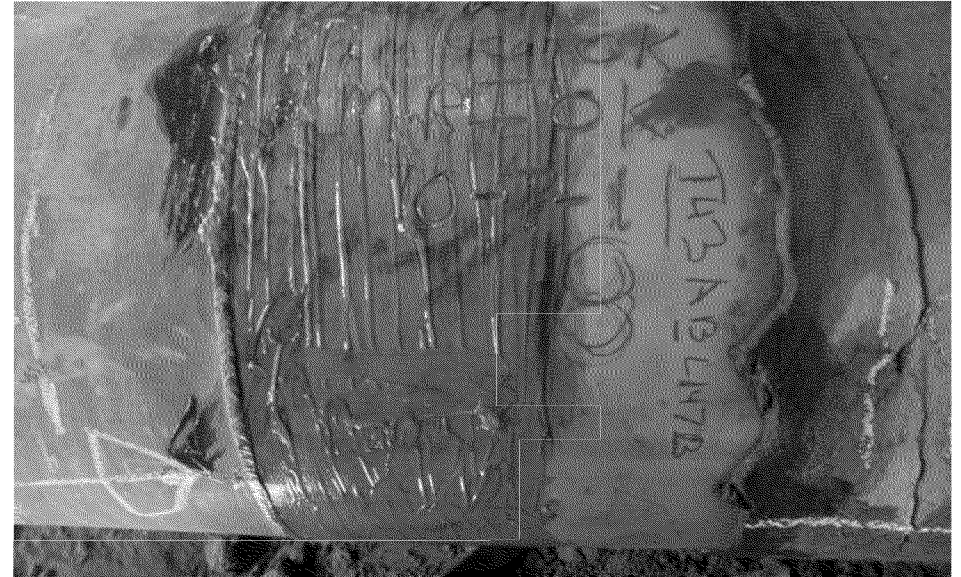
Overview DS of MPIOK and Lamination scan OK.

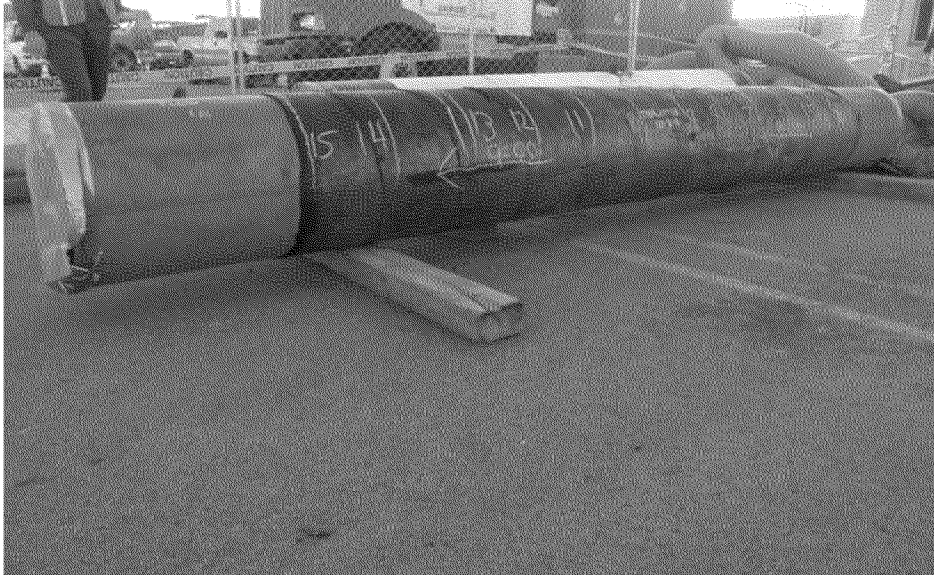
Removed pipe section coating assesment 9:00

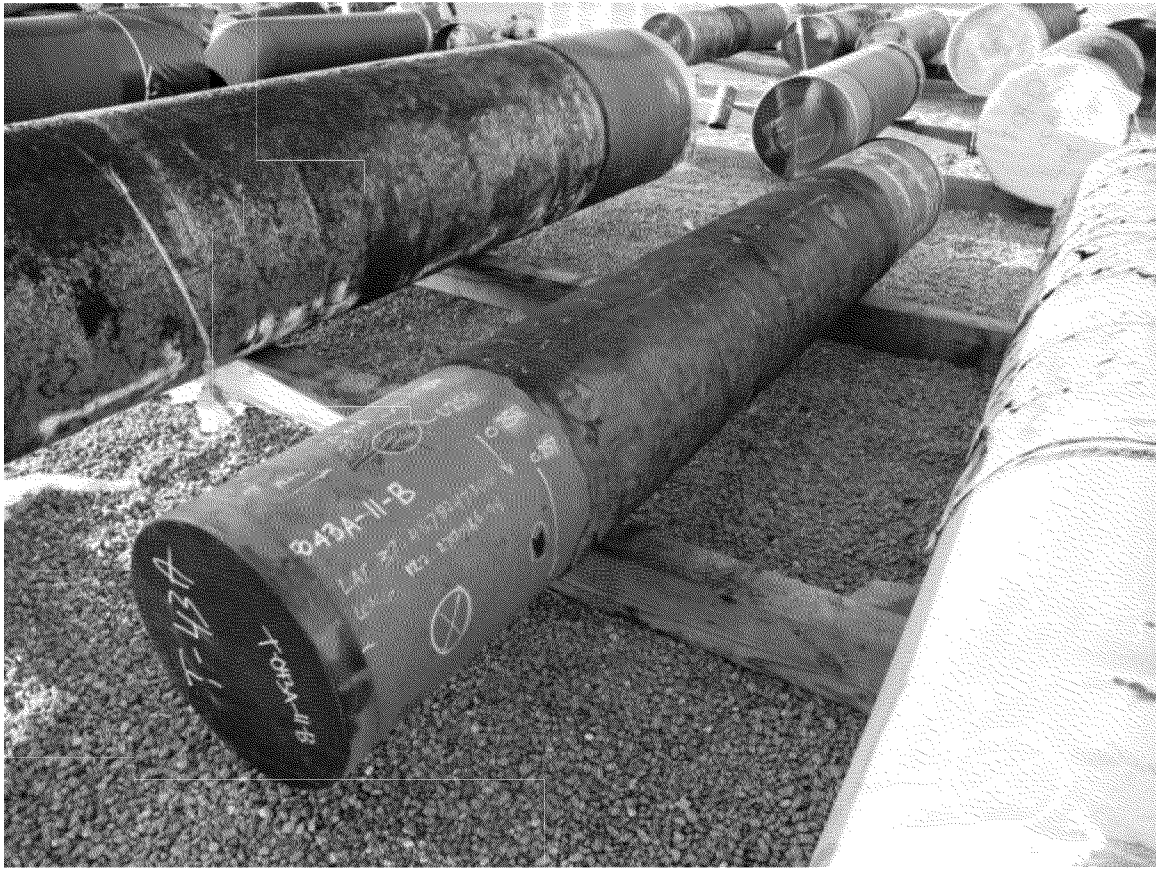
<u>Clock position</u>	<u>12:00</u>	<u>03:00</u>	<u>06:00</u>	<u>09:00</u>
	0.251"	0.253"	0.254"	0.247"

Pipe spool

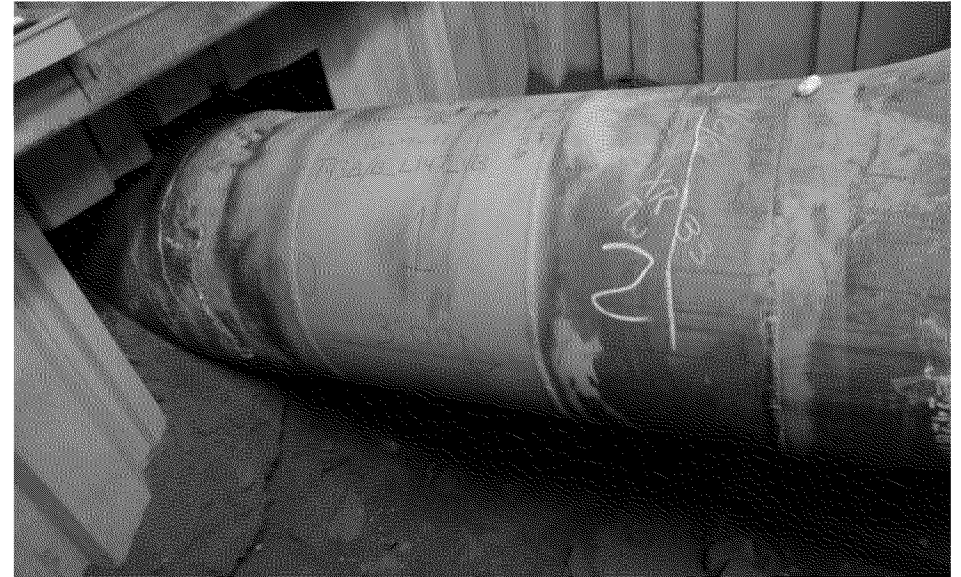
Overview of coating condition -1ft to 2ft, 3:00 position

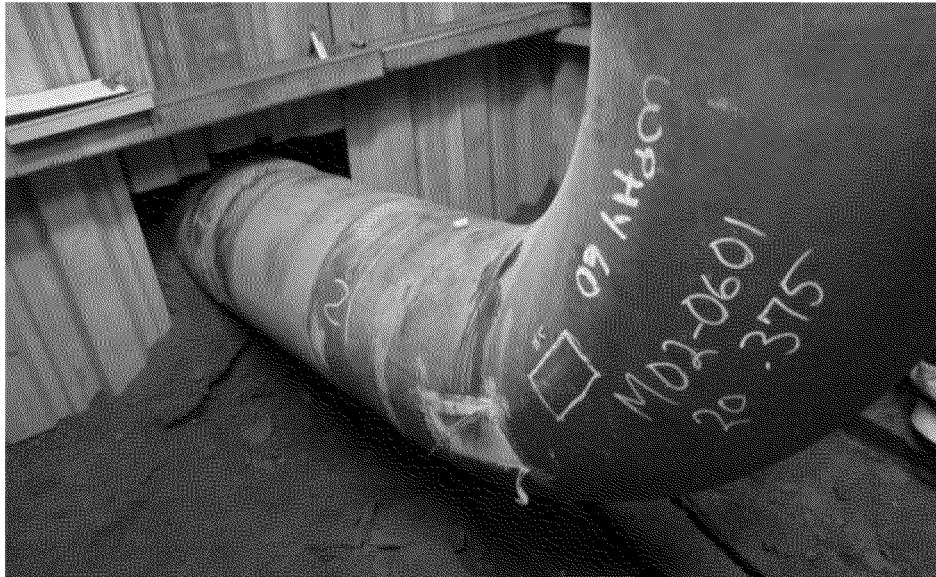
Overview of coating condition -1ft to 2ft, 3:00 position

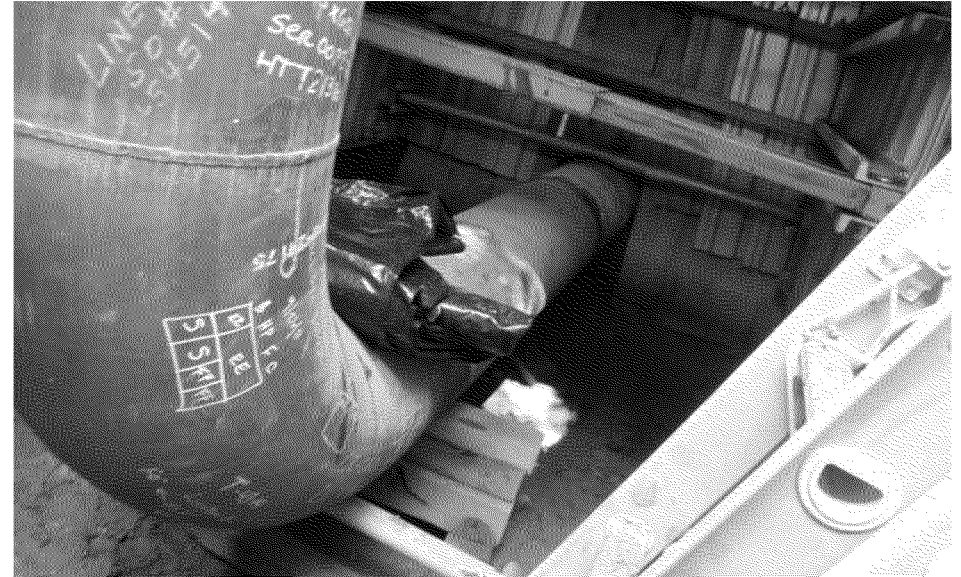
Overview of coating condition 17ft to 20ft, 3:00 position

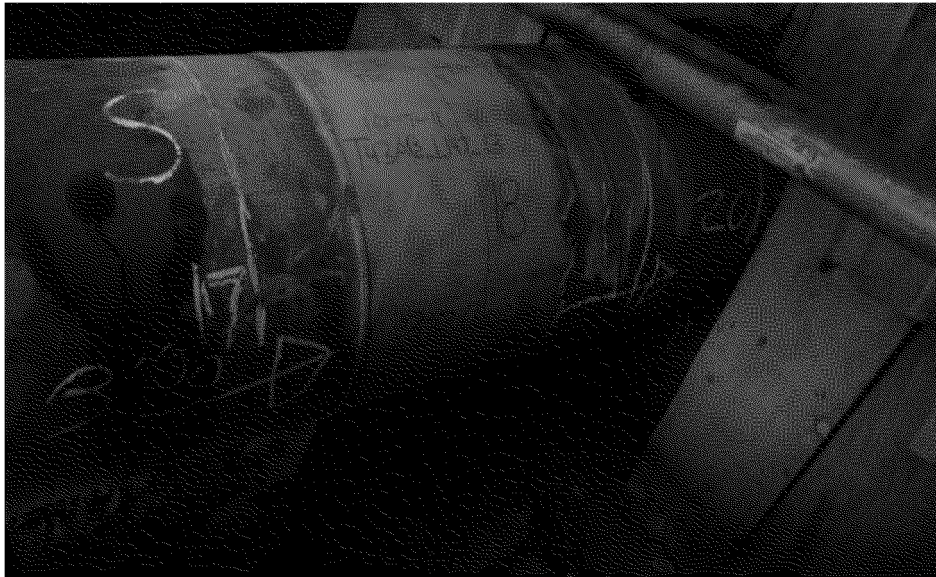
Overview of coating condition 17ft to 20ft, 3:00 position

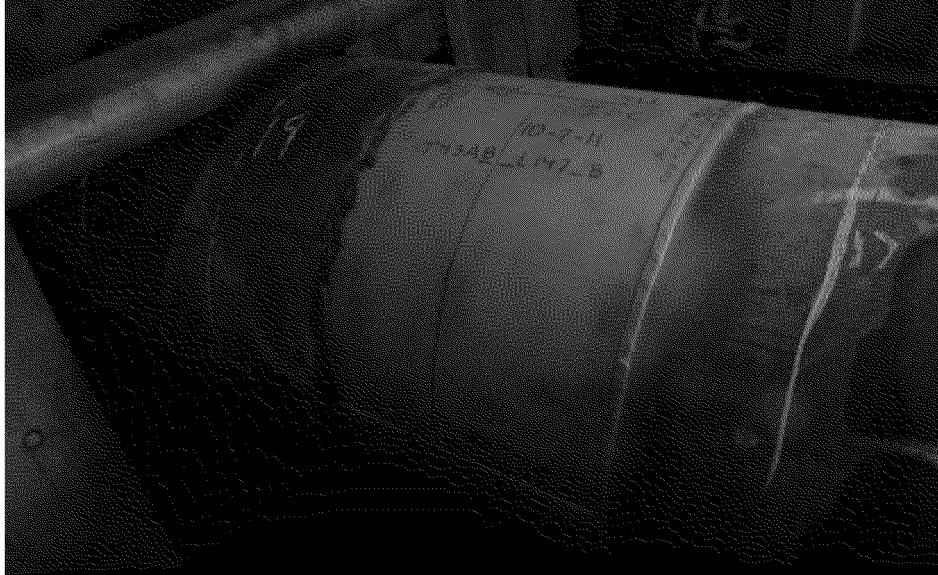
Overview of coating condition 17ft to 20ft, 9:00 position

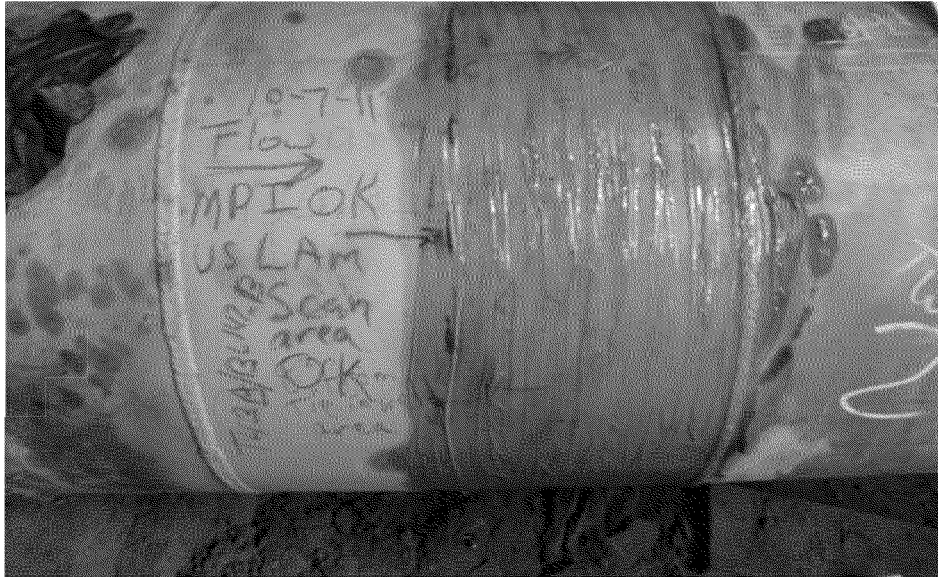
Overview of US MPIOK and Lamination scan OK.

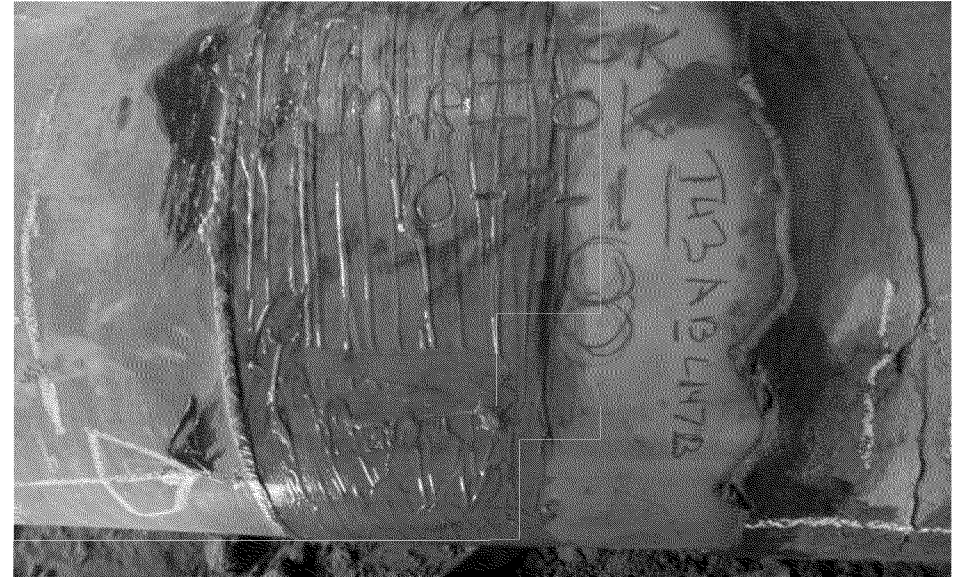
Overview DS of MPIOK and Lamination scan OK.
